HOLY TRINITY CHURCH

OLD BEWICK

AN ARCHAEOLOGICAL ASSESSMENT

JANUARY 2018

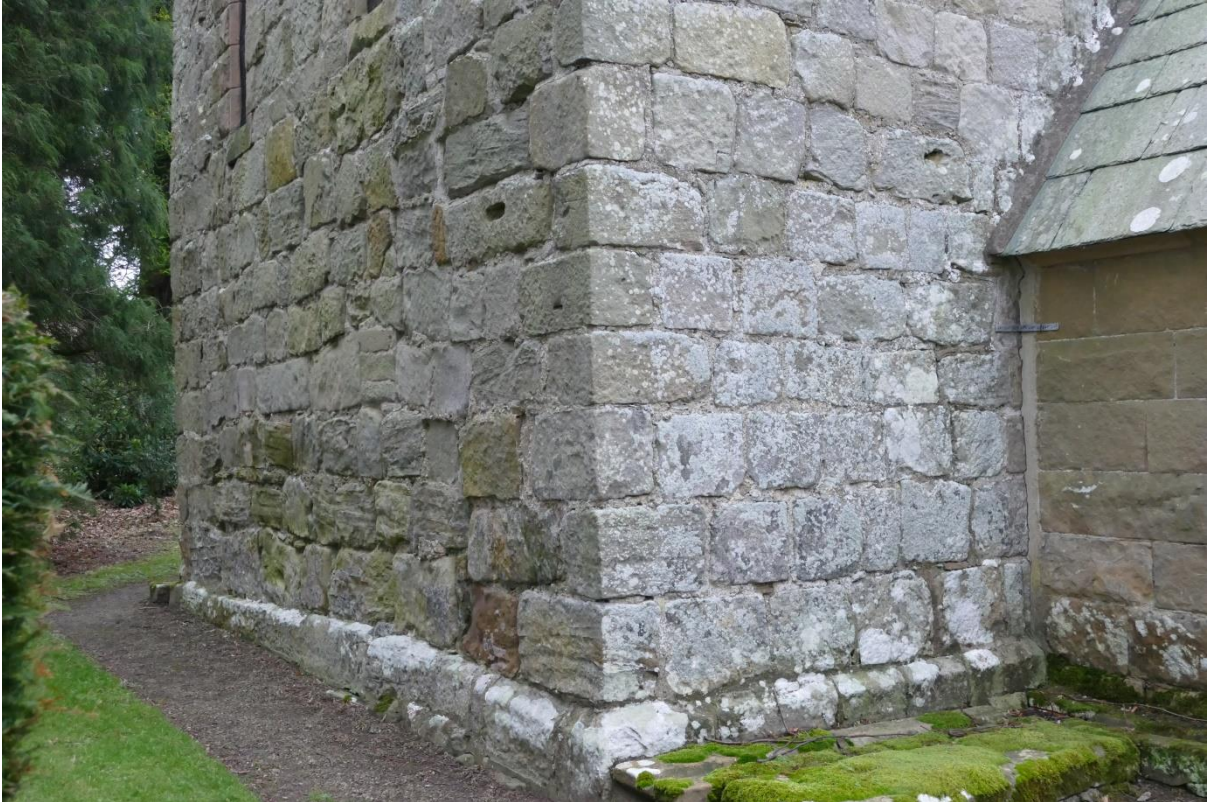
The south-west corner of the nave; contrast better-squared fabric of south wall (right) with less regular megalithic masonry of west end (left)

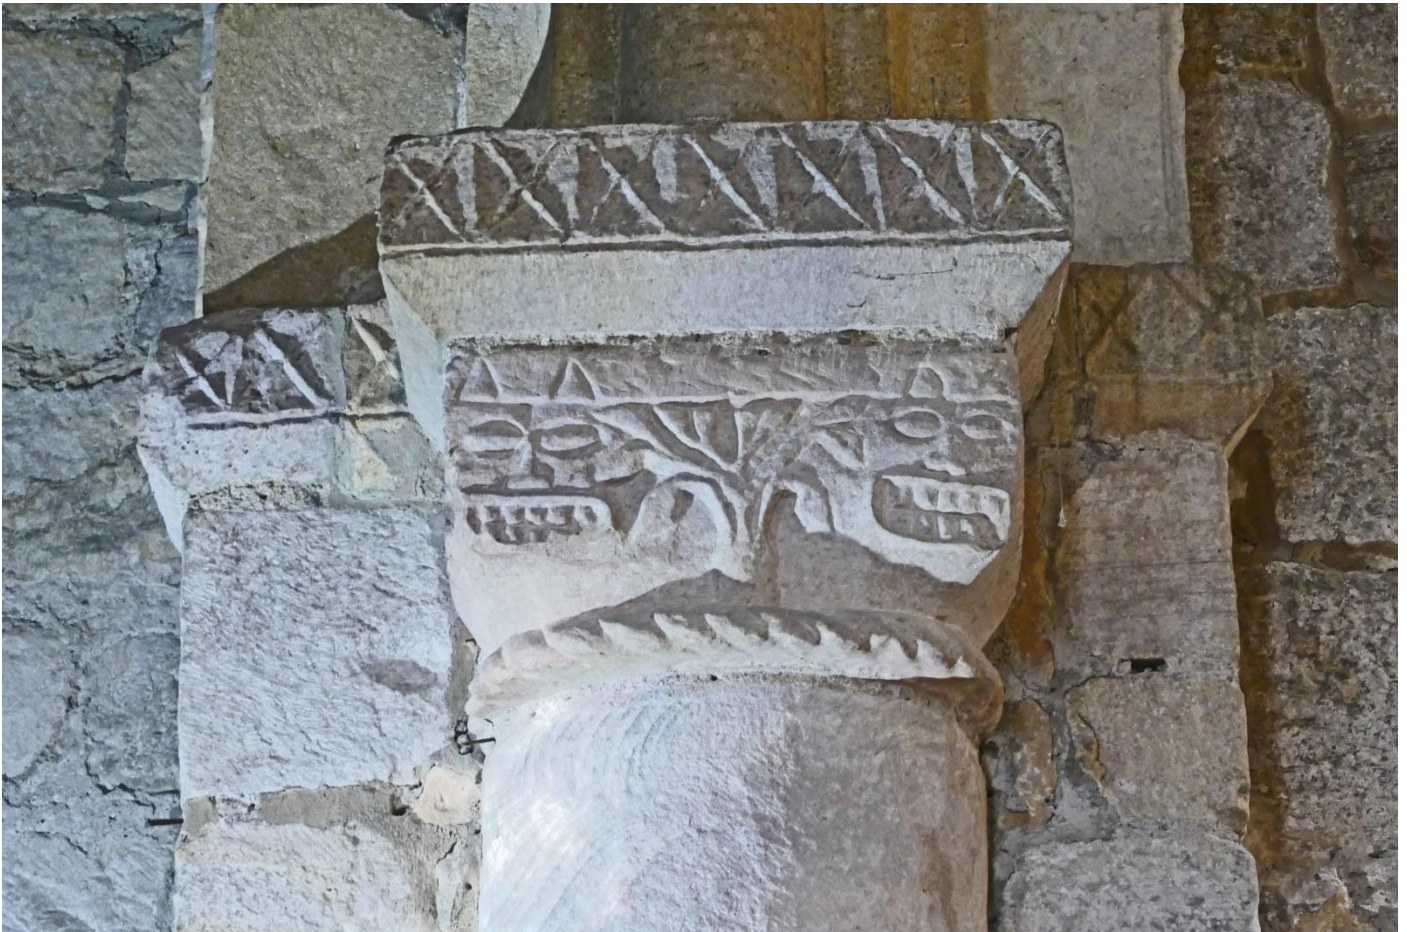
North Capital of Chancel Arch

Anciently the church was one of a number of chapels within the parish of Eglington. It has very little recorded history. In 1105 Queen Maud of Scotland gave or confirmed the manor of Bewick to Tynemouth Priory, and from this, and from the quoted similarity between the north capital of the chancel arch and one of the capitals in the late-11th century Norman chapel of Durham Castle which are seen as 'obviously by the same hands' the NCH assumes a late 11th or early 12th century date for the majority of the building, although it leaves open the possibility that the west end is part of a 'still older church'. In fact the capital is only broadly similar to the Durham ones⁴ and might well be a little later.

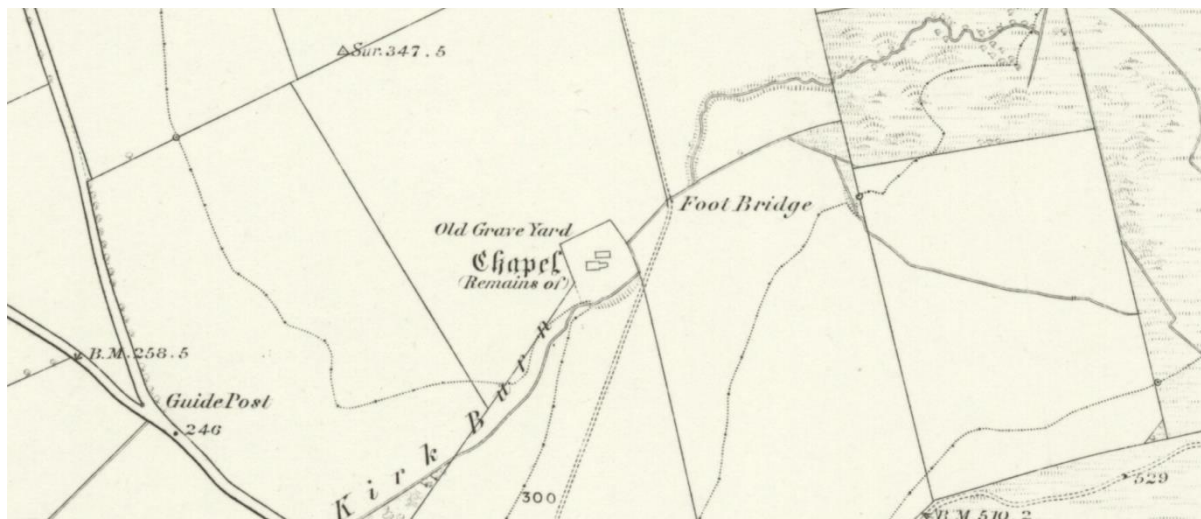
The outline of the ruined chapel before restoration is shown on the c 1860 Ordnance Survey 6":1 mile map (above) which also depicts, apparently unmentioned in other sources, the outline of a rectangular building set parallel to and a little north-east of the church.
