The Church of St Cuthbert,
Elsdon,
Northumbeland

An Archaeological Assessment
May 2010

PETER F RYDER
B.A., M.Phil, F.S.A
HISTORIC BUILDINGS CONSULTANT

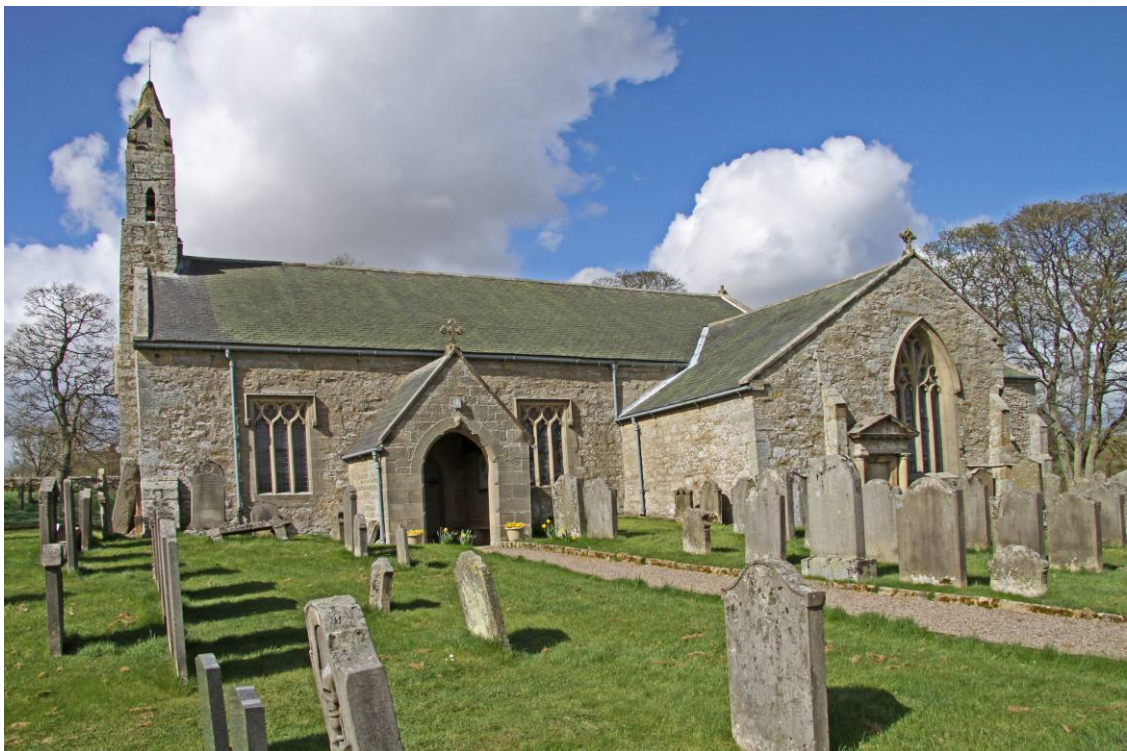
The church from the south

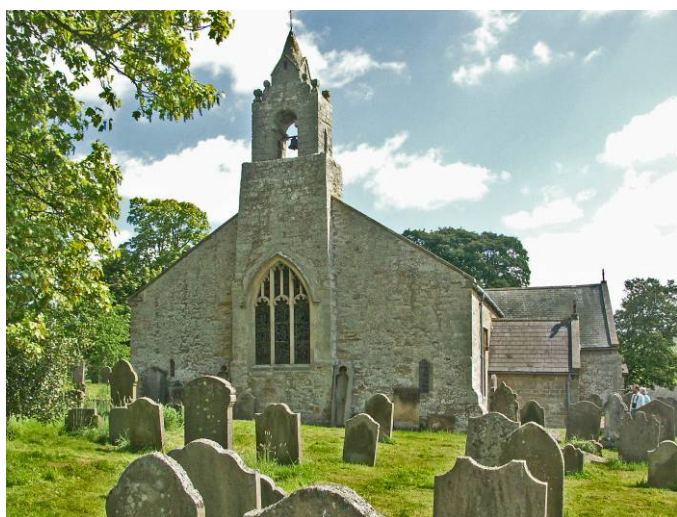
The west end of the **Nave** is built of coursed roughly squared stone, now very heavily mortared. The bellcote is carried by a broad but shallow projection, containing the west window of three cinquefoil-headed lights with panel tracery over under a two-centred arch; all its stonework is of later 19th-century date, and above its head is the four-centred arch of a previous window, although possibly no older than the early 19th century. The bellcote is one of a distinctive Northumberland group, probably of 17th century date; it has a round-headed arch with square imposts and a keystone, with finials on either side and a cross-gabled spirlet above, carrying a wrought-iron finial cross. On either side of the bellcote projection are short lengths of a big triple-stepped sloping plinth; beyond these, in the west walls of the aisles, are narrow windows that have had round heads, now somewhat mutilated; the larger one, on the south, has upright blocks as its jambs. The east face of the lower section of the bellcote shows the remains of the roof tabling of a taller and more-steeply-pitched nave roof, difficult to relate to the present tall aisles; this

The church from the west

presumably indicates that this part pre-dates the rebuilding of the aisles, and is thus probably of medieval date. The gable itself has a raised slab coping, with short horizontal returns at its feet, in a common late 18th or early 19th century manner. The east gable of the nave has a similar coping, and is topped by the base of a lost finial. The south wall of the nave - only a short length of which is exposed above the eastern slope of the transept roof - has a square oversailing course, of 19th-century character, to the eaves.

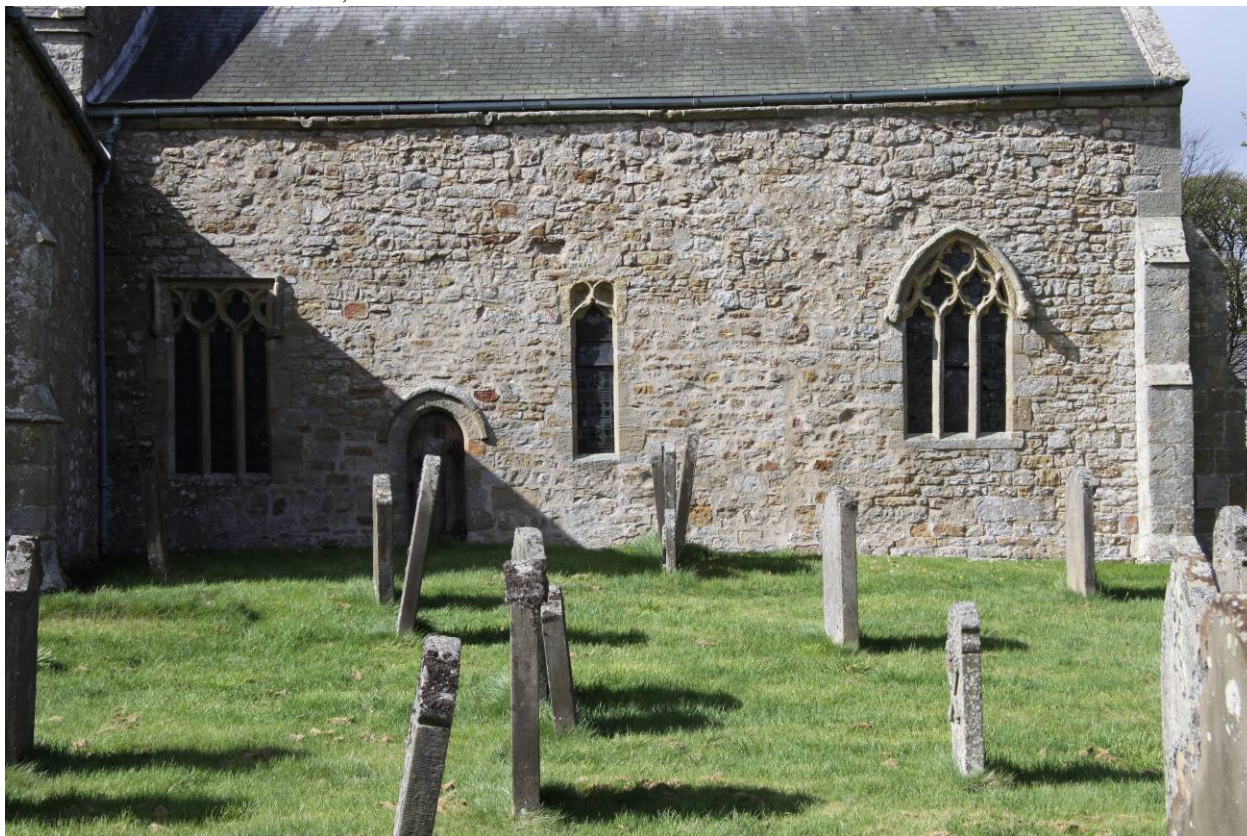
The **Chancel** is of similar fabric to the rest of the church, although less heavily mortared. Its south wall has been relatively untouched by the Victorian restorer, and is of large roughly-coursed rubble. At its west end is a square-headed three-light window of three trefoiled ogee-headed lights with cusped mouchettes above, under a moulded hood with worn heads stops. Its sill is set a little lower than those of the other windows in the wall, so that in effect it is a 'low side' window, the function of which used to exercise Victorian antiquarian minds. Then comes a priest's door with an irregular four-centred head and a continuous chamfer, with a hoodmould chamfered above and below, and beyond that a 14th-century single light window with a mutilated

trefoiled head and two sunk mouchettes above. East of this is a vertical crack, probably a simple structural failure rather than a discontinuity in the fabric, and finally an arched window of three trefoiled ogee-headed lights with simple reticulated tracery above, under a chamfered hood with large but badly worn head stops. At eaves level is an old oversailing course with several broken off drainage spouts, similar to those found on the parapets of several local castles and towers. Coupled with the internal thickening of the upper section of the wall (which on the external face looks to be all of a single build). This seems strong evidence that there was originally a parapet with a wall-walk behind it, clear evidence of defensive intent.

The chancel, seen from the south; note old stone spouts to eaves

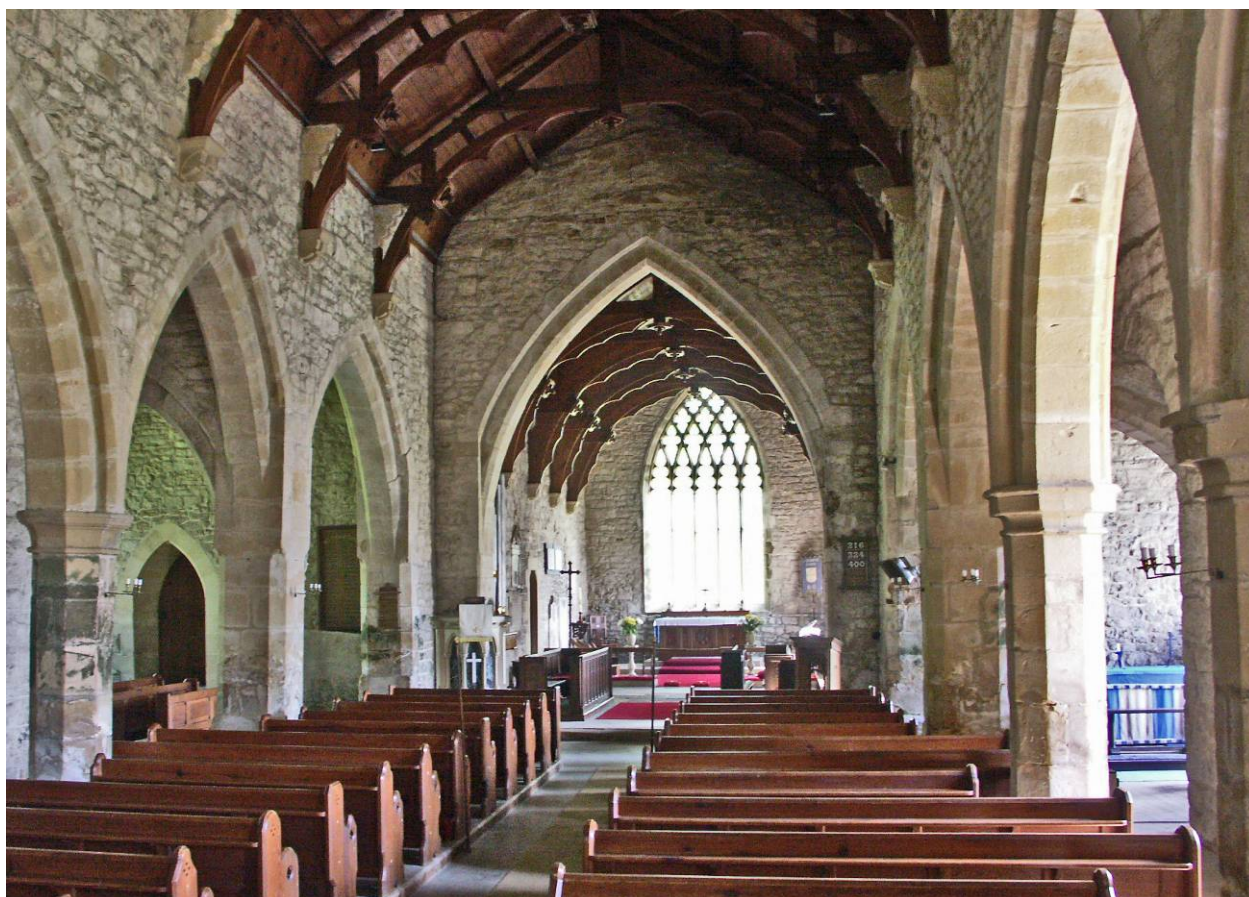
The interior looking east
