ST PAUL'S CHURCH, BRANXTON  
NORTHUMBERLAND  
AN ARCHAEOLOGICAL ASSESSMENT  
NOVEMBER 2012

### St Paul's Church, Branxton

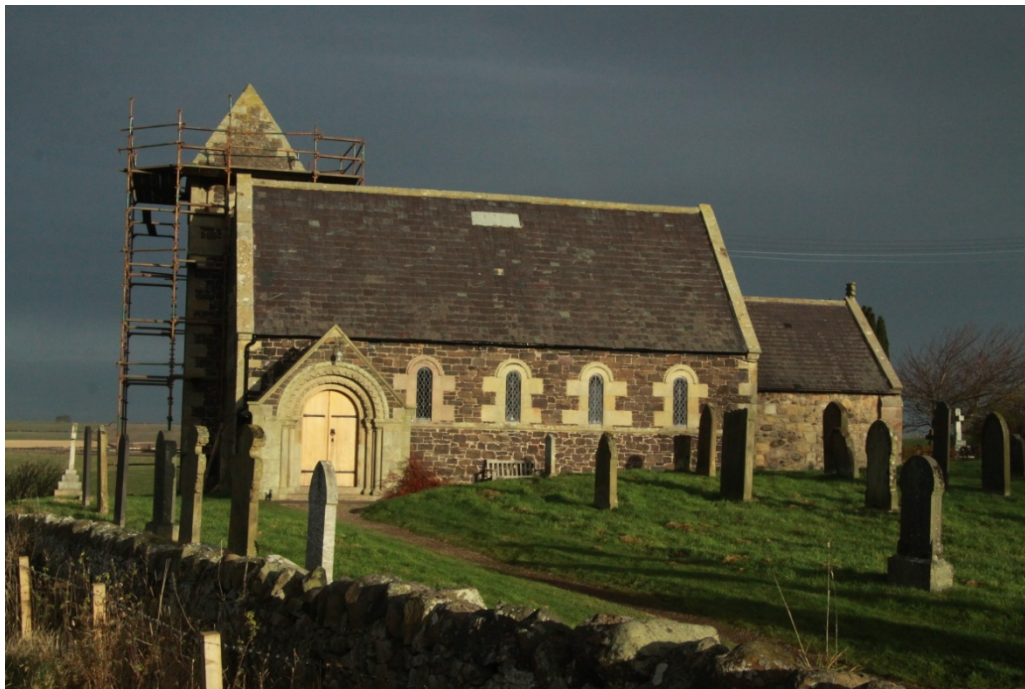
*The church from the south, November 2012*

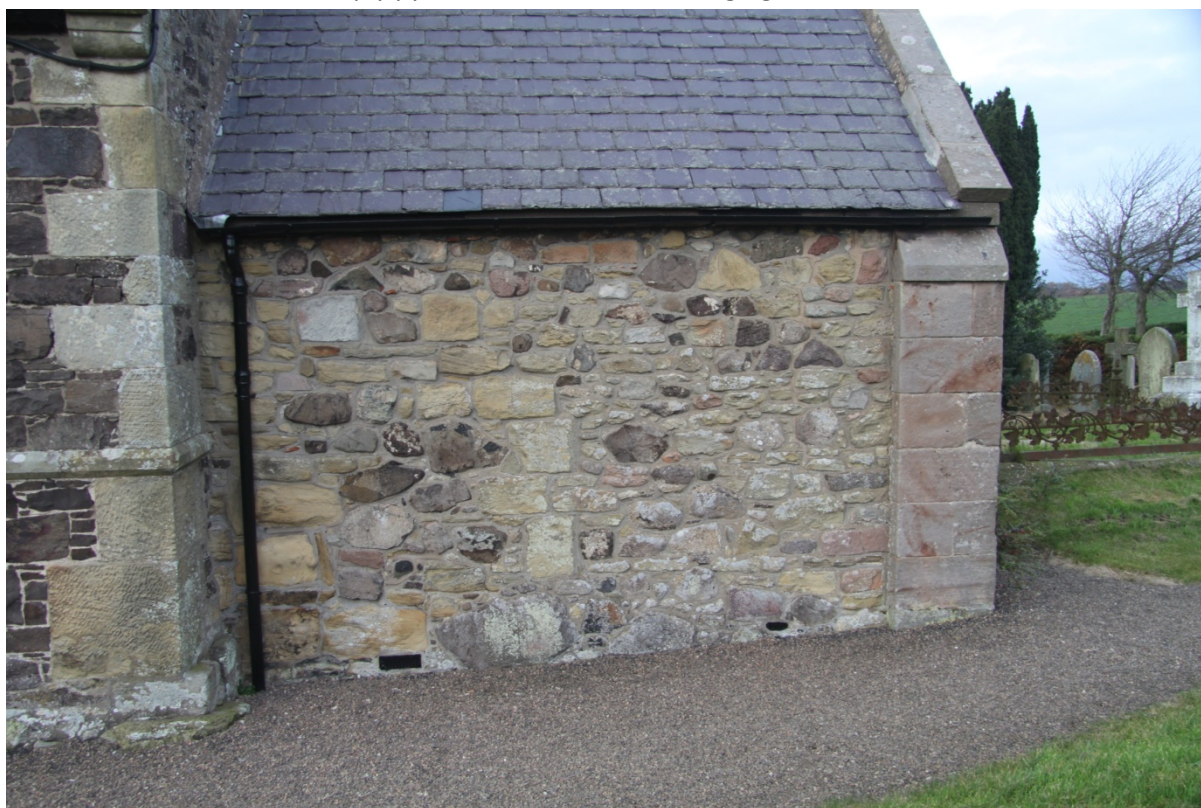
*The south wall of the chancel; note apparent remains of west jamb of opening (near centre) and re-used (?) angle quoins at south-east corner of nave*

The **Chancel** appears to retain medieval masonry in its side walls, which are today devoid of any openings. On the south the western section of the wall is of roughly-coursed large rubble (some igneous stone, some sandstone) as far as a ragged vertical joint which includes two upright chamfered blocks that looks as if they may be part of the west jamb of an early opening. The eastern part of the wall is of smaller rubble, and there is no clear indication of any east side to the putative opening. At the east end is a pilaster buttress of pink sandstone ashlar. The 19<sup>th</sup>-century east wall has quite a large round-headed window with an arch of two orders, the inner of square section and the outer with a roll moulding, carried on jamb shafts with cushion capitals, and imposts chamfered on their lower angles; there is a hoodmould, with turned-back ends, chamfered on its underside. The north wall has some large blocks in its base, but roughly-coursed rubble above; as on the south there is a 19<sup>th</sup>-century pilaster buttress at the east end. The only possible feature is close to the west end where three blocks look as if they could represent the east jamb and head of a small opening, perhaps a low-side window.

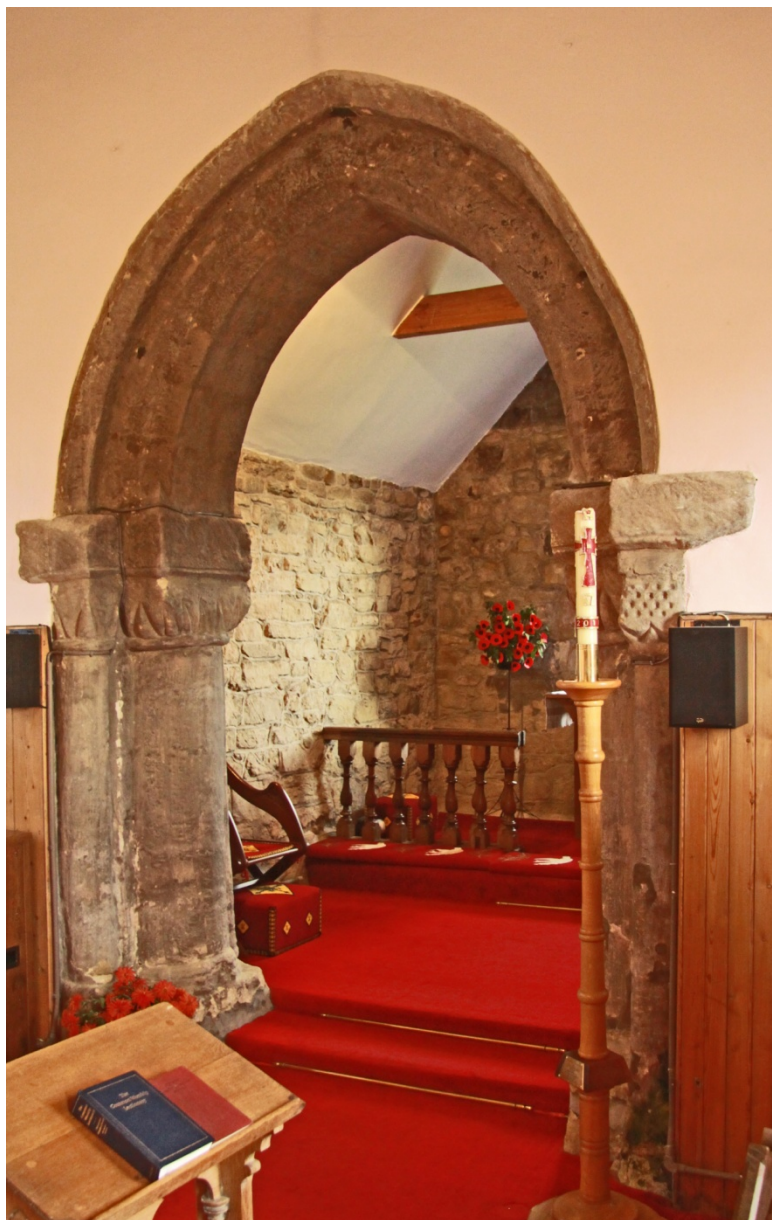
The one ancient feature of the interior is the chancel arch (right), which is somewhat unusual, and poses several problems. The arch itself is of two-centred form, and of two chamfered orders, with broach stops to chamfer of the inner order; towards the chancel the outer order looks of more recent stone, and may be 19<sup>th</sup> century. The arch looks broadly of 13<sup>th</sup> century type, but the jambs on which it rests are clearly older; each consists of a broad semicircular respond flanked by smaller attached shafts, all with scalloped capitals. All have moulded bases, those of the central respond having very battered projecting leaves. The capital of the outer shaft on the south, towards the nave, has a relief-carved pattern of a grid or perhaps interlace on its west face. The impost is heavy, and grooved and chamfered on their lower angles. The west face of the wall is plastered but the east face bare, showing that the big blocks that form the jambs of the arch are irregular, and do not bond deeply into the wall – have they been re-set?

The church, like many in Northumberland, doubtless suffered in the long wars with Scotland; the rather puzzling chancel arch may point to destruction and rebuilding; the arch clearly post-dates the jambs, which have the look of being re-set, and have the look of being made for a rather larger arch (which would have almost certainly been of semicircular form). Was a larger Romanesque church destroyed in some 13<sup>th</sup> century incursion, and a smaller building then erected re-using some materials from its predecessor?.

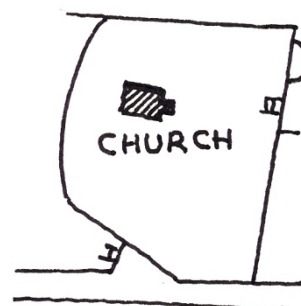
Sketch from 1823 map  
by Thomas Bell, surveyor
