ST GILES CHURCH, BIRTLEY

AN ARCHAEOLOGICAL ASSESSMENT

FEBRUARY 2019

PETER F RYDER
B.A, M.Phil, F.S.A
HISTORIC BUILDINGS CONSULTANT

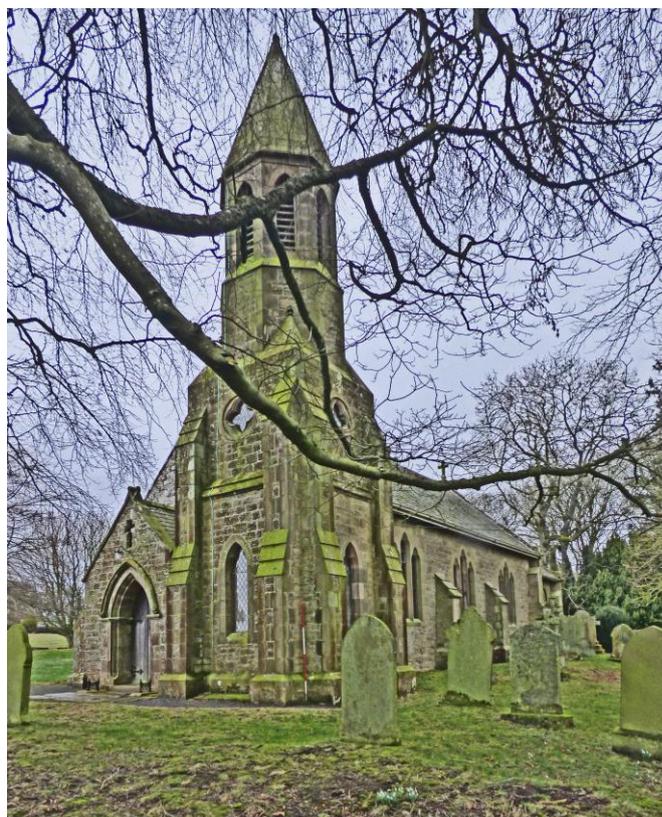
The **Tower** (right; south-west view) rises in three stages; it has a chamfered plinth, and paired stepped buttresses at the corners. Its west wall is flush with that of the adjacent porch, but its south wall projects a little beyond the south wall of the nave. The lower stage has trefoiled lancets on the south and west; a deeply-moulded string marks the base of the second stage, which has a round window with quatrefoil cusping in each face. The transition to the octagonal third stage is achieved by broaches at each corner; the octagonal belfry has a single lancet in each face, and is topped by a steep slated spire carrying a weathervane.

A number of early architectural fragments have been re-set in the eastern of the pair of buttresses at the south-east corner of the tower. Immediately below the first set-back are what look to be three moulded voussoirs, with another adjacent, set in the angle between the nave and tower walls; a little lower down the buttress are a stone with a possible piscina bowl, and a moulding at one end, and another with worn dog-tooth ornament. In the tower wall immediately north of the buttress is a small tapered slab with chamfered edges, almost certainly a medieval grave slab although any design has gone, and below it a stone with an Ordnance Survey benchmark.

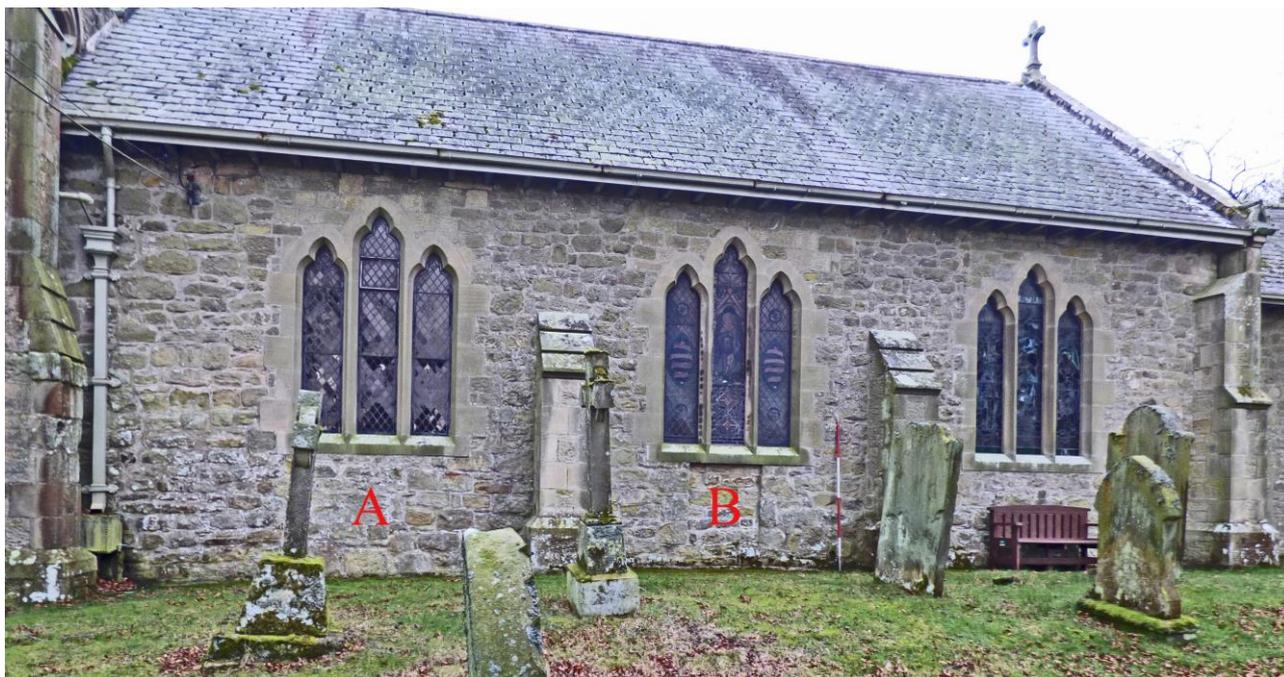
The south wall of the nave has three large 19th-century windows of three stepped trefoiled lancets, with a patch of contemporary pecked-stone walling above each. Below the windows are remains of two pre-19th century doorways. That in the western bay, a little west of the centre of the window, is little more than an vague patch of infill. Set centrally beneath the central window the lower part of a doorway now forms a recess c 5 cm deep; its jambs are of plain square section, and it appears to have a sill c 0.30 m above the present external ground level.

South nave wall: the two blocked doorways are labelled A and B

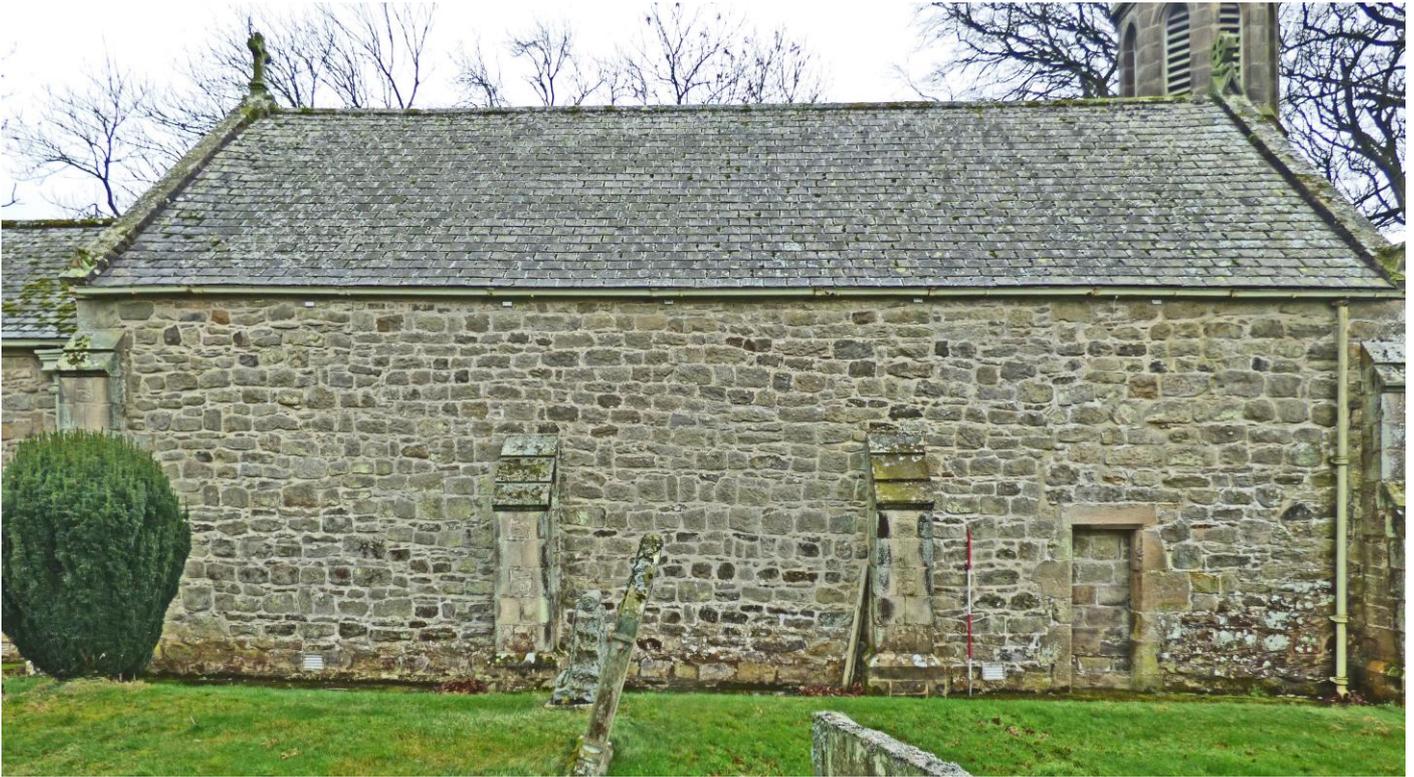
The north wall of the nave is windowless; in the western bay is the blocked north doorway, a plain square-headed opening with a chamfered surround and some large and irregular squared blocks in its jambs; its blocking is recessed behind the rebate of its jambs. To the east of the doorway is a ragged vertical joint also seen internally; the fabric to the west of this seems of rather larger blocks than to the east. To either side of the top of the buttress between the first and second bays are two stones (that to the west at a rather lower level) with a peculiar pattern (tooling?) of incised lines. In the central bay at mid-height are two courses of upright-section blocks, and low down in the eastern bay what looks like an irregular blocked opening about a metre high and wide.

The north wall of the nave

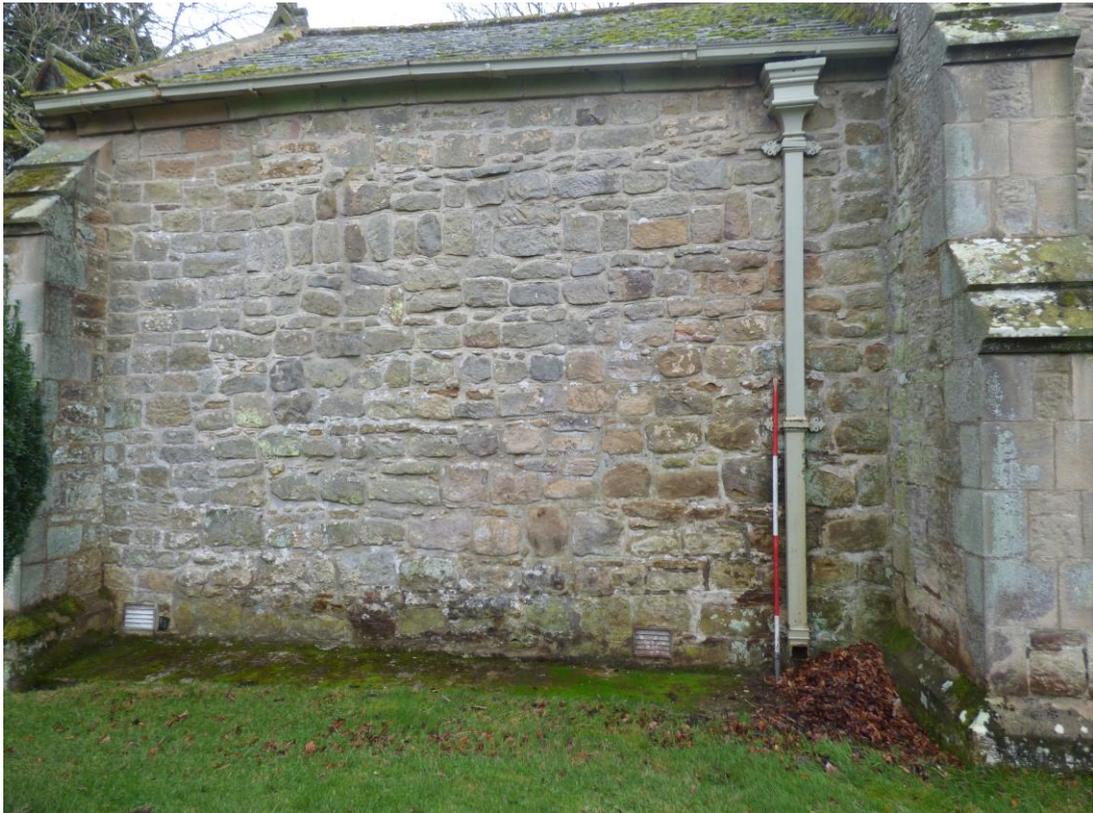
The south wall of the **Chancel** has an old priest's door near its west end, square-headed and with a chamfered surround; it is very like the north door of the nave. Its blocking is set well back, exposing its rebated jambs, and contains two very worn medieval grave slabs, with in front of them a decaying wooden cross commemorating the death of a First World War soldier, his name almost illegible, who was killed in action 7th December 1914. Several accounts refer to stones from the head of the original 12th-century east window being re-set in the wall above the priest's door, but there seems no sign of them. To the east of the door is a Victorian window of three stepped lancets, under a stepped moulded hood.

The north wall of the chancel has no openings; its only feature of interest is a line of ten large upright blocks around 1 m below the eaves, where there is a 19th century oversailing course with a hollow chamfer.

The north (above) and south (below) walls of the chancel

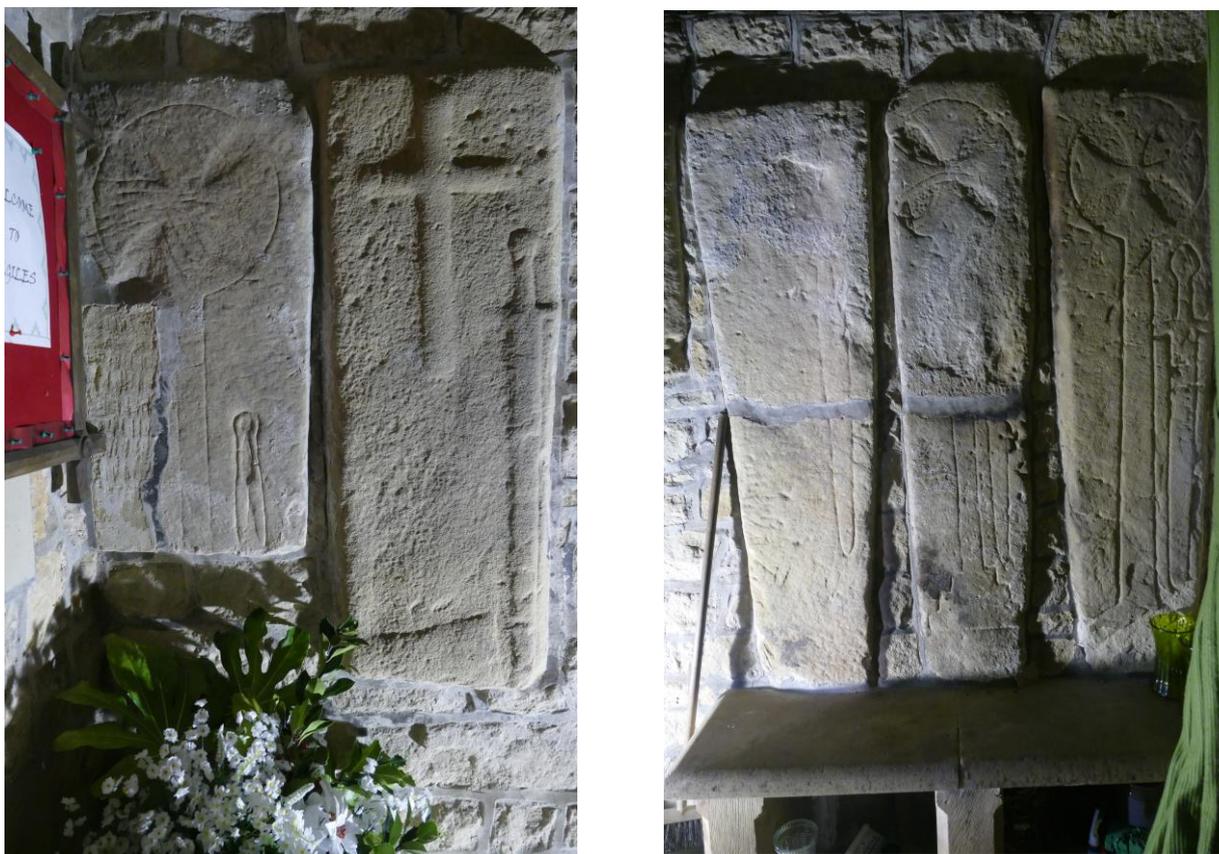
Medieval cross slabs in the side walls of the Porch

– left south side, right north side

The **West Porch** acts as a repository for a number of historic stones; two medieval cross slabs are built into the south wall, and four into the north, and addition several smaller pieces including a headstone cross and several 12th century architectural fragments are stored in the ashlar eaves. At the west end of the south wall is a rough segmental-pointed doorway into the base of the tower, cut through a metre-thick wall¹. On the north a stone bench, with moulded edges, is set against the eastern part of the wall and might have served as a coffin rest. The west doorway of the church is plainly Victorian- it has a two-centred arch with a broad chamfer, and, both internally and externally, alternating long and short voussoirs. Its taller segmental-pointed rear arch has a roll moulding to its head, and the jambs a chamfer with elaborate stops with a bar and trefoiled arch c 0.40 m below the top of each jamb, and the septfoil wheel window in the gable has an ashlar surround.

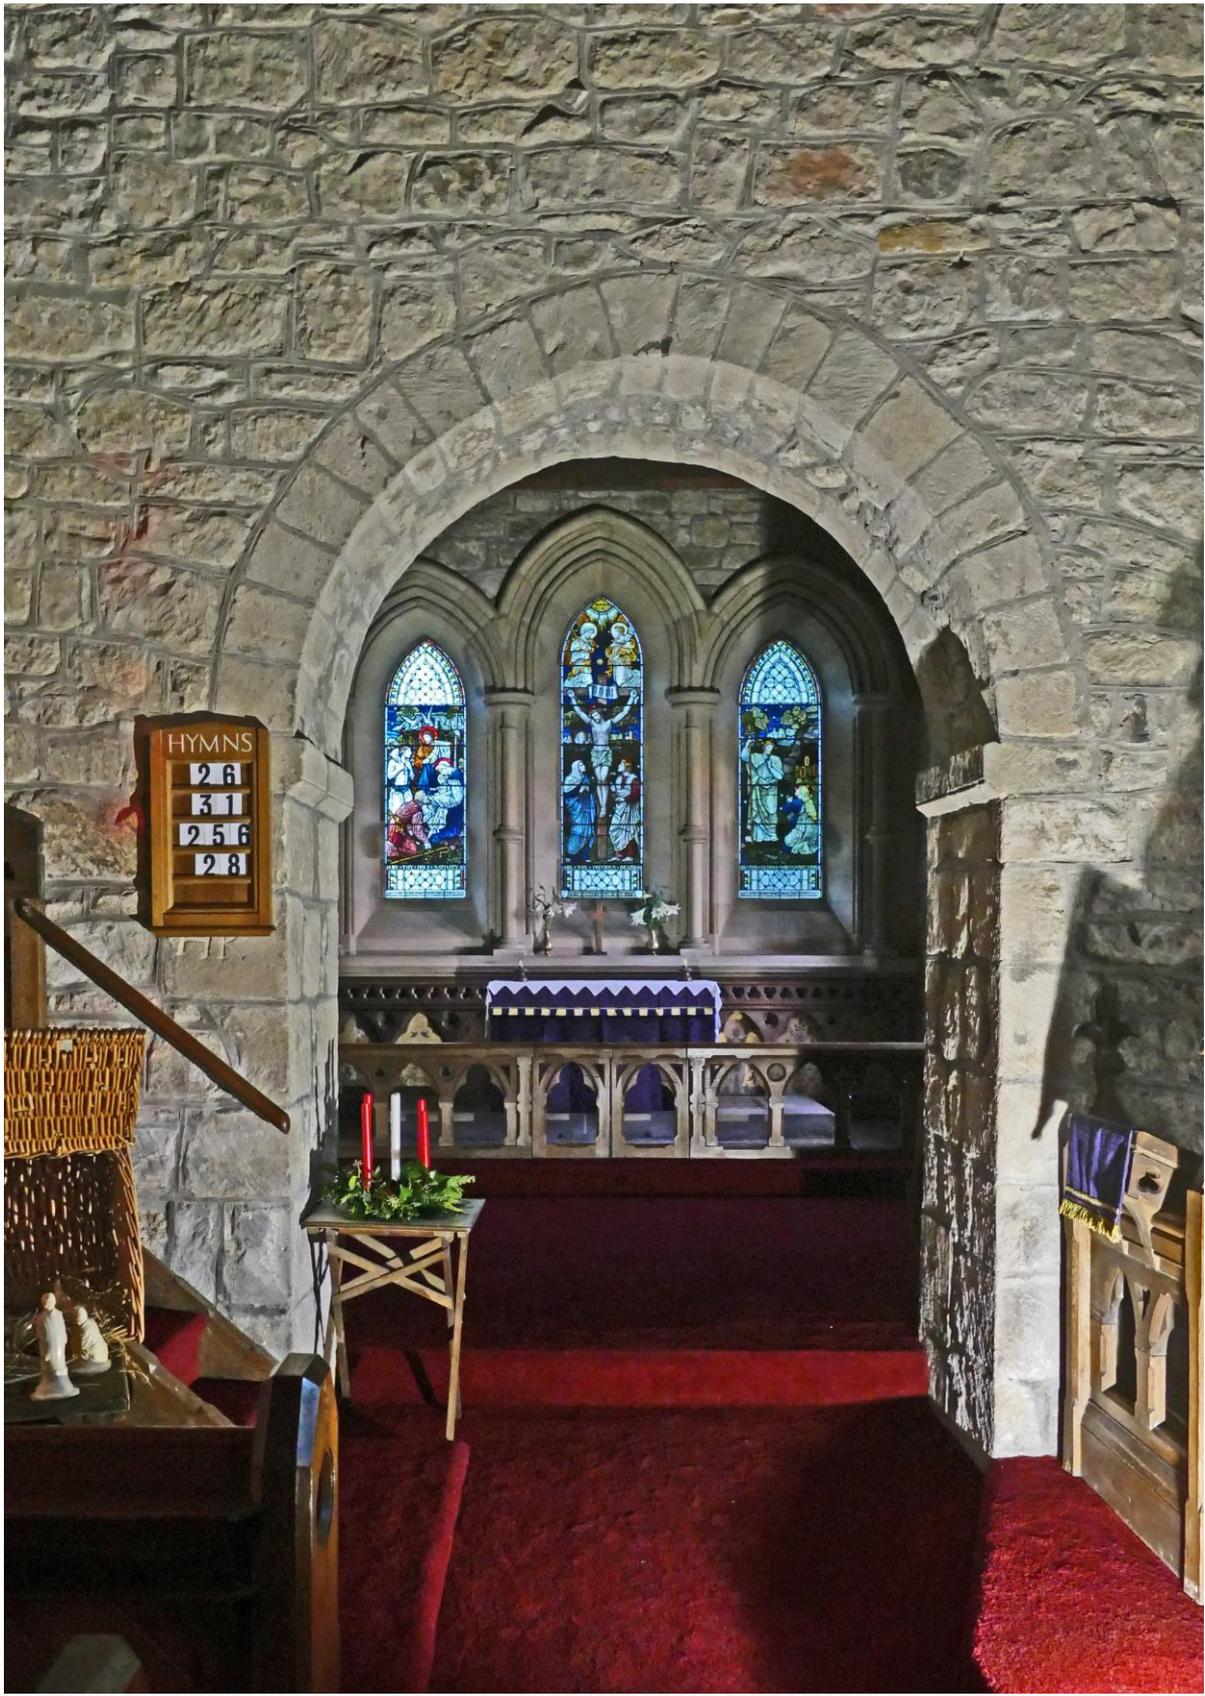
The Chancel Arch

The chancel arch is the best early feature of the church, set in a wall of roughly coursed stone 0.92 m in thickness. Towards the nave the arch has a slightly damaged semicircular head of a single order of square-edged voussoirs, of diagonally-tooled ashlar; the east face (where the semicircular form is better preserved) is similar, with rubble wall core in between the cut voussoirs. The imposts, grooved and with a chamfer on their lower angle, only project on the internal face of the arch; there is no sign of them, having been continued along the western face of the wall, as often happens, nor is there any sign of a hoodmould. The jambs are made up of very large squared blocks – the fifth up from the floor of the seven blocks that make up the west face of the north jamb has the deeply-incised letters ‘HR’; their character suggests a 17th or early 18th century date.

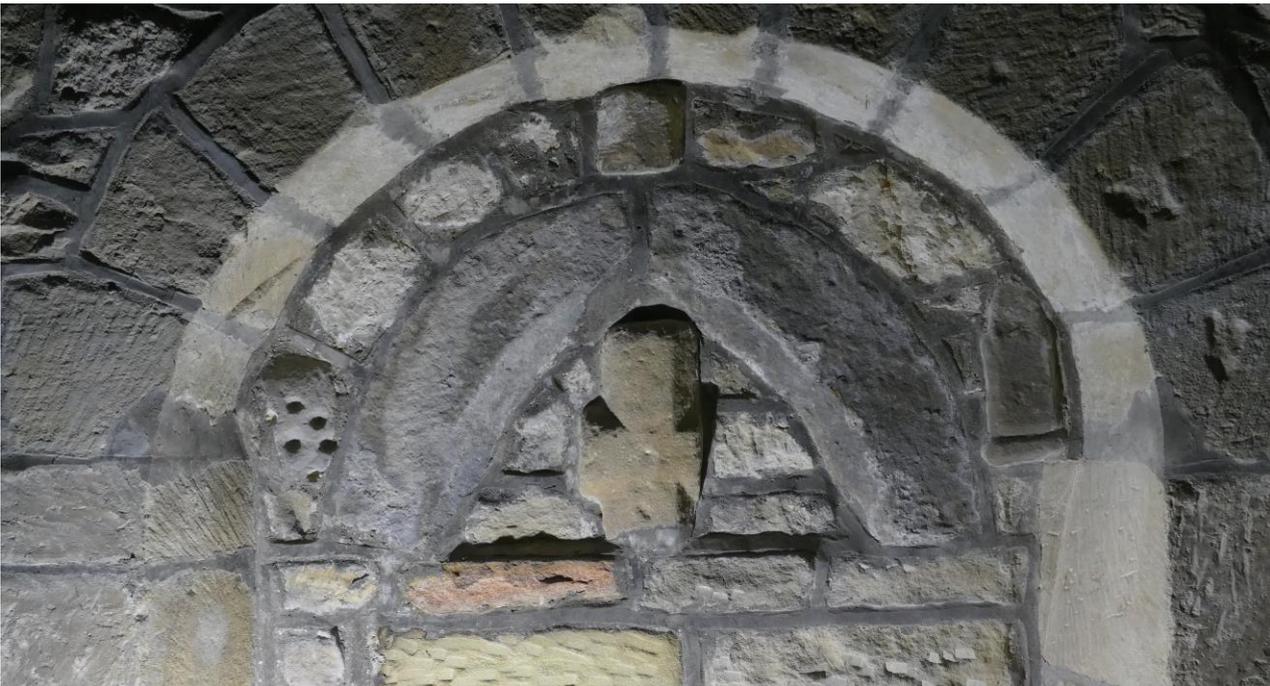
At the west end of the south wall of the **Chancel** the priest's door forms a recess, with a semicircular head formed by diagonally-tooled voussoirs of 12th-century character. Within the recess the Victorian restorer re-set several worked stone including the chamfered monolithic head of a lancet window, a cruciform stone, a cresset (lamp) stone with drilled indents, and what may be the end of a hoodmould. The Victorian south-east window has widely splayed internal jambs of fawn ashlar; below it is a round-arched piscine; the square-edged arch and projecting moulded sill look Victorian, but the quite large circular bowl, set well back, appears older.

The recess of the blocked priest's door, with various architectural fragments re-set in 1884

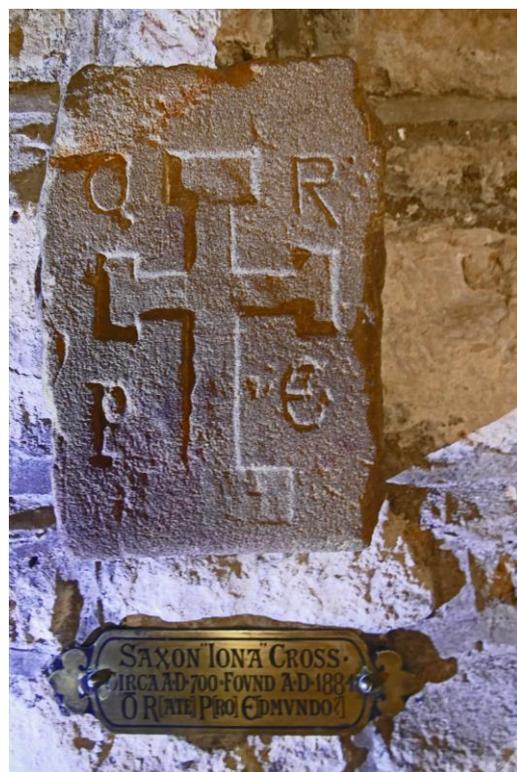
Before discussing the 12th century building, it must be noted that there is one piece of evidence that suggests that it had a far earlier predecessor – the small cross slab preserved in the chancel, which has been variously dated to c700 and the 8th century (right). This appears to be a type of headstone or grave marker that is usually associated with early monastic sites. Three other stones from the church are included in the *Corpus of Anglo-Saxon Sculpture* but two of these have been identified as of 11th century date, and the third could not be closely dated.

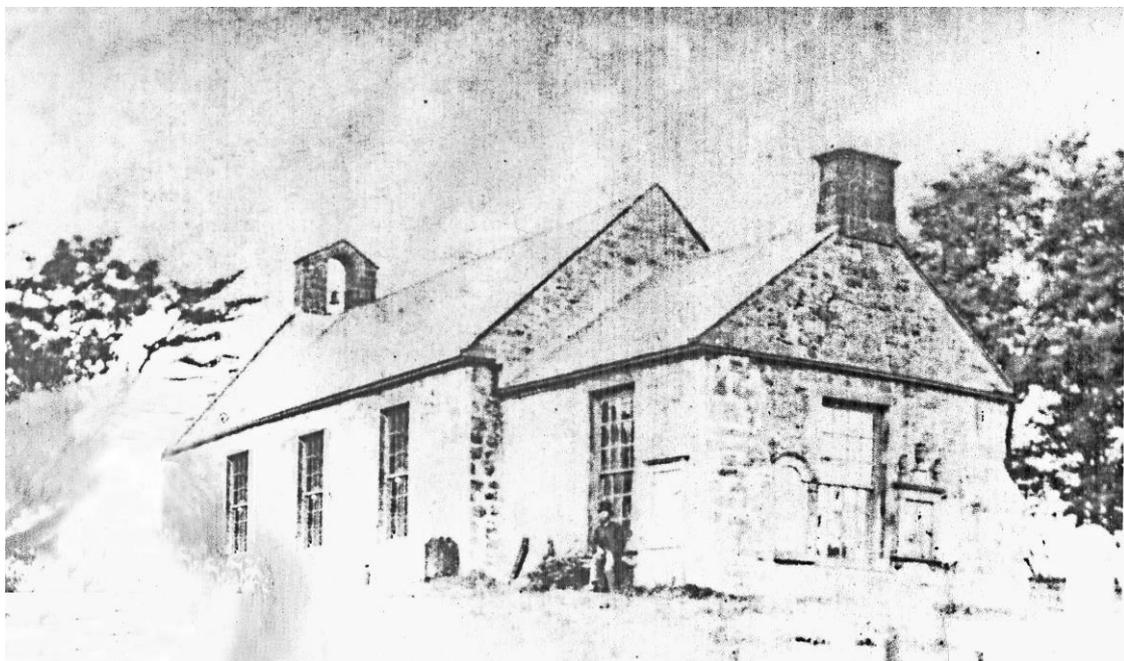
c1880 photograph, south-east view

⁴ A photograph of c1880 (see p.12, copy in village, original said to be in Northumberland County Council Archives at Woodhorn) shows the building from the south, with large square-headed sash windows, a simple arched bellcote at the west end and a chimney-like feature on the east gable.
