St Cuthbert's Church

Bellingham

An Archaeological Assessment

October 2014

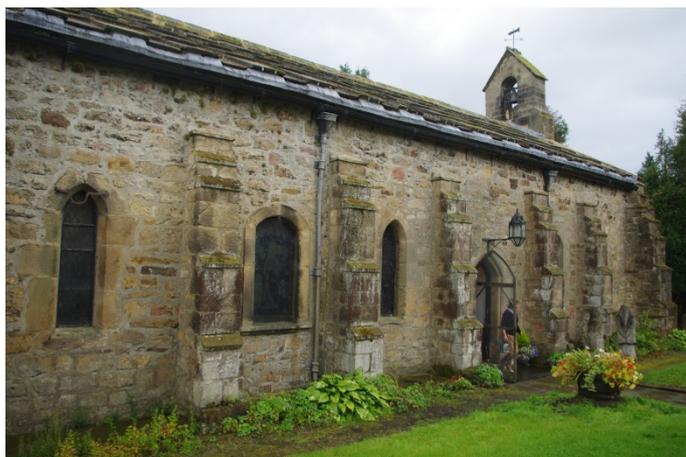
The **Nave** is built of roughly-coursed and roughly-squared sandstone stone, mostly fawn and yellow, but with a scatter of red and pink blocks which have probably been burned. The walls are heavily pointed, with remains of a former coat of render. The north elevation, towards the road, is articulated into six bays by multi-stepped buttresses; those at the ends rise to the full height of the wall, but the intermediate ones have low pyramidal caps c 0.50 m below the eaves. The doorway is in the third bay (numbering from the west) and has a near-triangular head, cut into two inclined blocks, with a moulding of two narrow chamfers separated by a square rebate, stopped c 0.5m above the ground. There seems to be some indication of disturbance, including a short straight joint, in the masonry above, perhaps indicating that there was once a recess or opening here as there is on the south. In the first, second, fourth and sixth bays (numbering from the west) are lancet windows of fairly broad proportions, with simple chamfered surrounds, and heads, like that of the doorway, cut into pairs of inclined blocks. The dressings of the lancet in the fourth bay shows evidence for a glass groove and bar sockets in its jambs¹; the lower part of its sill has been roughly cut away, as if there has been an opening beneath it at some stage, although there is no other sign of this.² In the fifth bay is a broader window with a shallow segmental arch and a raised stone surround above a projecting moulded sill, of 18th century character. The buttresses have projecting square footings, and chamfered off-sets, the off-sets projecting slightly above a square return to the wall face below. The buttress at the east end is very substantial, and returns or some distance as a shallow projection along the east wall; it has a chamfered plinth on its east side, suggesting that it is in fact part of the east wall of the original north aisle, retained and remodelled as a buttress.

The north side of the nave

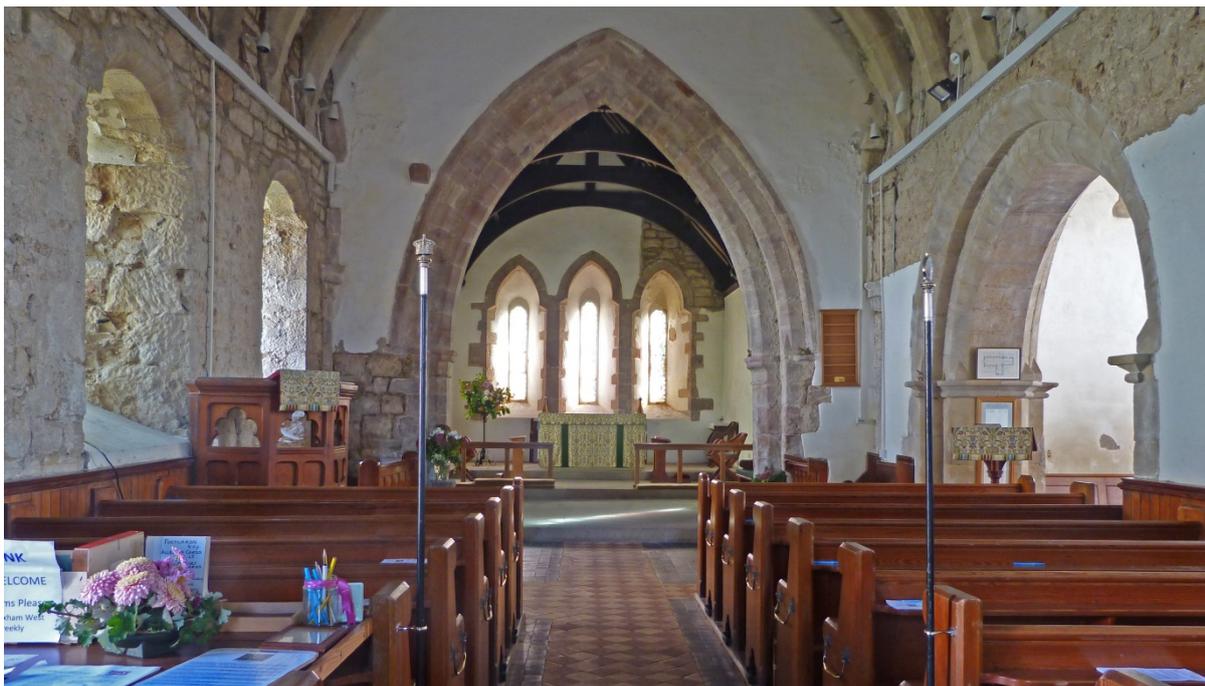
Interior looking east

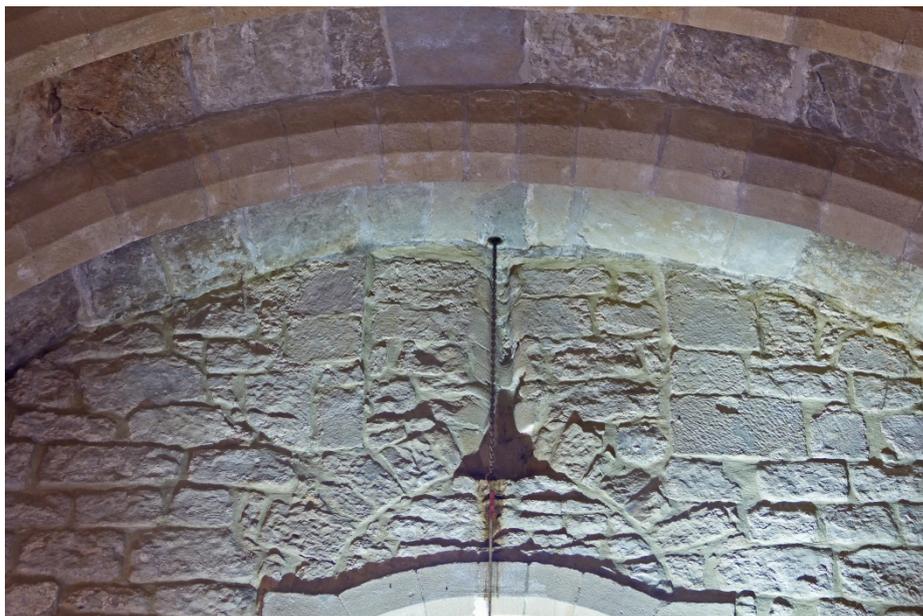
The interior of the church is generally plastered and whitewashed (with exposed dressings), although at the time of this assessment plaster had been removed from several areas⁸; there is a boarded dado in the nave and transept. In the west wall of the **Nave** the west window has jambs (still plastered) that seem to be cut into the walling stone, but the sill and segmental rear arch, both with chamfers, are of 19th-century ashlar; directly above the latter is the semicircular rear arch of an earlier opening, its apex cut into by a deep groove, clearly worn by a bell rope, that drops down from the apex of the vault through the infill of a still-earlier opening, of which three or four stones of each jamb are visible. This opening has its north jamb is in line with that of the present west window, and its south c 10 cm within; its sill has been destroyed by the rear arch of the previous window, and its head is cut across by the nave vault.

Features in the upper part of the west wall of the nave, revealed by recent removal of plaster.

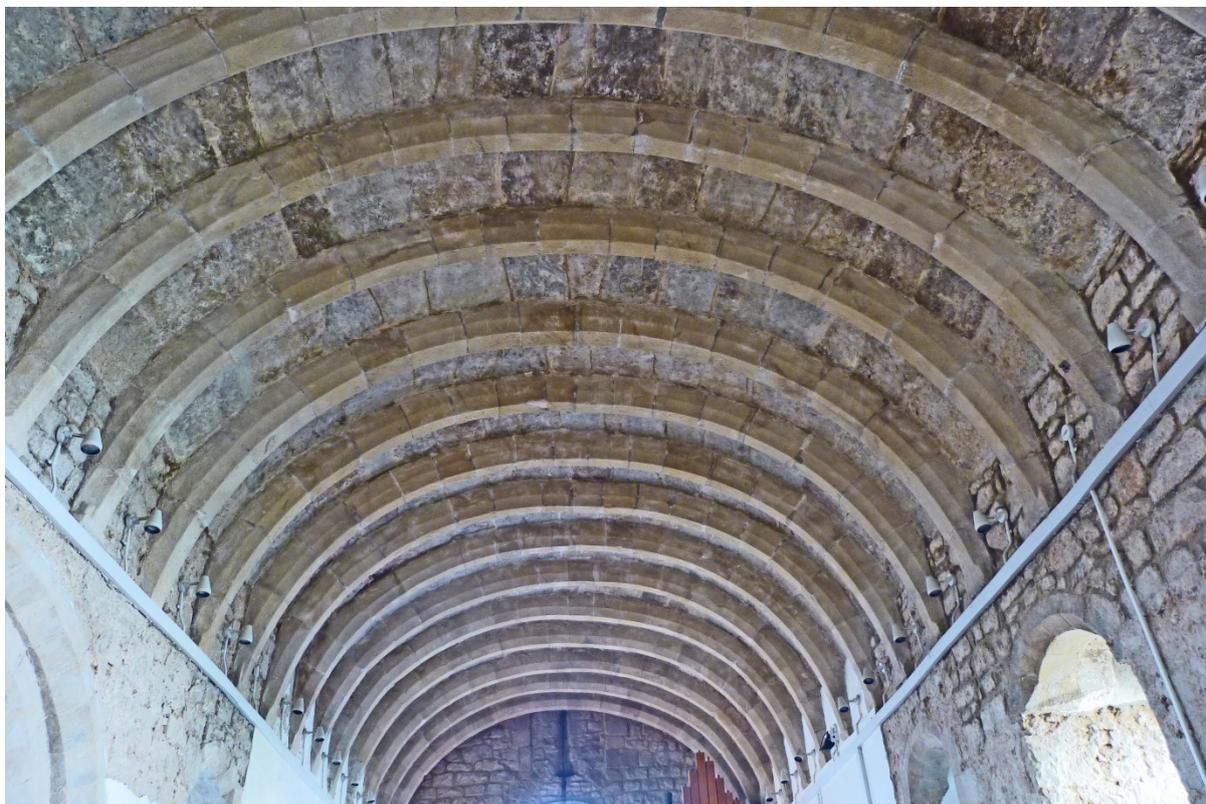
The nave has a near-semicircular barrel vault carried on fifteen ashlar ribs, with chamfered lower angles, the chamfers being stopped in a variety of manners, some broaches, other more elaborate; the ribs also display a number of masons' marks. There are several courses of roughly-shaped small stones above the springing of the ribs, above which the vault is of large roughly-tooled slabs of flaggy sandstone, varying in colour, some trapezoidal in form rather than rectangular.

The Nave vault (looking west)

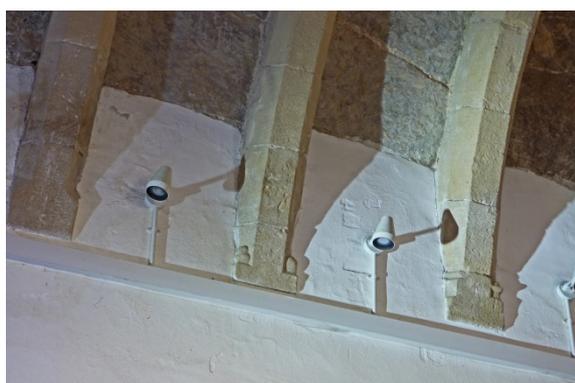
Varied chamfer stops to the vaulting ribs (south wall)

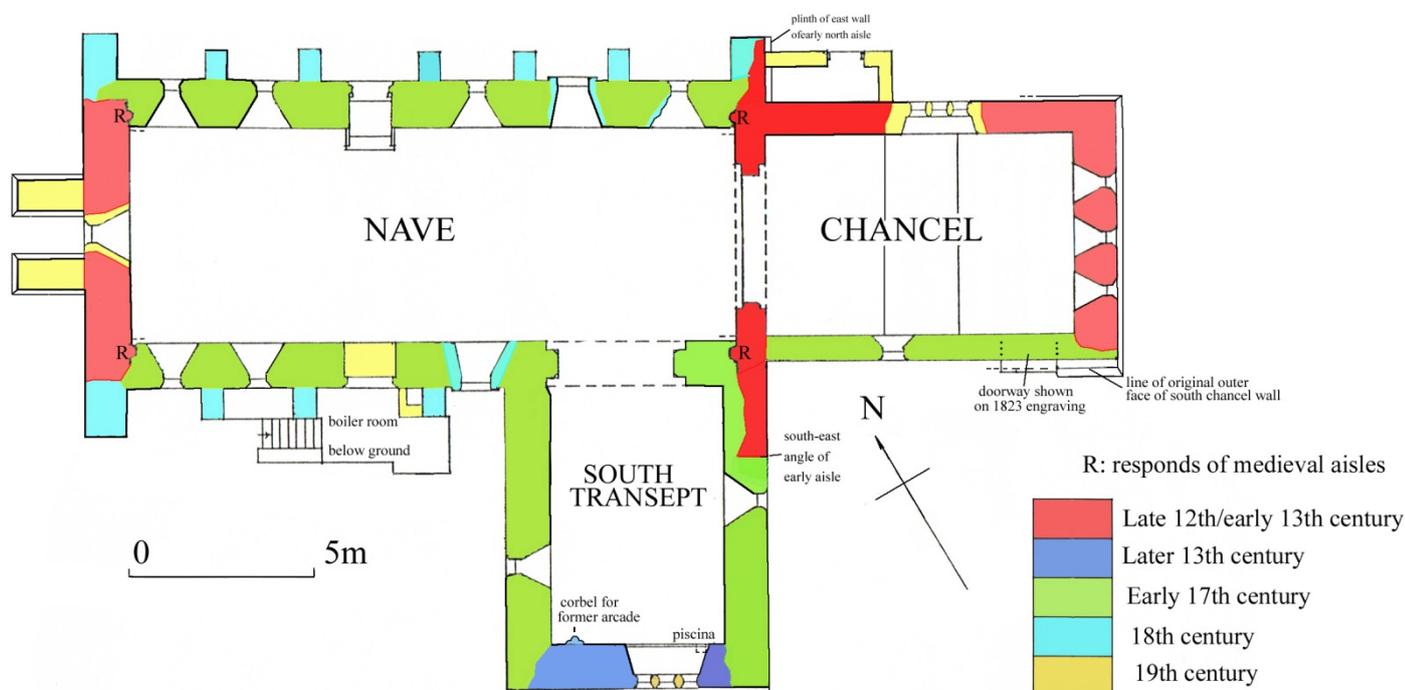
ST CUTHBERT'S CHURCH, BELLINGHAM Provisional Phased Plan

based on 1937 plan by H L Honeyman in
Northumberland County History XV (1940) p.225
revised P F Ryder 2014
