St Michael the Archangel, Alnham

Archaeological Assessment, including report on 2018 works

Archaeological Assessment and Report on 2018 Works

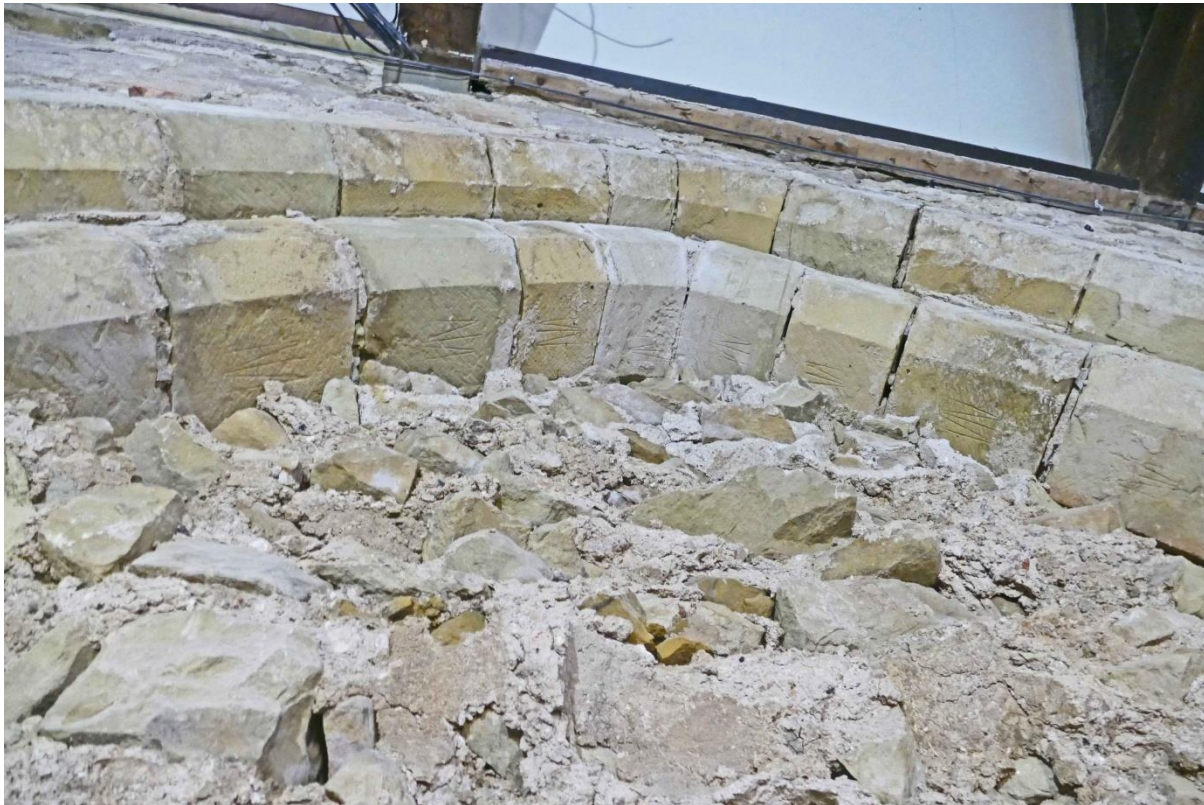
North Arcade: incised 'Mary marks' on voussoirs

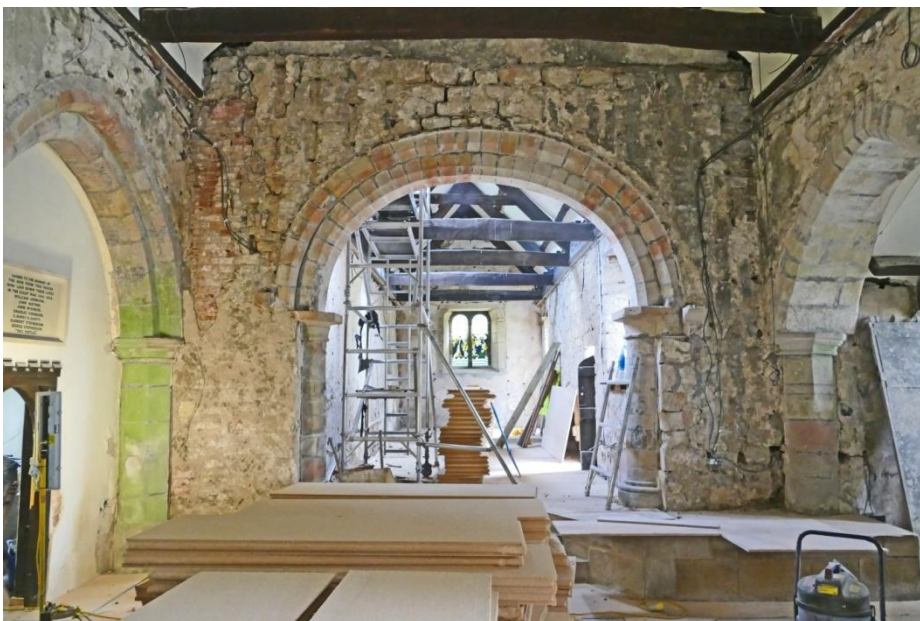
Interior looking east during the 2018 works, showing chancel arch, and eastern respond of south arcade.

Three steps lead up from the nave into the **Chancel**, which is entered under a chancel arch of distorted semicircular form, and of two chamfered orders; several stones are reddened, as if by fire; a little above the arch is a horizontal set back of c 10cm. When the plaster was removed in 2018 there was no real sign of any hoodmould, although on either side of the arch are rough projecting blocks that may either be former hoodmould stops of parts of a former projecting impost band, the northern perhaps a worn human head and the southern a stepped and chamfered block. The wall above the arch is of coursed squared stone, although much affected by settlement cracks; to the north is an extensive area of 19th century brickwork, relating to the flue (presumably from a stove) that rose to the still-extant chimney stack at the north end of the gable. The responds of the arch, of semicircular plan, have 19th-century 'holdwater' bases at the level of present chancel floor, and older capitals with a roll at the neck and a semi-octagonal abacus that looks to have been re-cut. Towards the narrower chancel the outer order forms a segmental arch, dying into the wall on the north c 0.40 m and on the south c 0.80 m above the capital.

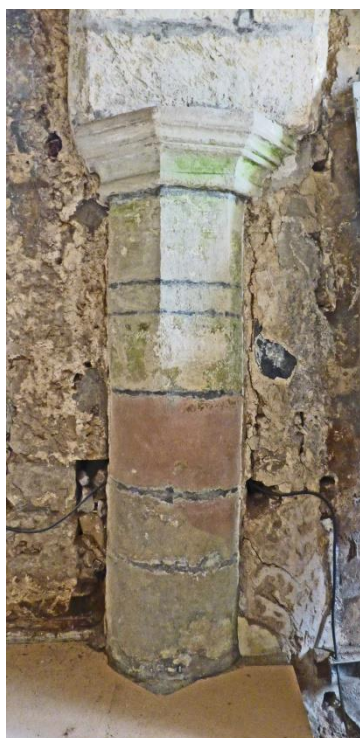
East Respond South Arcade

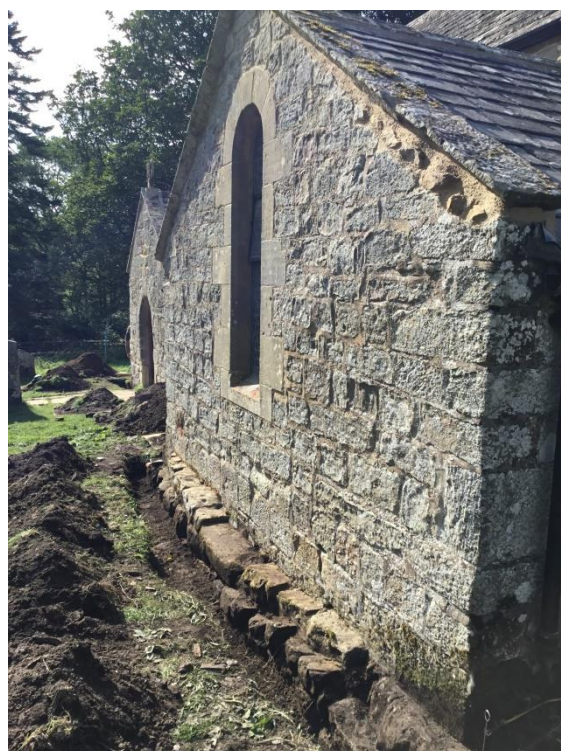
The footings of the transept, seen during the 2018 drainage works, are difficult to interpret in detail. On the west there is an upper course – in effect a square-topped plinth - of well-squared blocks resting on a lower footings of two to three courses of rougher stones that seems to be on a different alignment with the wall above, projecting 250 mm at the south and but narrowing to 50 mm at the north. On the south an irregular footing of at least three courses, going down to a depth of at least 430 mm, bows out in the centre of the wall to 350 mm. On the east there has clearly been considerable disturbance, almost certainly associated with underlying vaults, including a recessed section of walling hard up against the south-east nave quoin.

South end South Transept with footings

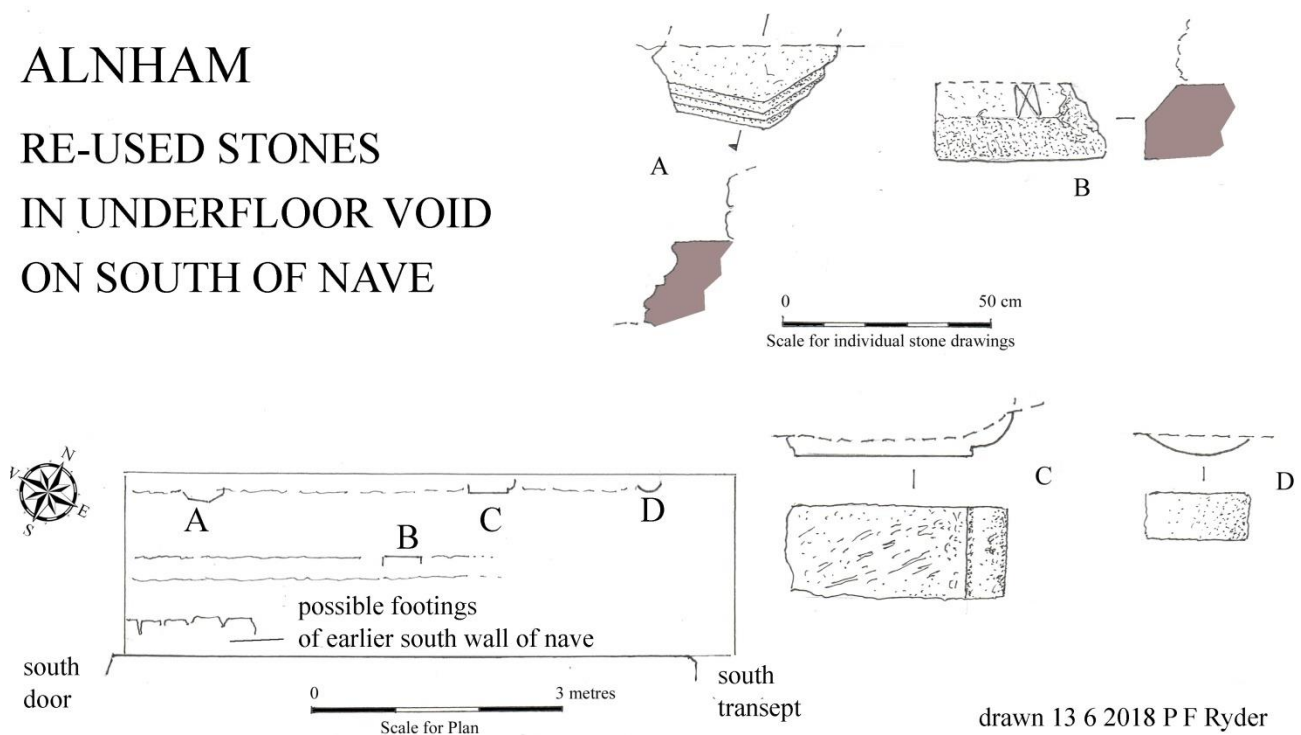
RE-USED STONES IN UNDERFLOOR VOID ON SOUTH OF NAVE

On 13 6 18 the floor timbers of the nave floor, to the south of the central aisle were briefly lifted to allow a cursory examination of the features beneath. Immediately to the east of the south door, a series of large blocks, their inner face c 480 mm inside the face of the present nave wall, may be the footings of an earlier nave south wall. Axial walls 0.90 and 1.90 m north of this were constructed to support the pew platform, and almost certainly of 19th century date. They were of rough rubble construction, but incorporated a number of re-used stones (for positions see drawing):

- (A) A large section of a 13th century pier capital. Almost identical to those of the north arcade. (which remains intact) and thus almost certainly coming from the lost south arcade.
- (B) A block with a chamfered edge and a neatly-incised pair of opposed triangles. This could be simply a mason's mark, but bearing in mind the repeated incised device on the dressings of the north arcade (the so-called 'Mary marks') it may have had some other significance, and may have been a related motif which distinguished the lost south arcade.
- (C) Block with a rebated semicircular end, perhaps part of a 12th-century respond.
- (D) Block of segmental section, part of a pier or respond.

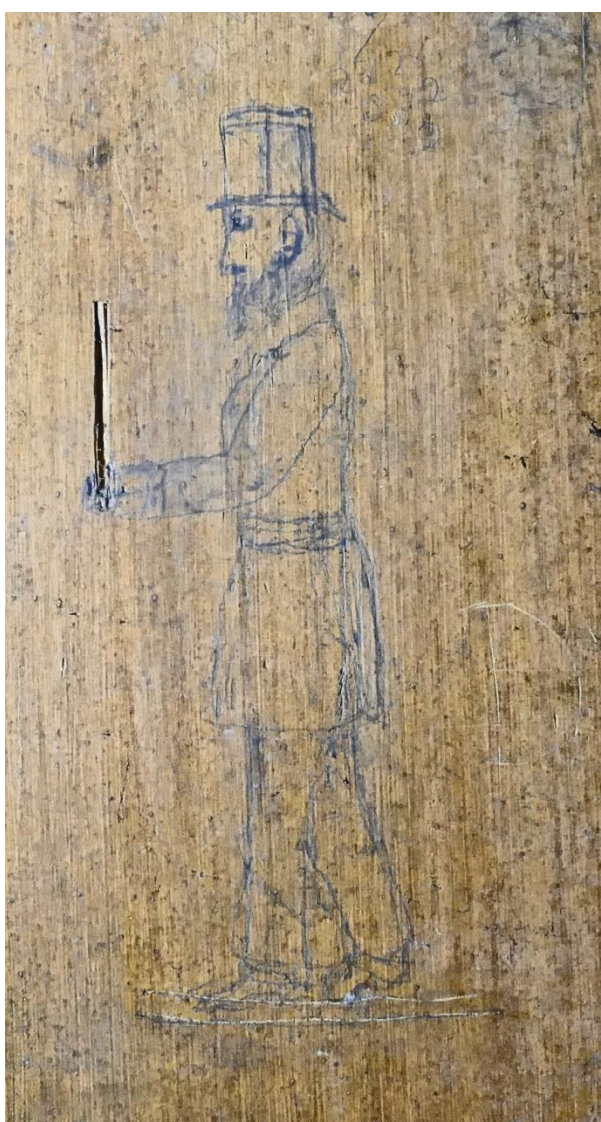
When the panelled dado was removed from the eastern part of the south wall of the nave, pencil graffiti were found on its reverse. These were faint and difficult to photograph, but included some drawings of figures – one of a Victorian gentleman in a stovepipe hat (below) – notes pertaining to scriptural texts and the date '1865'¹⁷. The drawings were in a number of hands, and some more accomplished than others.

The dado from the north wall of the chancel also bore graffiti, but these were scratched into the varnish rather than drawn in pencil. These included the name 'WILLIAM BROWN' sketches of architectural features – an arcade and a bellcote – and again the date '1865'
