ST PETER'S CHURCH, CHILLINGHAM

AN ARCHAEOLOGICAL ASSESSMENT

APRIL 2019

PETER F RYDER
B.A., M.Phil, F.S.A
HISTORIC BUILDINGS CONSULTANT

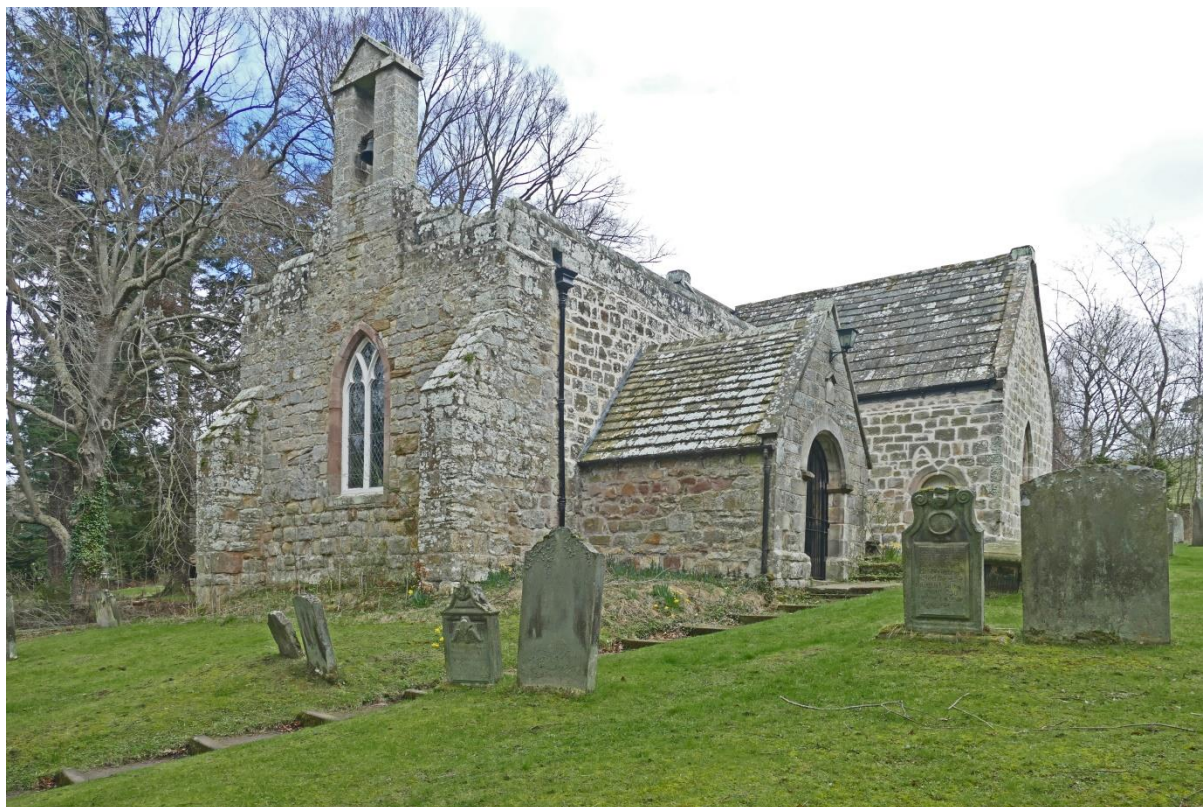
The church seen from the south-west

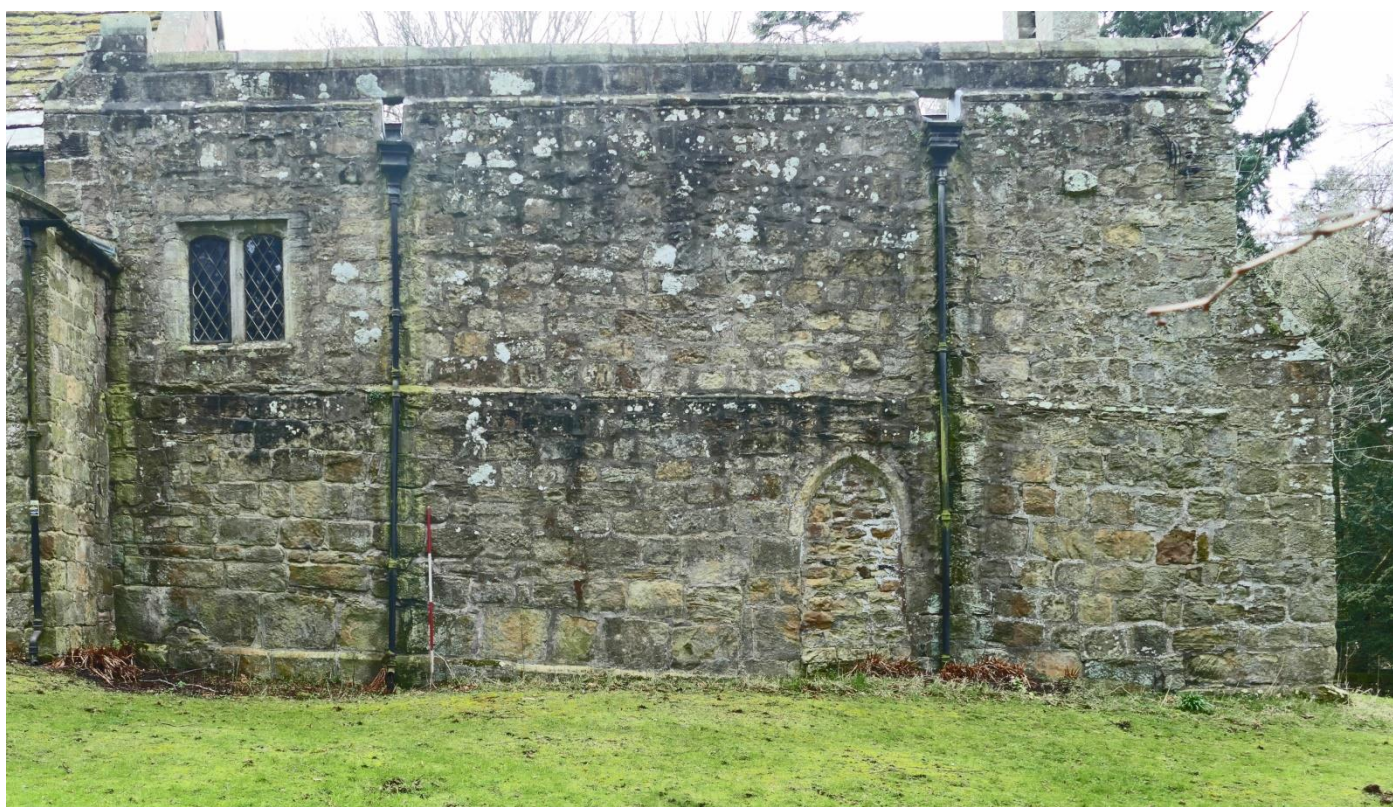
The north wall of the nave (above) has a chamfered plinth that slopes down even more steeply than the ground surface, so as to disappear half way along the wall – a short length of chamfer at the west end relates to the added north-west buttress. There are some especially large blocks immediately above the plinth, with a huge one at the east end that has a rough arched cutout in its lower edge, part of a blocked opening that cuts through the plinth below. A couple of courses above this two adjacent L-shaped blocks suggest the base of a window, and a little higher still is what looks like a narrow infilled vertical slot. Some or all of these features must relate to a former heating chamber set in the angle between the nave and the North-West Pew². There is also a chamfered off-set which on this side is c 3 m above the ground , again following the slope of the ground. The only

architectural feature in the wall below is the blocked north door, towards the west end of the wall; this has a chamfered two-centred arch, with its head formed from two blocks. In the upper part of the wall there is a single two-light window near the east end, with depressed segmental arches to its lights, very similar to the two windows in the south wall.

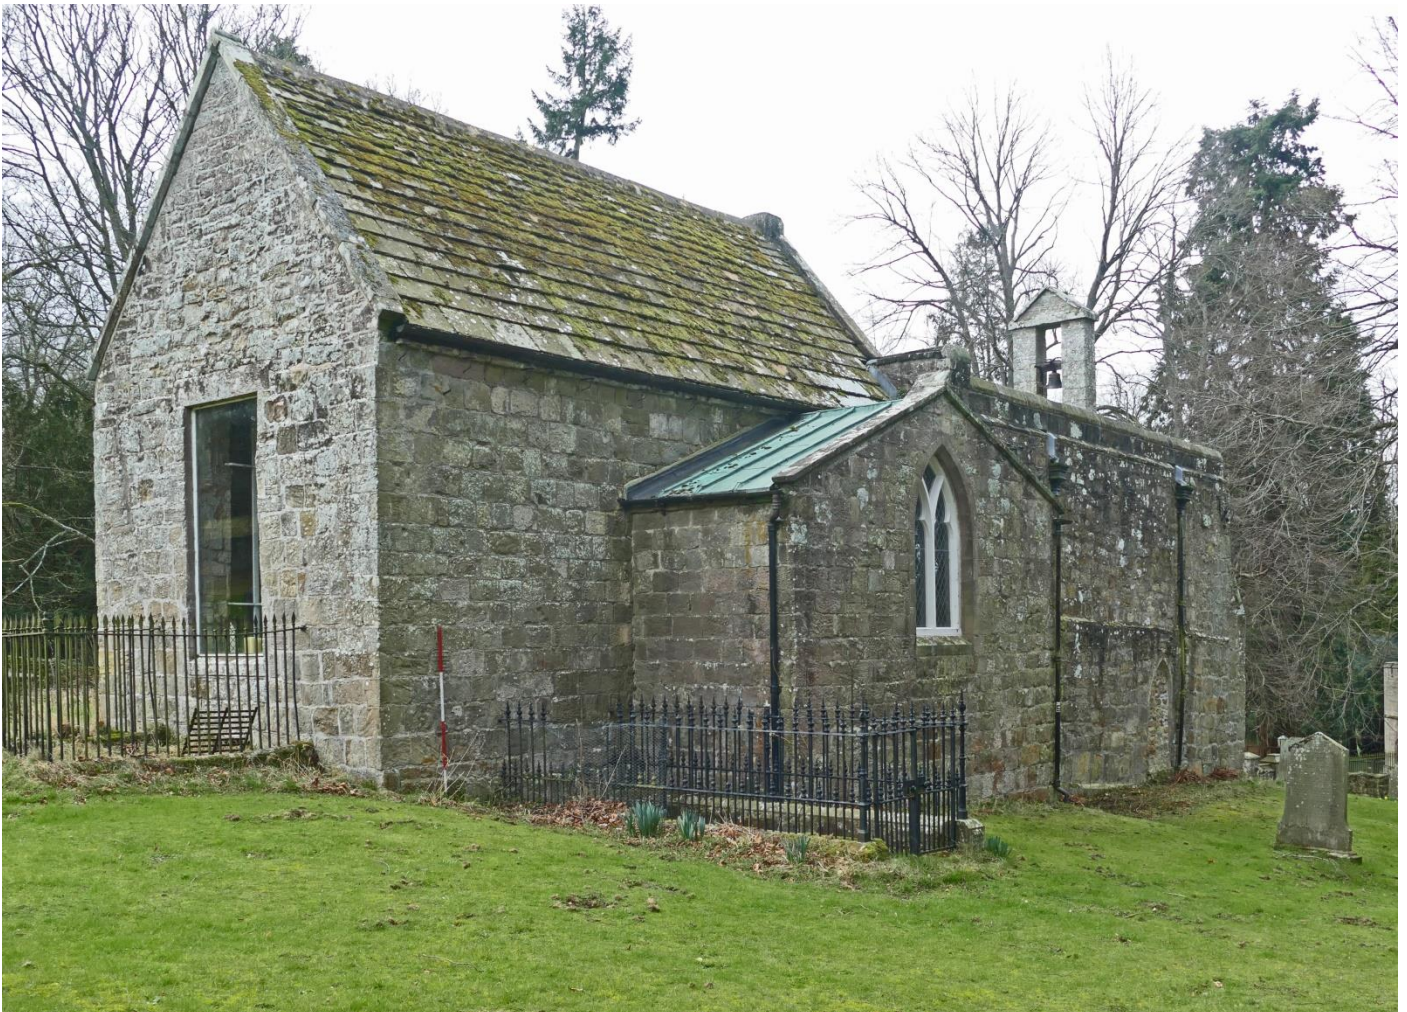
The church from the north-west, with steps down to crypt.

The north wall of the chancel is of undisturbed coursed and squared blocks, some showing diagonal tooling; its only feature is a slight offset at plinth level, and at a lower level a 19th century doorway into the crypt, reached by a flight of steps between walls capped by cast-iron rails; it has a round arch, with rock-faced voussoirs.

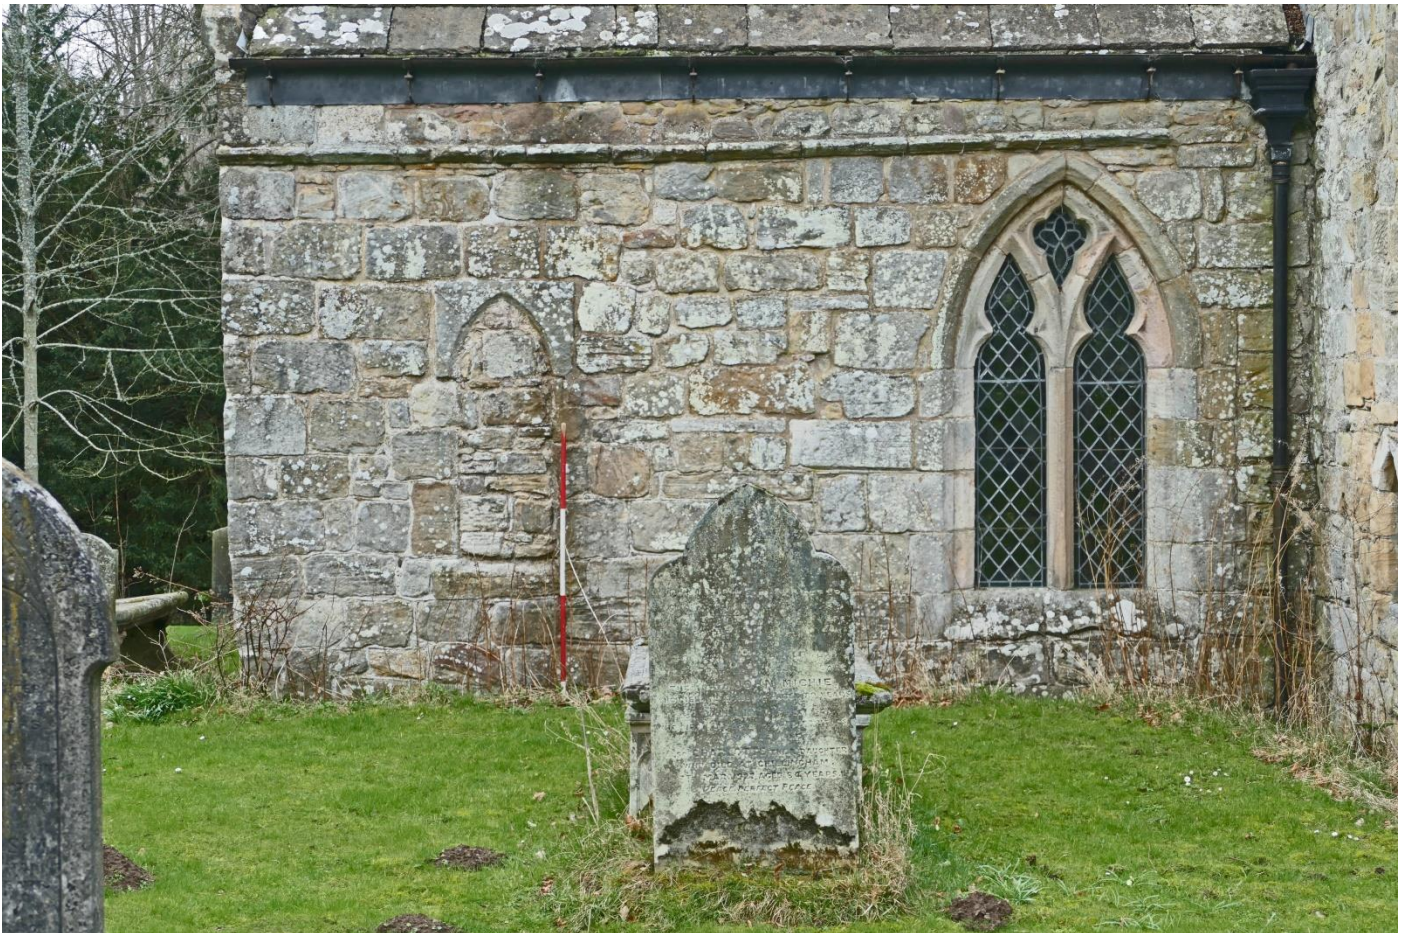
The South Chapel, east wall.

The east side of the chapel has a window very like that on the south, set north-of-centre, with to the north of it and only c 0.30 m from the chancel wall a length of straight joint. Towards the south end of the wall is a smaller lancet, now blocked, with a monolithic head (like the now-fragmentary one opposite in the west wall). Higher up, just above the head of the larger window, is a moulded string course, now very worn.

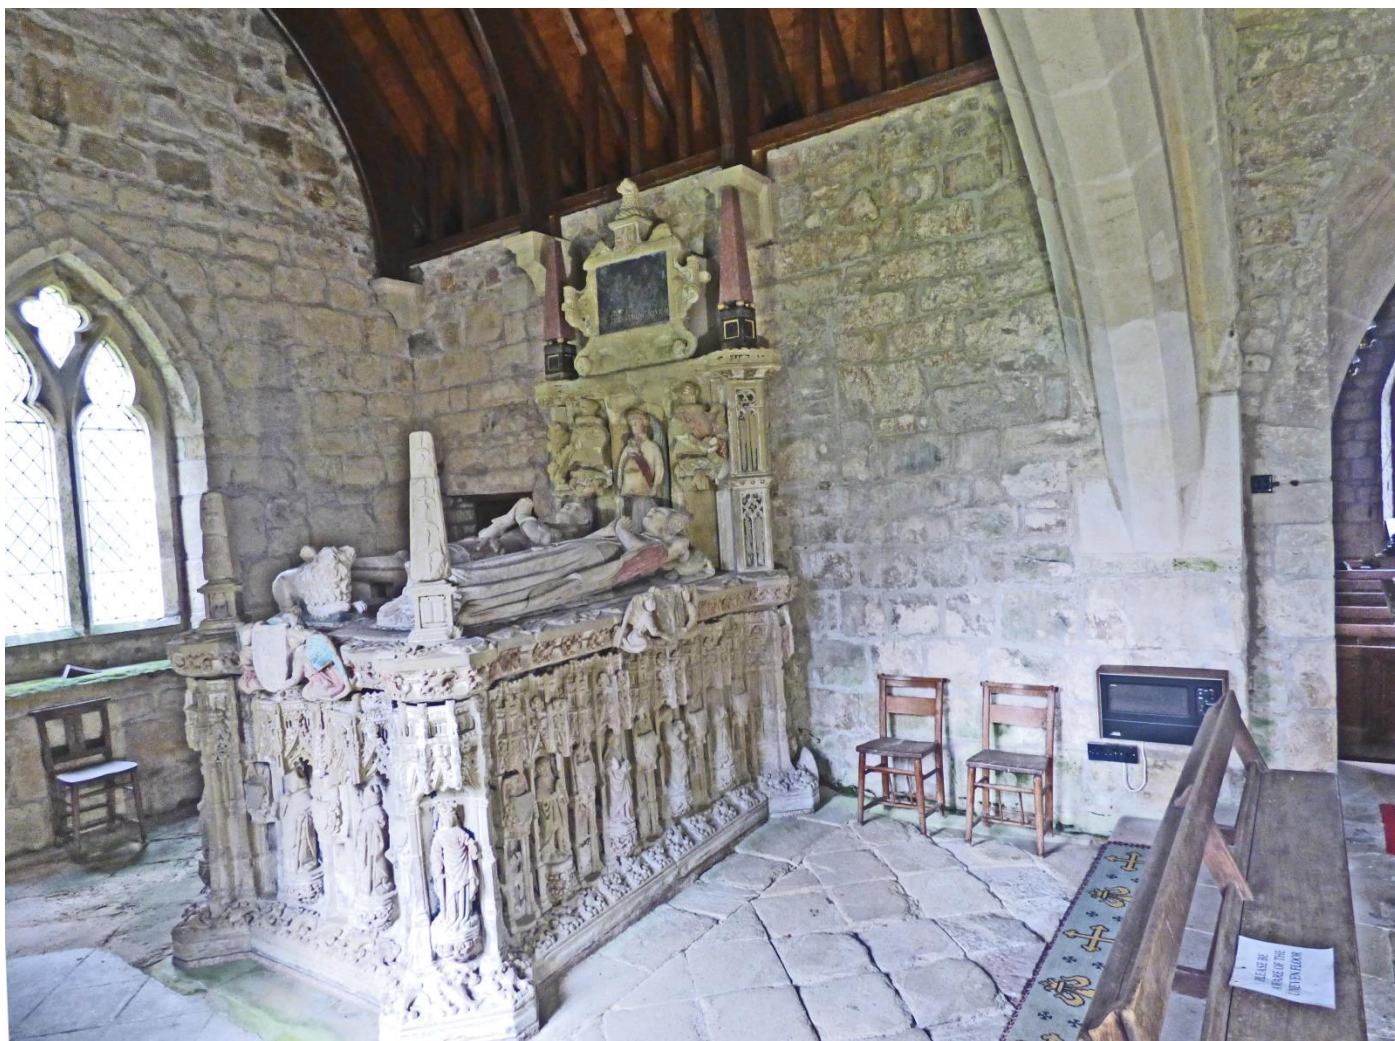
The South Chapel contains the spectacular tomb of c1450 of Sir Ralph Grey and his wife Elizabeth FitzHugh; this is arguably the most important medieval monument in Northumberland, but a detailed description of it is beyond the scope of this report⁵. The internal faces of all three walls of the chapel are of some structural complexity.

South Chapel, with Grey tomb, looking south-west

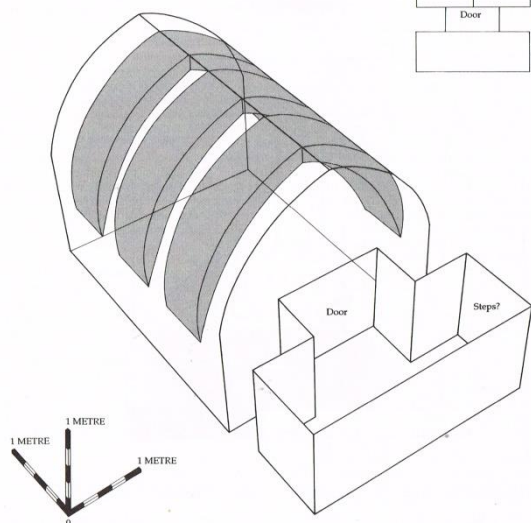
Details of the vault beneath the tomb, and its (infilled) stepped approach from the east, are given by Heslop and Harbottle⁶.

(left. Isometric drawing of crypt beneath Grey tomb. After Heslop & Harbottle 1999)

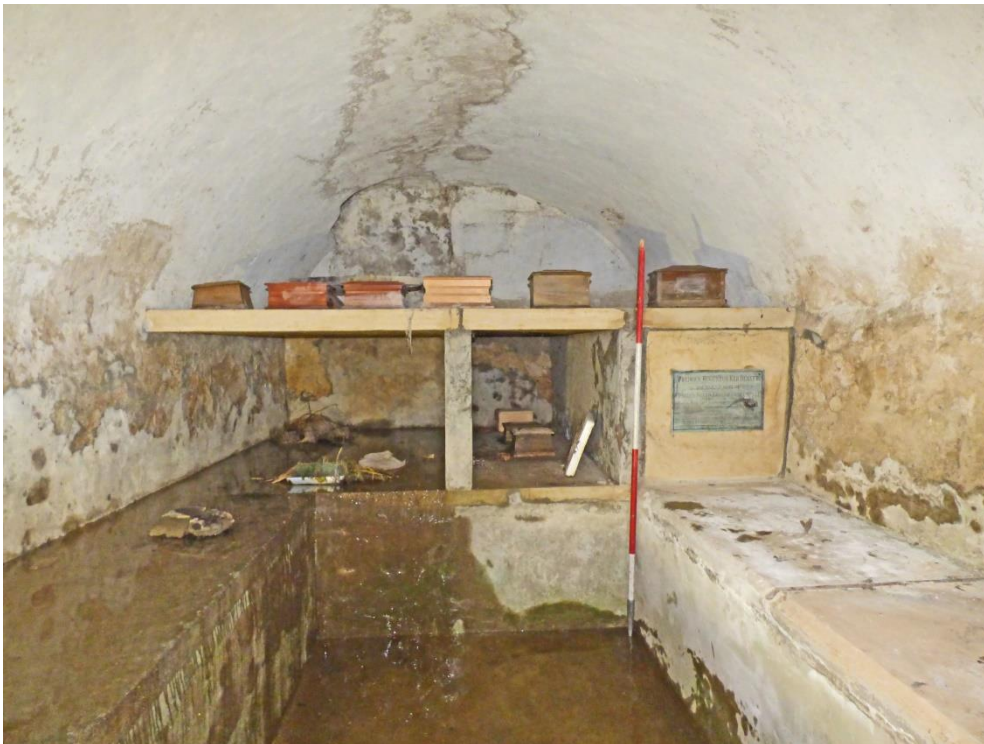
The crypt under the chancel, now only accessible through the late-19th century doorway on the north, is unfortunately fairly mute architecturally. The doorway (with an internal lintel of modern blockwork) enters it close to the east end of its north wall. It is a rectangular chamber 6.5 m long by 3.1 m wide, with a segmental barrel vault. Its walls and roof are all plastered, except at the east end where this has fallen and revealed coursed squared stone of rather indeterminate character. Concrete benches on three walls and two levels of burial spaces (only one occupied) at the west end all look fairly recent; behind this can be seen traces of what was presumably the original entry, at the south end of the west wall,

which must have been a descending stair from the south-west corner of the chancel, which has resulted in a small part of the vault being cut away. The only other opening is the window already described in the centre of the east end, the opening of which steps down through the thick wall to come in immediately below the vault.

The crypt beneath the chancel, looking west

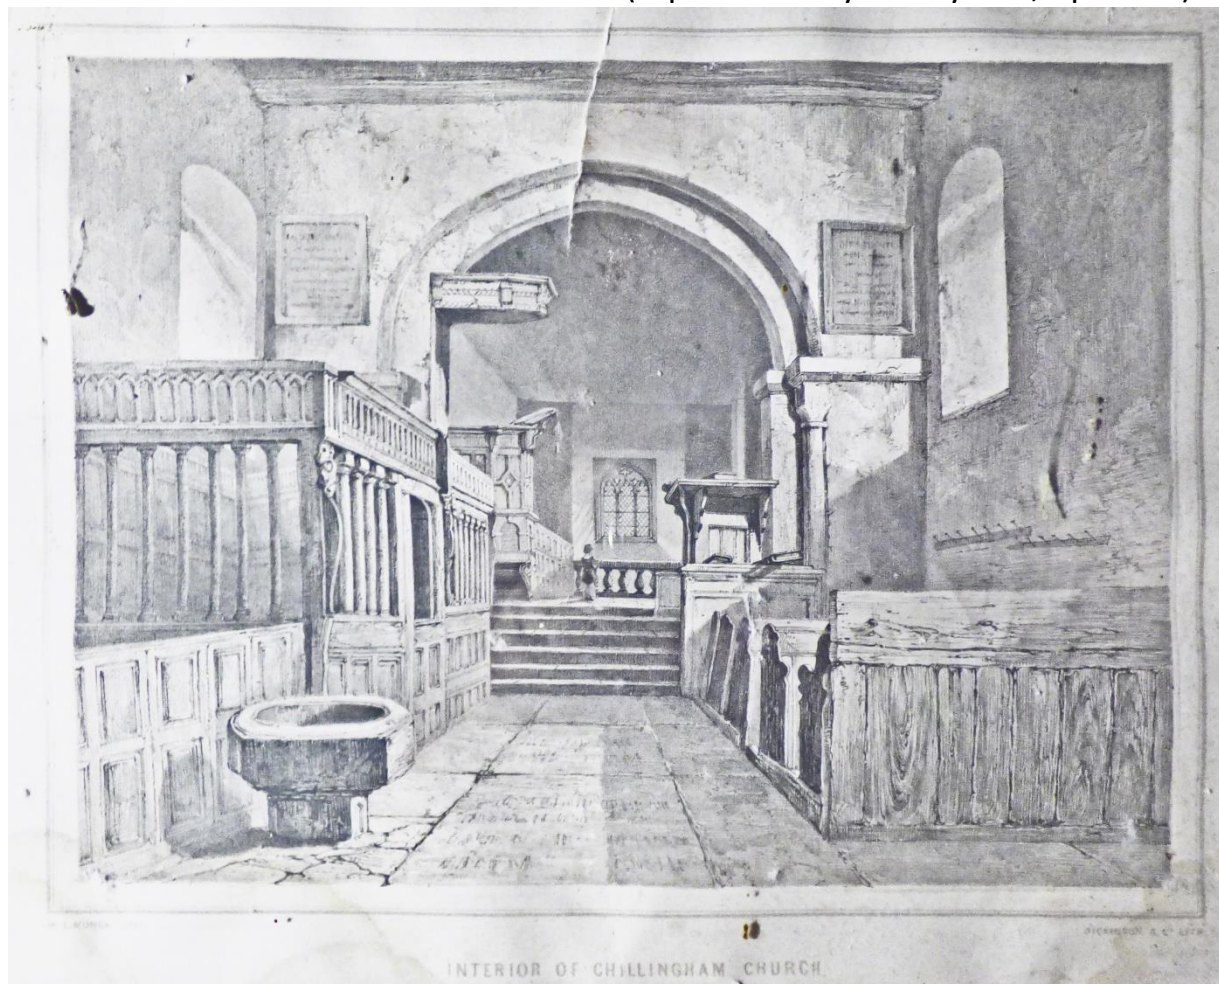
Pencil drawing in church, based on Varley's 1809 watercolour

Another late medieval change seems to have been the remodelling of the chancel arch, although we only have Varley's 1809 painting to go on, which shows a four-centred arch apparently of two chamfered orders, resting on 12th century responds and (on the south) an impost band.
