The Parish Church of St Mary the Virgin  
**Stamfordham**

An Archaeological Assessment

February 2013

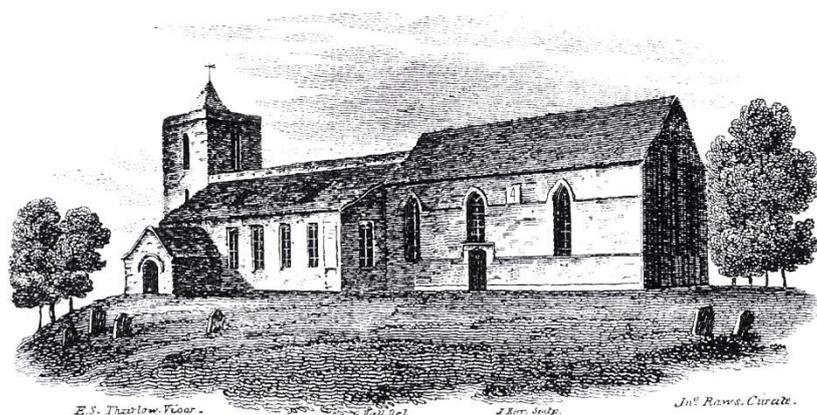
STAMFORDHAM CHURCH.  
North<sup>th</sup>

An 1823 engraving of the church by W.Davison, of Alnwick<sup>2</sup> (below) shows the tower with a low spire, the nave with a flat roof, a south aisle with four square-headed two-light

windows to the east of the porch, and another in its east end, and a chancel much as now.

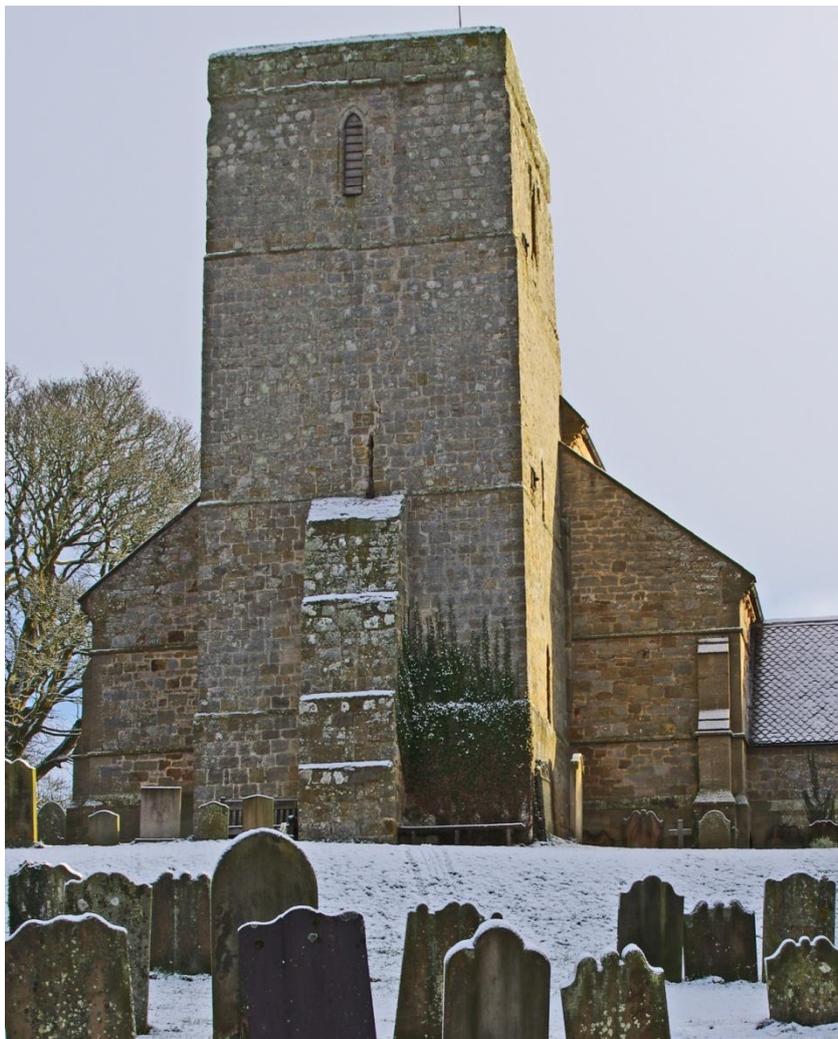
The **West Tower** rises in four stages, each slightly set-back and divided by chamfered off-sets, the lower two slightly proud of the wall. The first off-set is c 2 m above the ground, the second at mid-height and the third just below the belfry, topped by an odd recessed course, above which a chamfered off-set carries the plain parapet. In the centre of the west side of the tower is a big stepped buttress with four-sloping set-backs, rising to the second off-set; in the angle between it and the tower wall to the south is an irregular projection, apparently part of some earlier feature – it might possibly represent the

south-west corner of the putative Saxon porch that pre-dated the tower. The lower stage of the tower has a lancet window on the south, immediately above the first off-set; its head is cut into a large block with an unusual stepped extrados; at the same level there is a blocked lancet in the western buttress. The second stage of the tower has a small lancet on the south, again with the peculiarity of its head being cut into a shaped block, this time of rough semi-cruciform shape.

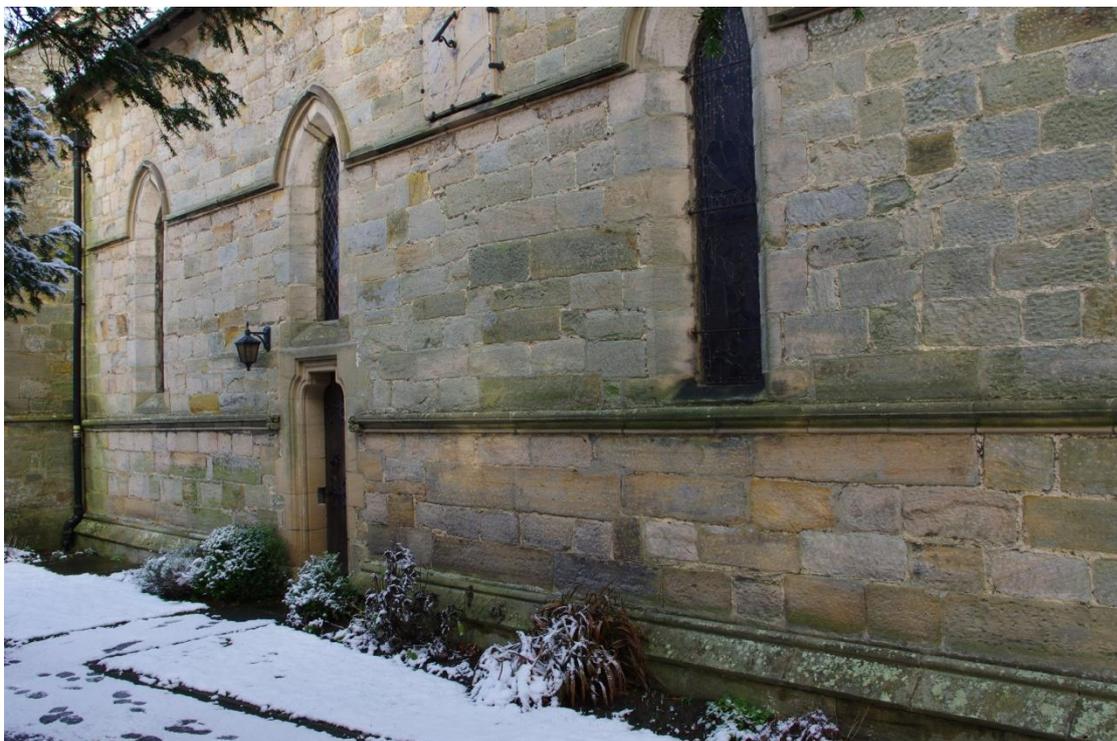
The south wall of the chancel is of coursed squared stone, including some very elongate blocks (up to c 1 m in length); at the east end, above the lower string, is an area of quite different pecked stonework. There is a 19<sup>th</sup>-century ashlar plinth, topped by a roll moulding, and deeply-moulded strings at the level of the sills of the three lancet windows, and forming a hoodmould to their heads. The lancets are quite large, and have broad chamfered surrounds; the central one has its sill at a higher level, being set above the priest's door, which has a deeply-moulded shouldered arch in 19<sup>th</sup>-century ashlar; the lower string is terminated in a foliate boss on either side of it.. Immediately to the east of the doorway a walling stone with '1727 / BD 1727' incised may be part of a headstone, and fixed to the wall between the central and eastern lancets, above the upper string, is a fine sundial dated '1768' with the text 'while we have TIME/ let us do good unto all men.'

*The south wall of the chancel, looking west*

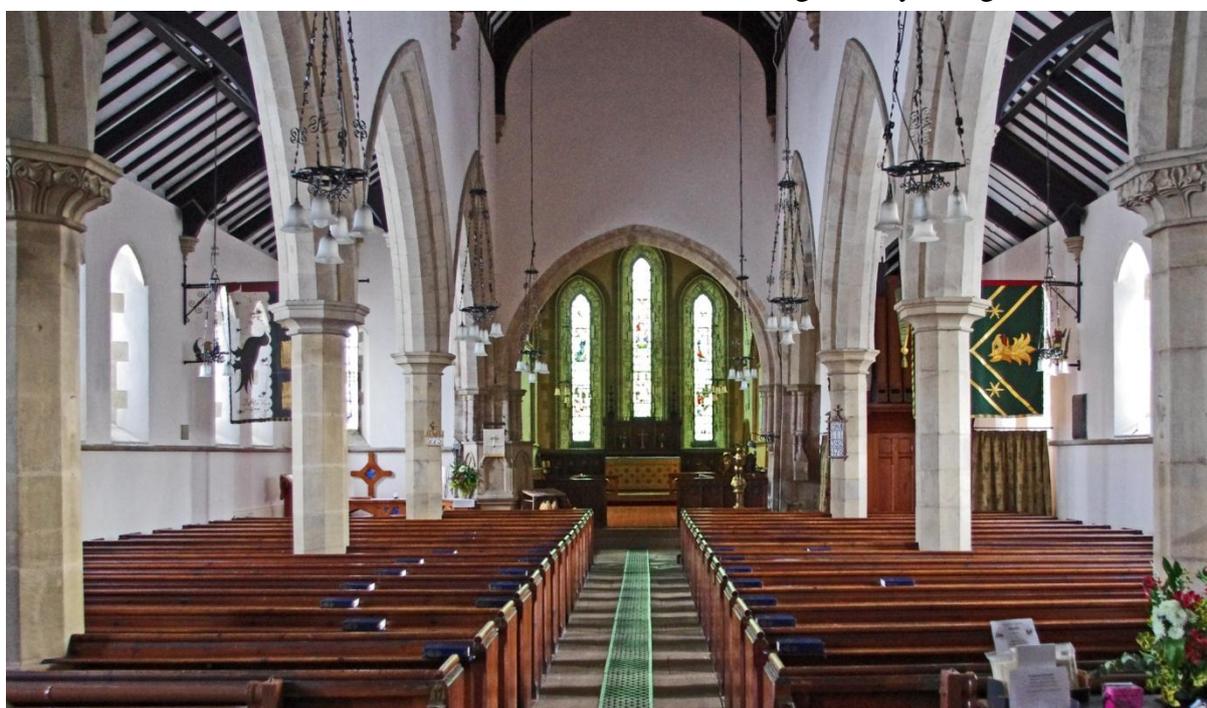
*Interior looking east*

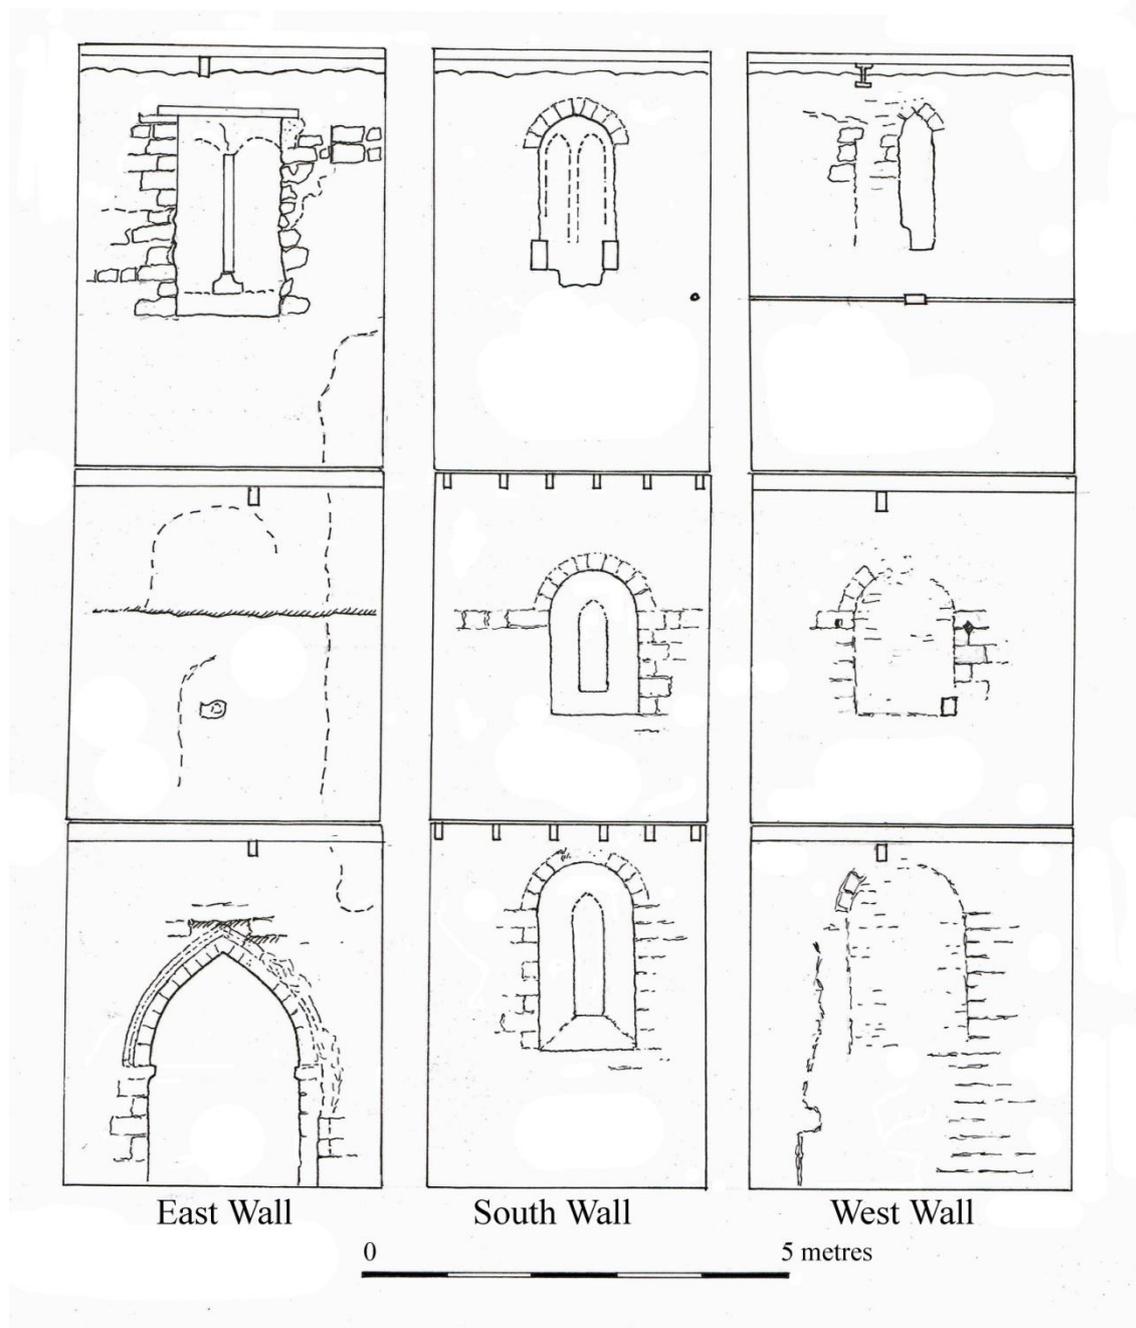
St Mary's Church, Stamfordham  
Internal Sketch Elevations of Tower

The **Tower** is entered by the arch in the west wall of the nave, which contains a pair of modern boarded doors; on the other side of these the opening is in a very different form, and not easy to make sense of. The impost band in its unrestored forms, is square above and hollow-chamfered below, but very decayed, especially on the south. The inner order of the arch which springs from it, of simple square section, looks either restoration or re-cut, but the outer 'order' was left untouched. This begins above the north jamb as a normal hoodmould, chamfered below, but by the time it reaches the apex of the arch the wall face

has bulged forward and overhangs it raggedly by 10cm or more, making it very clear that the present arch is an insertion in older fabric. This hoodmould/outer order is much damaged on the south side of the arch, where the whole wall thickens and the jamb steps out, as if to take a full outer order; this step has a broad chamfer starting a little above the floor, but as it rises this is so badly damaged (apparently by fire) that the whole profile of the arch is lost.

The east wall of the lower stage of the tower, above the arch, is of coursed but quite irregular fabric, in contrast to the other three walls which are of better-coursed diagonally-tooled stone

which, together with the near semicircular rear arches of the south and west (blocked) windows is of typical 12<sup>th</sup>-century character. At the south end of the east wall, high is, is what looks like an infilled socket (modern cables come through here, so it could be relatively recent) but above it is a slightly recessed column of disturbed masonry which rises to c 1.5m above the floor of the third (belfry) stage of the tower; it is difficult to say whether this is the result of structural movements, or just possibly the removal of the south wall of an earlier and rather narrower tower or storeyed porch (see Structural Development section)

The tower is obviously of peculiar interest and complexity, so any works here should be accompanied by detailed archaeological recording – note that the drawings provided with this report are no more than sketches.

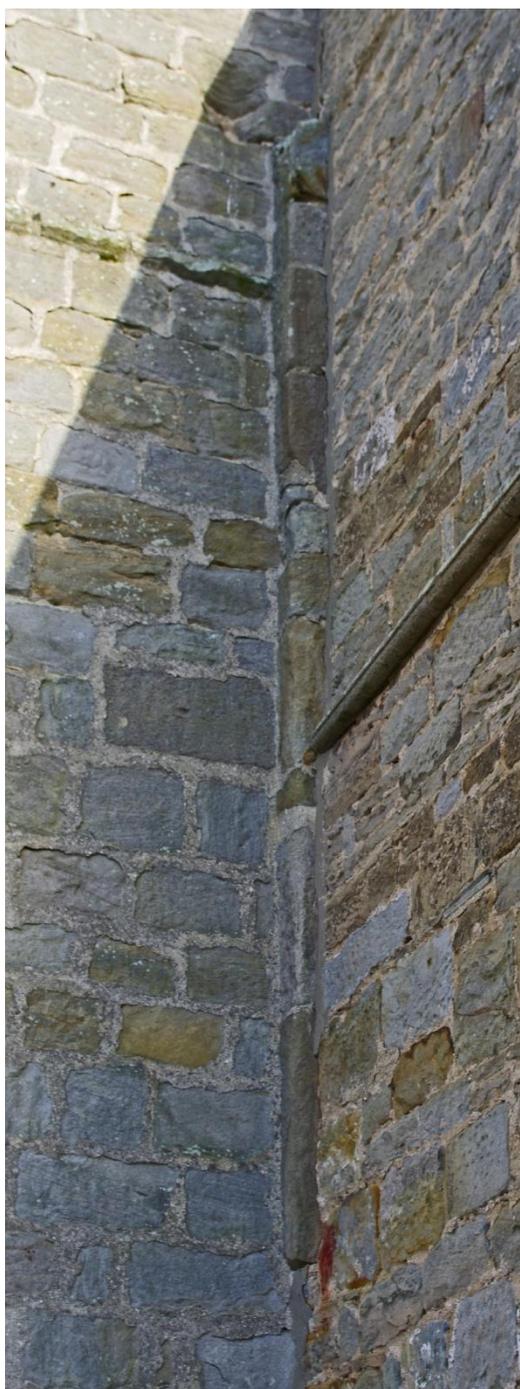
All the external masonry of nave, aisles and south porch is of 1848, with the limited but important exception of the corners of the south-western nave quoins in the angle between tower and south aisle. This is clearly in-situ work, and leaning outwards, so in the lower wall it is wholly concealed, but further up appears as a projection. The angle quoins are clearly substantial blocks of Anglo-Saxon character, and probably of megalithic side-alternate form, although this cannot be substantiated. It is likely that similar early fabric survives at each angle of the nave, but at the others it is totally concealed by later additions, although there is a short length of straight joint close to the south end of the east end of the north aisle, above the upper string course – no large quoins are visible, so it is difficult to know what it represents, although it must indicate the survival of some pre-1848 fabric.

*Nave South-West Quoin*

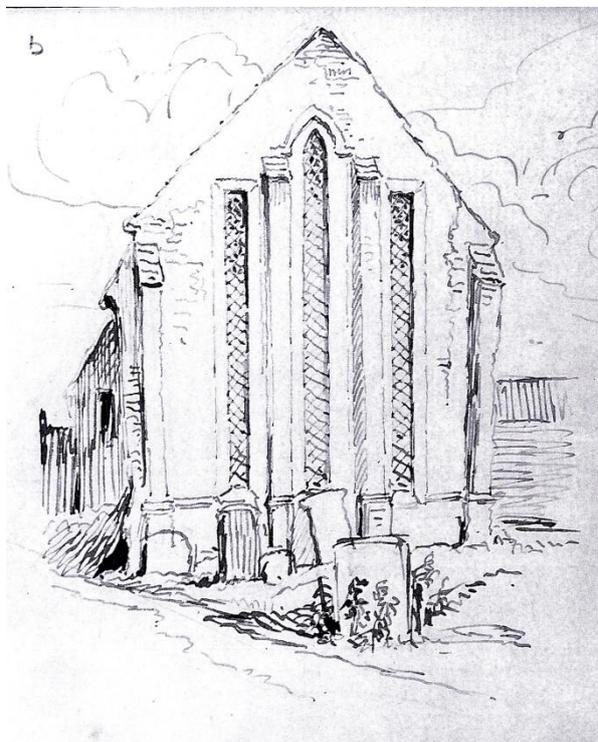
1844 sketches of the church<sup>4</sup> show the east end of the chancel, with the outer lights of the triplet having square heads, and the old font; a note states that ‘the taste of the debased age has tortured the building with sash windows’.

*1844 sketch of Chancel*

It is clear that the church was also altered in the post-medieval centuries; many windows had been converted into sashes. The square-heads of the flanking lights in the eastern triplet shown in the 1844 sketch were probably also later alterations, to facilitate easier glazing. Galleries were also inserted, as both Glynne and Ferrey regretted. All this was swept away in 1848 by Ferrey's scheme, which was said by some to have left the church 'over-restored' (Nikolaus Pevsner) but this is a little unfair, if one accepts his word of the structural necessity for major works, the universal desire at this time to return buildings to an idealised medieval form, and the excellent quality of the work had carried out.
