HISTORIC BUILDINGS CONSULTANT

The Church of Our Lady, Seaton Delaval

The Delaval Family Vault

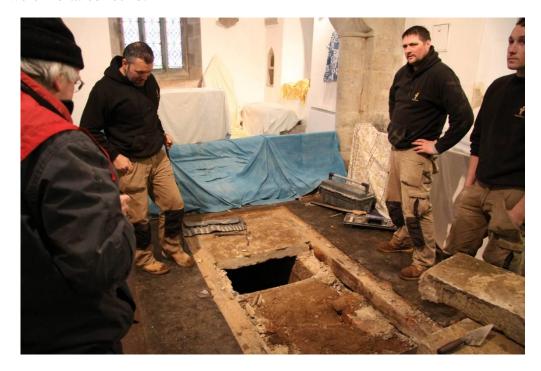
An area of modern floor covering in the centre of the chancel was removed, to expose a floor consisting of a range of rectangular north-south slabs set between two eastwest beams c 0.95 m apart. Six slabs, each 0.38 m wide, were exposed; the beams, each 80 mm wide (and, as later revealed, 135 mm deep), each contained three pairs of mortices for (removed) uprights, perhaps the front of former choir stalls. The slabs were mortared round.

Removal of the fourth slab (from the west) reveals the head of the stair down to the vault

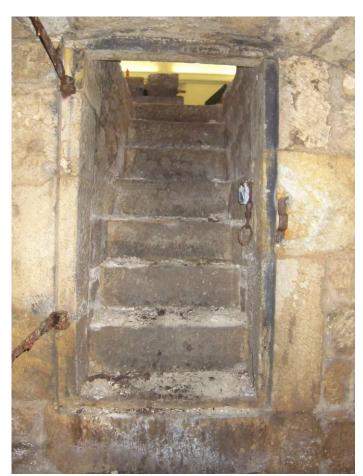
The steep staircase consisted of seven regular steps, each c 250 mm deep, set between walls 0.75 m apart, which are built of coursed squared stone, quite heavily mortared. At its foot a plain squareheaded doorway 1.42 m high and 0.75 m wide, opened into the vault; towards the vault this is rebated all round. The lintel, 0.16 m thick, is set 0.25 m below the soffit of the slabs covering the stair (which form the chancel floor) but only 0.05 m below the soffit of the roof of the vault. The opening has been closed by a door; its hinges remain, set within the southern rebate, but the woodwork has fallen away completely, its decaying remains now scattered in the vault floor. On the west wall of the vault just inside the north

The Stair looking west (Richard Carlton)

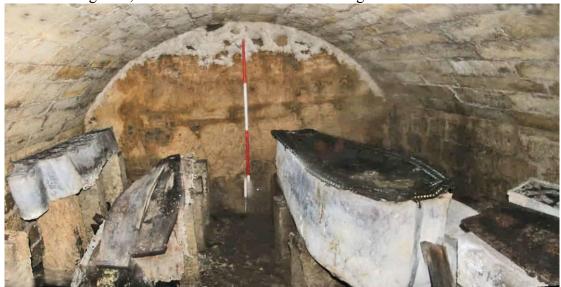
The vault is rectangular in plan, 4.2 m east-west by 3.6 m north south, and occupies almost the full area of the Sanctuary; its east end is more or less in line with the Sanctuary east wall, although the side walls are set c .25 m inside the lines of those above. It is covered by a shallow segmental vault, springing from the side walls at half its central height of 2.1 m. The walls and vault are of neatly-squared sandstone – with a distinctive narrow course at the springing of the vault – except for the east wall, which is cut directly in bedrock, except for the top c 0.35 m which is heavily cemented over² There is a thin layer of debris on the floor, which seems likely to be largely of bedrock³. There are a few markings on the vault, probably in a thick pencil – above the centre of coffin 5 is what looks like 'XVII' (with a double 'X') and above coffin 1 a single 'X; elsewhere there are one or two single strokes.

The vault, looking east, showing all six coffins (1 far right to 6 left)

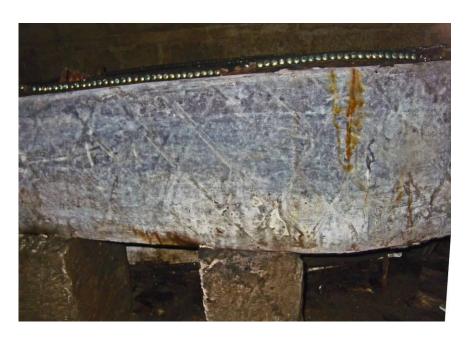
- (4) A similar six-sided coffin, raised on three coffin rests; as with (2) it has been encased in wood, but only its top survives the lead sides show an interesting lightly-incised diaper/ criss-cross pattern; it is not clear whether this is intended to be decorative, or relates to some sort of binding or means of affixing the wooden casing. The top is covered by leathercloth, and has a border of brass studs, mostly still bright, with inward-pointing triangles at the corners and along the sides. Lying loose on the top are three embossed brass plates, and two sides of a metal box-like structure, exactly like those remaining in situ on coffin

(above) Diaper pattern on the side of coffin (4)

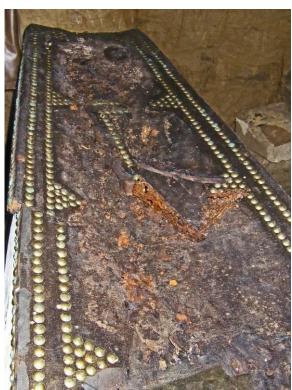
(left) Top plate of coffin (4) showing leathercloth (?) covering on boarding, with decorative border of brass studs; In the centre is a loose fragment of material with a similar patterned border, from another of the coffins, and two sides of a box-like structure, probably from coffin (2)

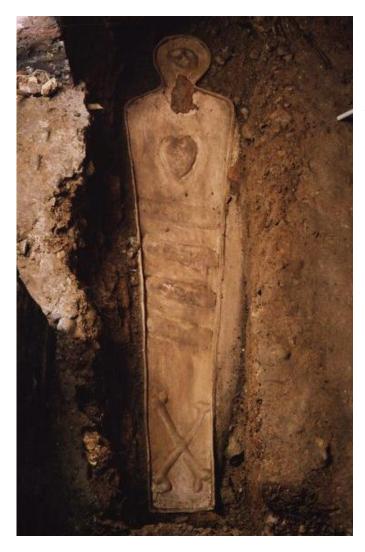
The vault beneath the Chapel at Dilston Castle, near Corbridge, Northumberland, has recently been examined by Northern Pennines Archaeology and a full report is available⁷. A series of coffins had been removed in the late 19th century, but a trial excavation in the vault floor revealed a lead 'anthropoid' coffin very similar in form to nos 1 and 6 at Seaton Delaval, bearing an embossed skull at the top, a heart, and below that four 'embossed' bars (but without any inscription) with crossed bones at the base. Dr Julian W S Liten of the British Museum identified it as typical of the second half of the 17th century – which would suggest that the Seaton Delaval examples of 1722 and 1723 represent a certain stylistic conservatism.

Lead Coffin at Dilston (photo Frank Giecco, Northern Pennines Archaeology)

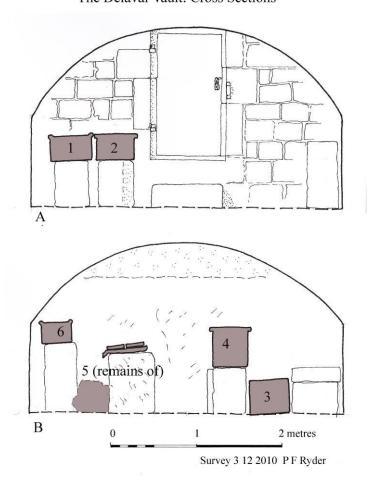
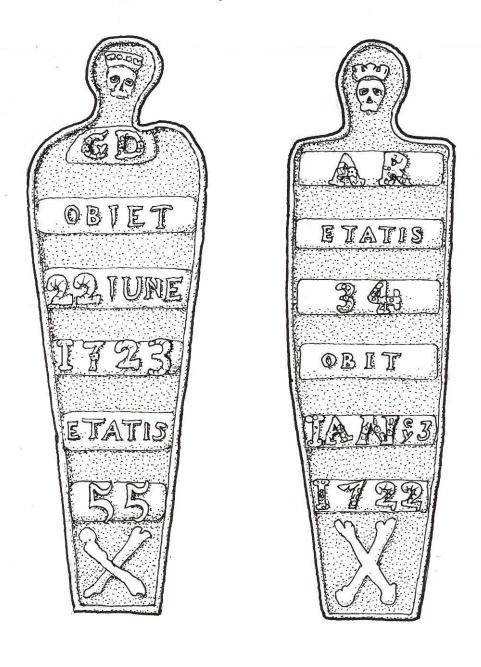
Lead Coffins of Sir George Delaval and Sir Alexander Ruthven

(1) Lead coffin adjacent to the west end of the south wall; a shaped coffin with its top shouldered to a narrow 'neck' and rounded head, in which is an embossed death's head with a crown. Beneath are a series of raised pillow-like bands bearing applied letters – the larger ones (here in bold) are ornate with floral decoration;

- (5) A coffin (recorded in 1893 as 'Elizabeth Hick died Febry 25 1796 Aged 23 years') which has disintegrated, leaving only its base (external lead and two shaped planks of the inner) resting on its three blocks; the remains of the remainder are heaped on the floor to the north, with the skull lying loose. Elizabeth was a mistress of Lord John Delaval (d.1808) who is buried in Westminster Abbey); he would have been 68 at the time of her death.
- (6) Lead coffin set against the east end of the north wall, on three blocks. In form and decoration crowned death's head at the top and crossed bones at the base it is virtually identical to (1), except a little more square-shouldered. The inscription reads
