HALTON CHAPEL

(THE CHURCH OF ST OSWALD, ST CUTHBERT AND KING ALFWALD)

AN ARCHAEOLOGICAL ASSESSMENT JULY 2020

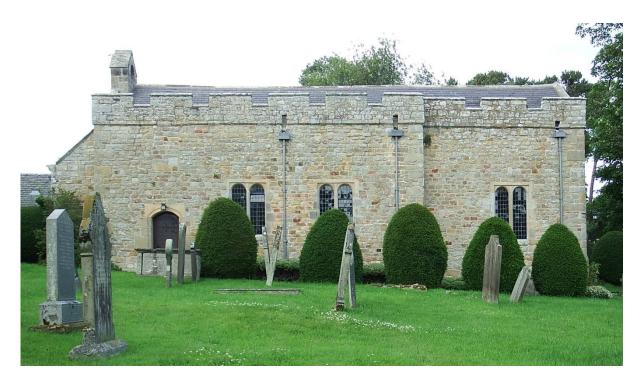
The Chapel from the south

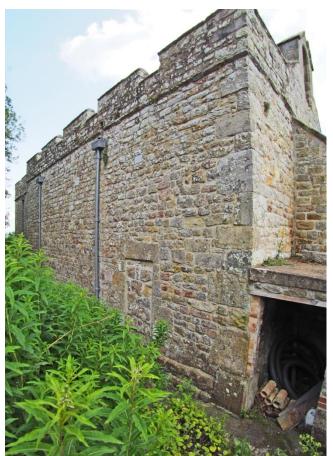
The only feature in the north wall of the nave (left) is a blocked square-headed doorway towards the west end, with its surrounding chamfer stopped on the lowest block of each jamb, and a threshold that is now c 0.40 m above the present external ground level, which has been lowered to facilitate drainage. At the base of each of the northern angles of the nave is a very large well-squared block (Roman?) projecting slightly from, the wall; the northwestern has a second very large quoin directly above it, but otherwise the quoins are similar to those at the other angles, substantial and alternating but not of any diagnostic character. Over most of the length of the wall a single course of slightly-projecting footings is exposed; to the west the door this becomes a pair of

courses, the lower projecting more boldly. The parapet is as on the south of the nave.

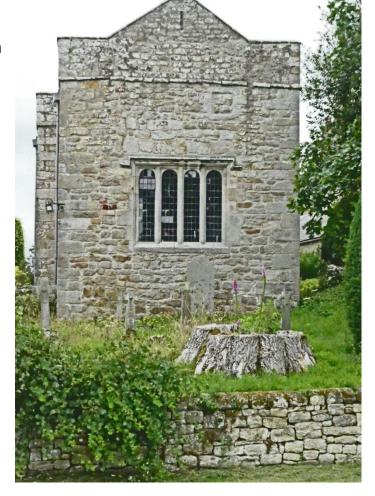
The east end of the chancel (right) is somewhat different to the other walls of the church, being of roughly-coursed more elongate blocks. It has a square-headed window of four elliptical-arched lights, broadly similar to those on the south except that its seems of rather earlier

character - its lights are rather narrower, the outer frame is chamfered rather than a square rebate, and there is a casement-moulded hood with turned-back ends. Directly above the window is a course of eight or nine large wedge-shaped blocks, perhaps re-used from the coping of a wall, and above those, towards the north end of the wall, is a blocked window, almost square, with a chamfered surround. At the foot of the parapet the chamfered oversailing course of the south wall return for a metre or so beyond the south-east angle of the chancel but then, after a short break, becomes a rougher projecting string (with another short gap near the north end). The parapet above has a central gablet, with a plain square-headed slit vent.

On the basis of the Carnaby monograms on the rear arch of the east window, the east wall would seem to be of mid-16th century date; it is both thicker than the other walls, and of markedly different fabric. Its high-level window seems to imply that it belonged to a two-storeyed structure quite different to the present chapel.

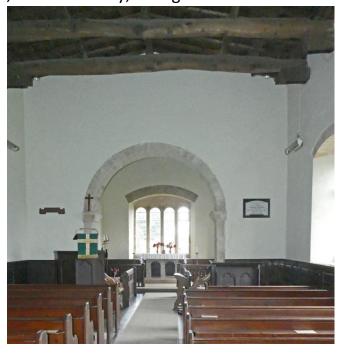
The nave roof is of eight bays, with heavy and irregular tie beams, later given the additional support of short stub ties beneath their ends, bolted into the older timbers above. There is a roll-moulded wall plate, one level of purlins supported by triangular wooden blocks resting on top of the principals, and a central short king-post, with scooped and chamfered sides, supporting the ridge.

Nave looking east

The **Chancel arch** is generally regarded as the oldest feature of the church, and is usually ascribed a 12th century although a Saxon date is sometimes suggested. It is an absolutely plain semicircular arch, of one square order (without any through stones) springing from imposts with a broad chamfer below, and absolutely plain square jambs. The imposts are each a single large slab, 220mm thick and 930 mm from east to west. Towards the nave they only return for c 0.30 m, but towards the chancel the southern returns for 800 mm

and the northern for 660 mm, roughly two-thirds of the way to the side walls. The dressings have a light diagonal chisel tooling.

admittedly does look simple Romanesque work, but it could also be of 17th or even early 18th century date; its dressings have a simple diagonal tooling that does not look early, and the wall in which it is set is of exactly the same thickness – 690 mm – as the side walls of the church. Photographs taken with low angle lighting suggest that behind the plaster the wall is of rubble, unlike the coursed squared Roman stone of the external walls, but this is no surprise, given that it would have been intended that it was plastered on both faces. So what is the date of the rest of the fabric?

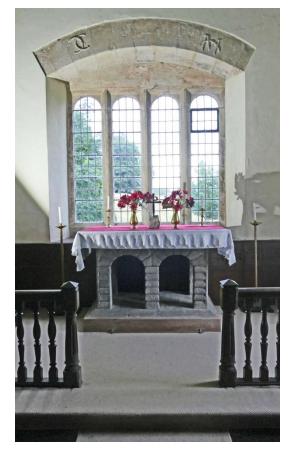
In the chancel the south window again has a segmental rear arch; to the west of it the outline of a blocked doorway can be traced behind plaster. The east window (below) has a

segmental rear arch; on the vertical face of the voussoirs are two monograms carved in relief, the northern a pair of the letter C, set back-to-back and overlapped, and the southern a combination of M and C. Incised on the soffit of the south end of the arch is a letter S with a vertical rod running through it, incised and infilled with some dark material. The monograms are thought to represent Cuthbert Carnaby (c1510-1586) and his wife Margery.

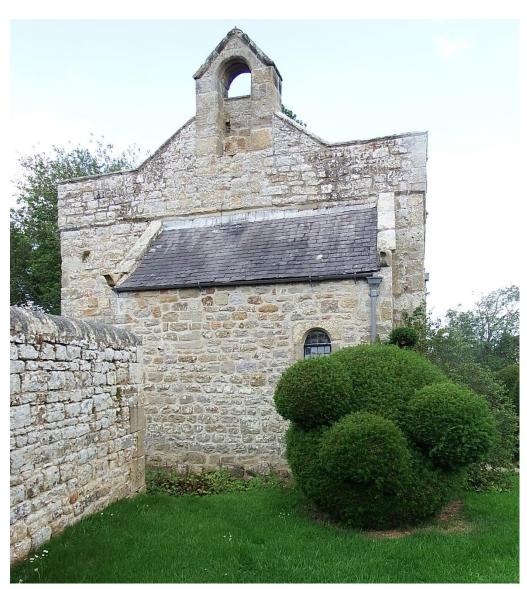
The west end has a pent-roofed stair projection, set a little south of centre, its roof coming up to an oversailing course (a continuation of that on the side walls). Near its south end is a small round-headed window in a square frame, its head cut into a single block, and a single upright forming each jamb. Further north and rather higher in the wall are the remains of a small, apparently square window. The sill seems to remain in situ, and the blocking includes two sections of rebated jamb. Above the oversailing course is a plain parapet, with a central gablet that seems to have been raised around an earlier bellcote which has a round-headed chamfered arch (now partly infilled – there is no longer any bell) and a gabled top, with a coping chamfered on its underside.

West view, with projection for gallery stair (and topiary pig)

The 18th century building clearly had a western stair and a gallery – faint traces of which show through plaster on the west wall – which was probably removed in some unrecorded 19th century restoration, when the high level window which lit the gallery was blocked, as well as the priest's door on the south of the chancel.
