The Church of St John the Baptist Newcastle-upon-Tyne

An Archaeological Assessment
January 2020

PETER F RYDER
B.A., M.Phil, F.S.A
HISTORIC BUILDINGS CONSULTANT

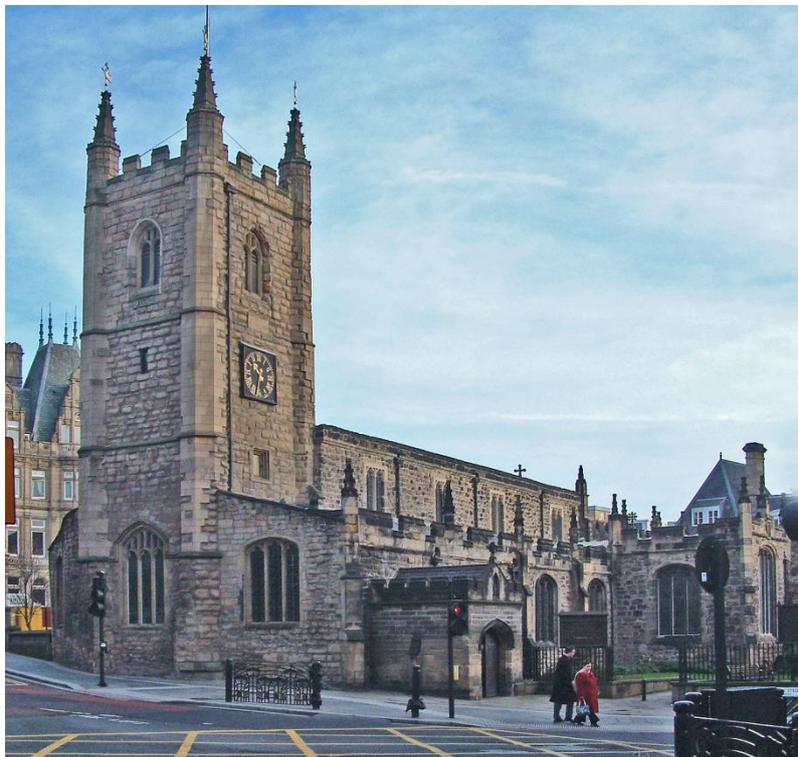
The church from the south-west

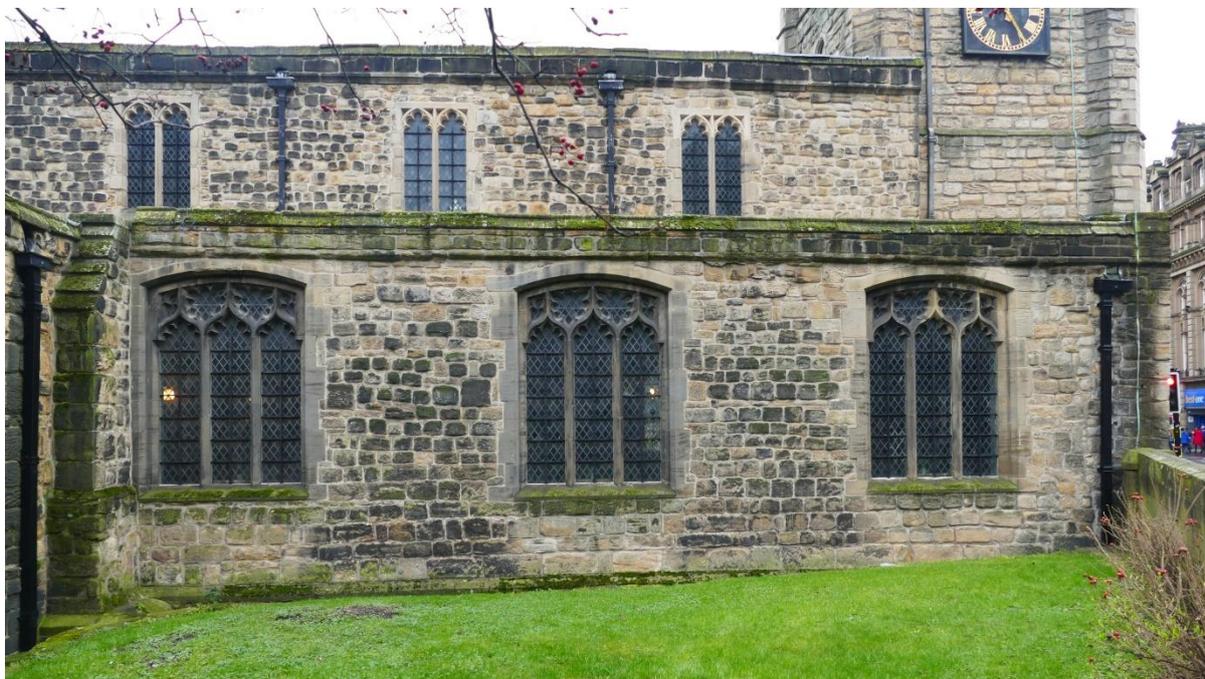
The north wall of the aisle (above) is of coursed squared stone, with large and clearly re-used blocks in the course above the plinth, and further up some smaller almost square stones; all this may be re-used Roman work. The wall is of three bays, and has a continuous chamfered plinth, which ends in a chamfered return a few cm short of the short wall which abuts on the north-west corner of the aisle; this return must relate to the medieval north door⁶. The only buttress is at the east end of the wall, and has the west wall of the North Transept aisle abutting against it. The irregular projecting footing now exposed below the plinth widens to form a broad base for this buttress. The windows are each of three lights, with cinquefoil-headed ogee-arched lights, and simple tracery over under a shallow segmental arch, with a chamfered frame. They are of 14th century character, although all their stonework is Victorian restoration. There is a chamfered oversailing course at the base of the parapet, which has a simple moulded coping.

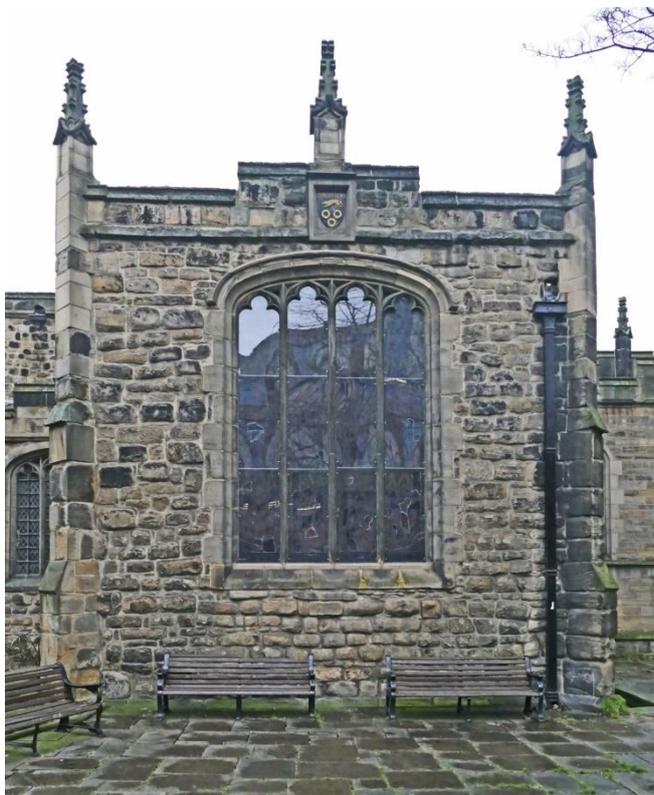
The **North Transept** (below, seen from the north) has an aisle on its west side, and is built of coursed squared stone. There is a continuous chamfered plinth on the north of transept and aisle (possibly renewed, as there is strong evidence that the aisle is an addition). The transept but

not the aisle has a string course, chamfered above and below, beneath its windows. There are a pair of set-back stepped buttresses at its north-east angle, a buttress between transept and aisle (which is oddly set so as to overlap the west wall of the transept by a few cm) and

The west aisle of the transept is an addition, and could correlate with the recorded 1412 foundation of the Chantry of St Thomas of Canterbury – but a western aisle is hardly the place for a chantry, which would require an altar, and that usually needs an east wall.

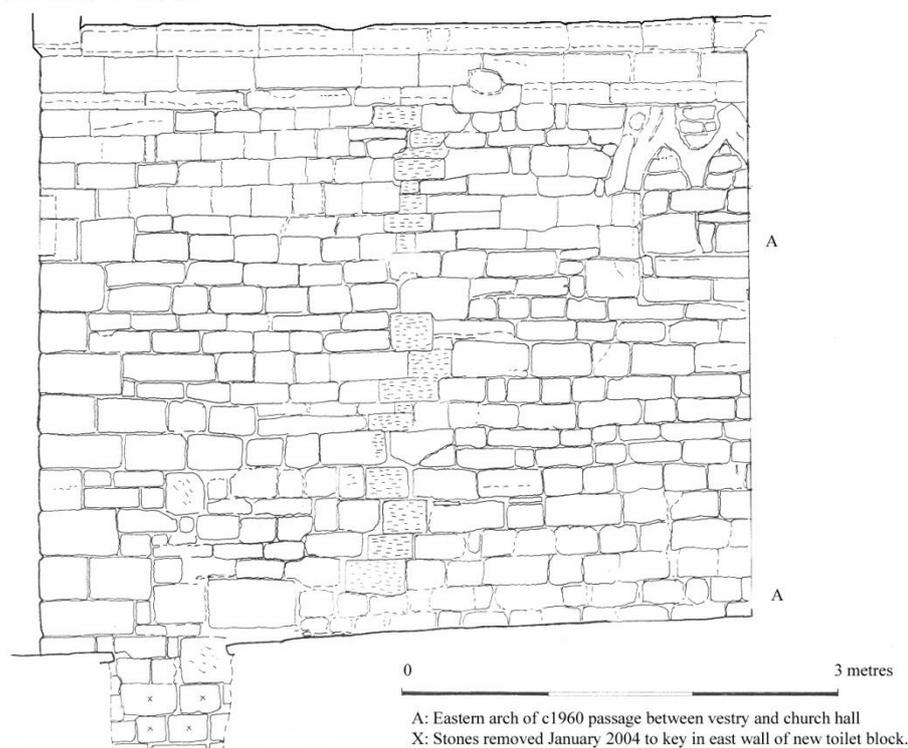
Drawing 2

North Elevation of
Clergy Vestry, drawn
from rectified photographs

The external face of the north wall of the clergy vestry (above) was recorded in 2004⁹; towards its west end (right) were remains of a 14th-century window of two ogee-headed lights and some sort of piercing in the spandrel, its monolithic head cut across by a later parapet, with a roll-moulded coping, suggesting that the original structure was lowered, perhaps in the 16th century.

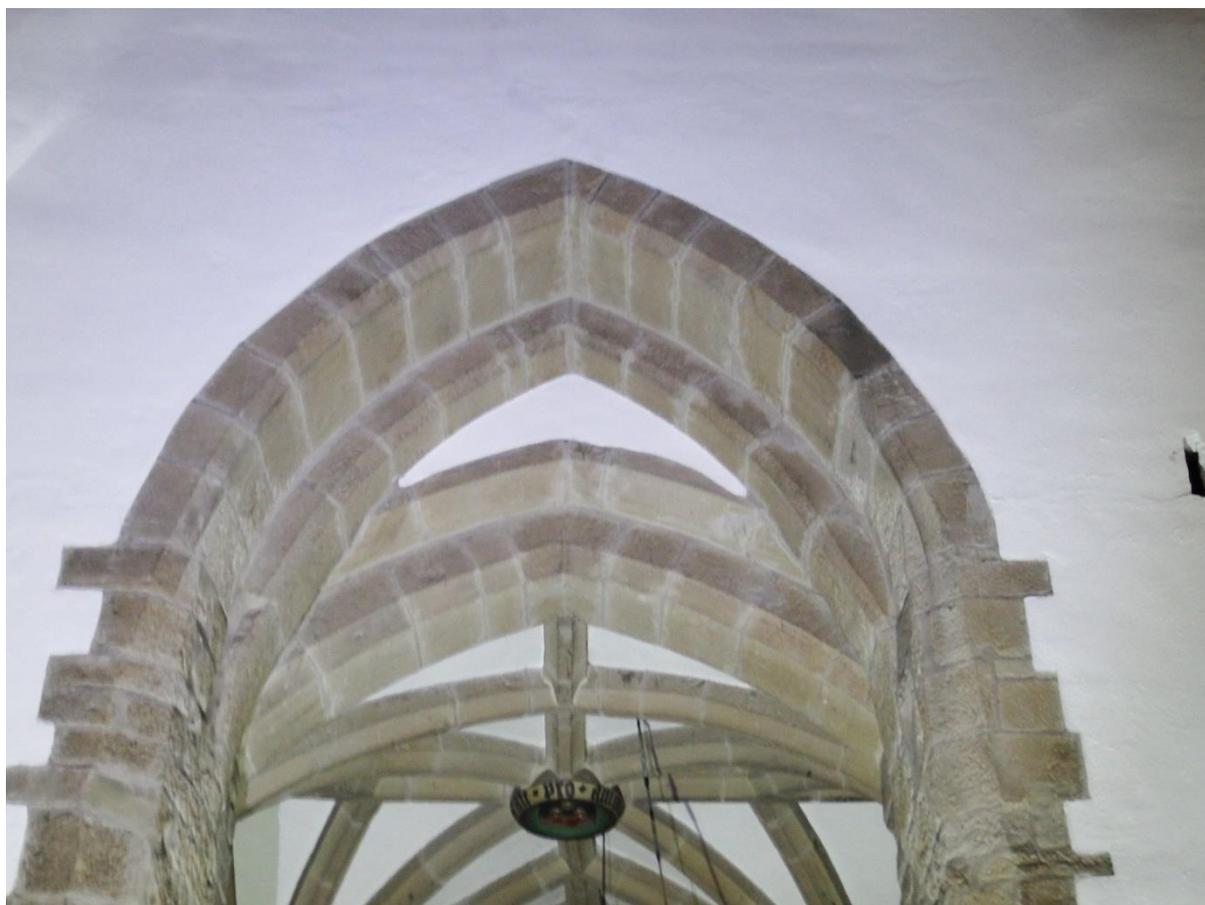
The upper part of the tower arch is the rear arch of a 13th century west window; above and to either side the steep slope of the contemporary roof-line is visible through the plaster.

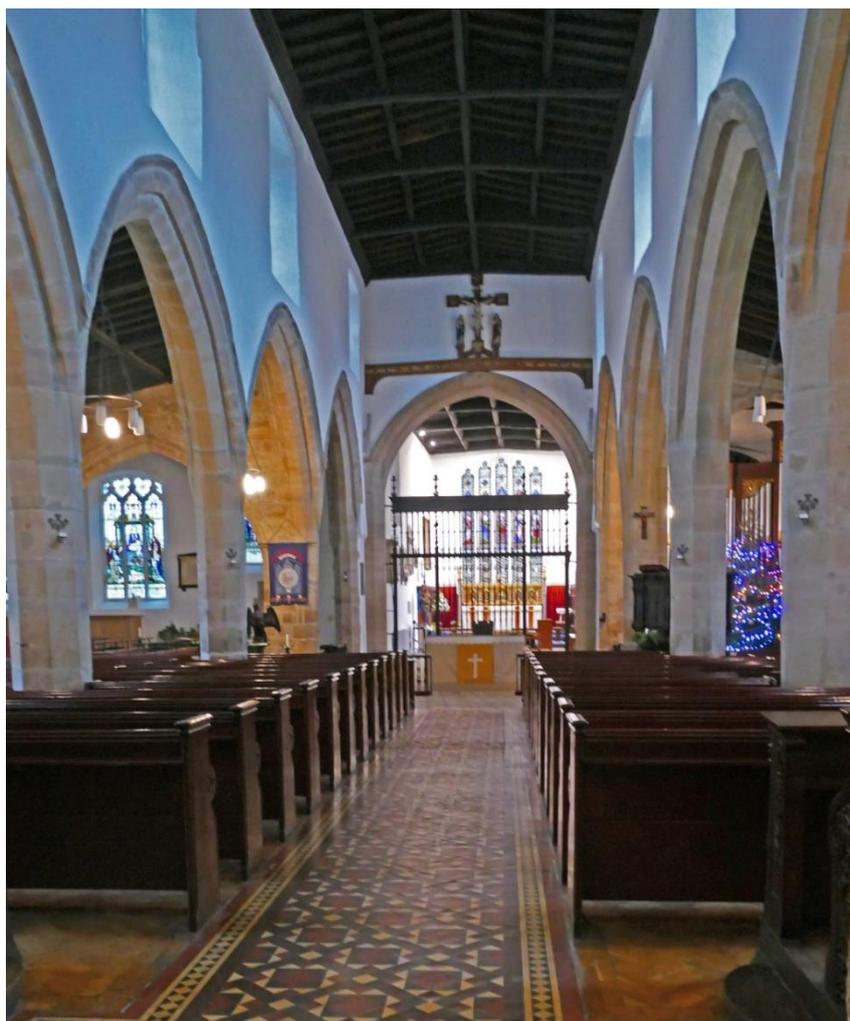
Above the arcades, the clerestory windows have shallow segmental rear arches. To the east the chancel arch is set well back, and the upper portions of the side walls are carried on oversailing chamfered courses at around the level of the springing of the arcade arches; higher up on the south wall a recessed panel; (behind plaster) represents the upper door of the former rood stair; sockets for the ends of the rood beam were filled in during the 1923 repairs¹¹.

Interior looking east

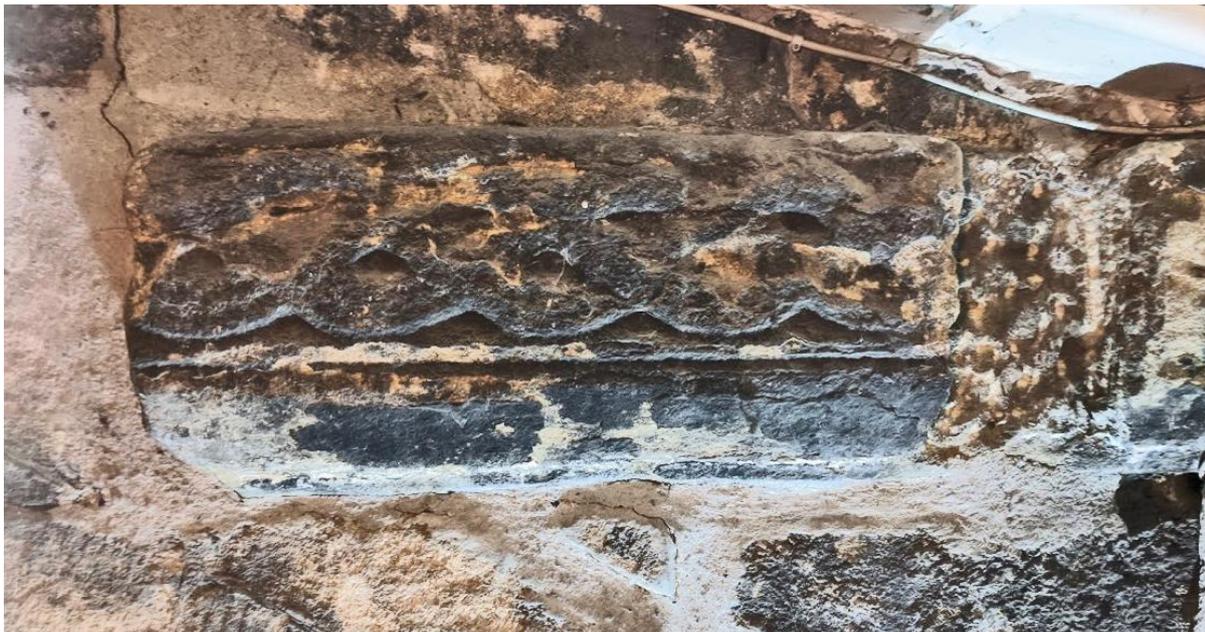
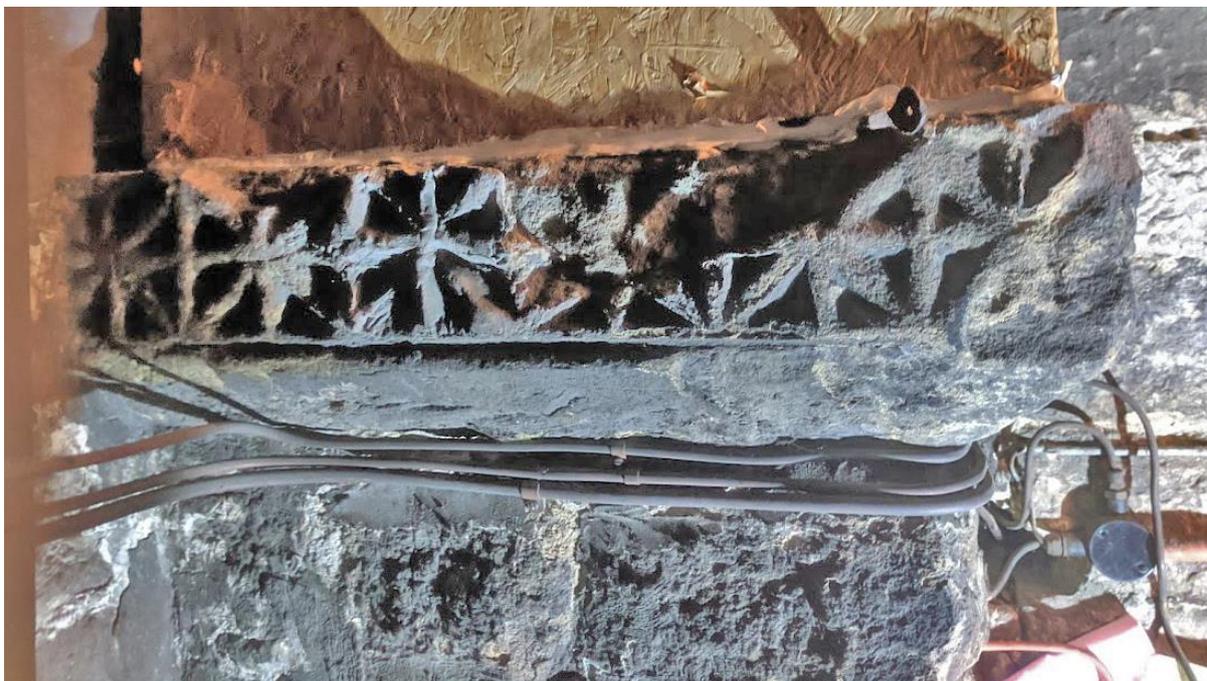
Remains of 12th century string courses on the buttresses at the west ends of the chancel walls

Above, on the northern buttress, with interlace/plait-work which is more familiar as a Pre-Conquest motif, although the section of the string (with a groove and a chamfer below) is a very typical 12th-century one. Below, on the southern buttress, sunk stair ornament, a typical 12th-century form.

Within the **Organ Chamber** the only significant feature is an early buttress at the west end of the south wall of the chancel, which has survived the rebuilding of the remainder of the wall, and has a raised band/string course with the remains of the typically 12th-century sunk star ornament, above a groove and a chamfered lower angle.

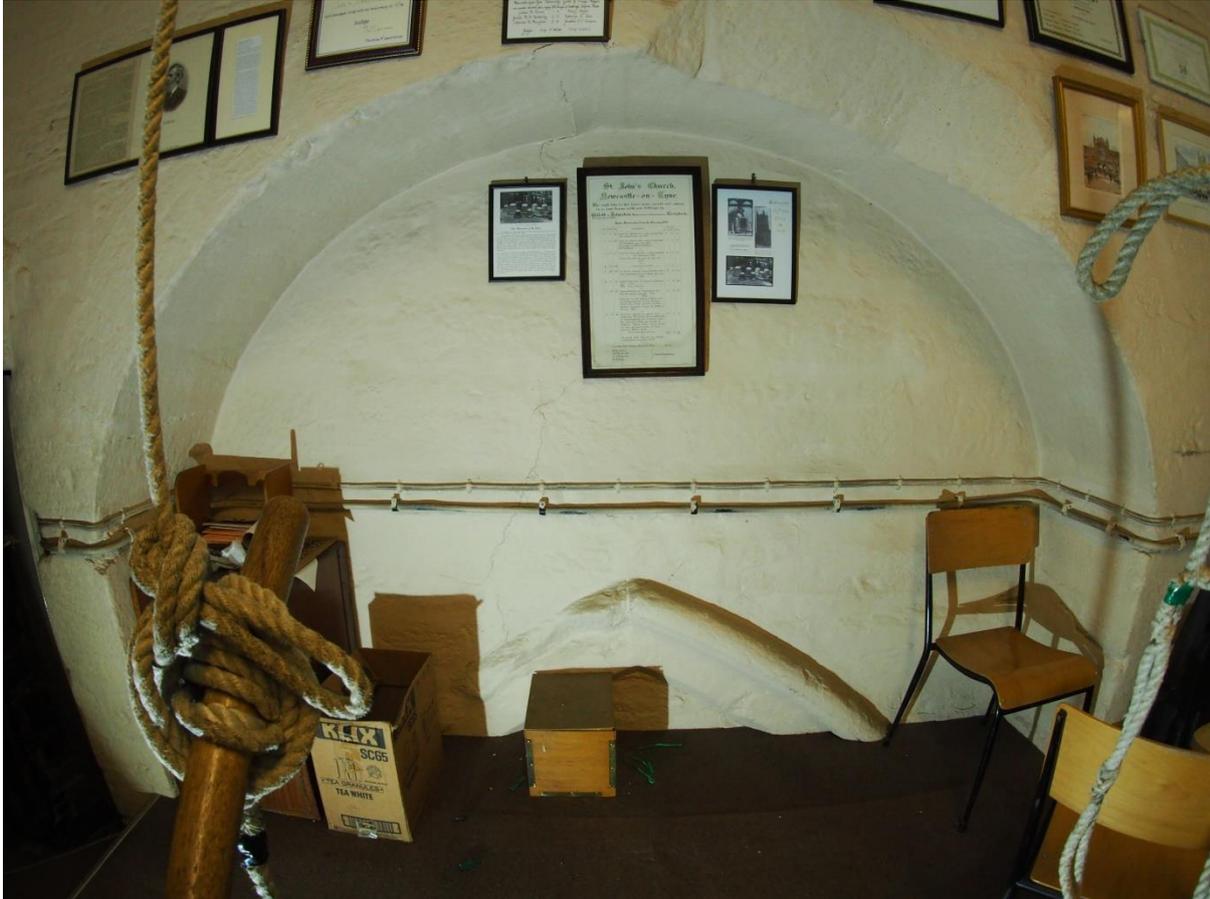
The east side of the Ringing Chamber, with the head and hoodmould of the 13th century east window, within a rough semicircular arch of the same date, which probably carried a bellcote.

The West Tower is said to be of c1230, but this can be strongly contested. The only evidence the date is the acutely pointed form of the tower arch, which a close inspection shows is actually an enlargement of an original window in the west end of the church, set under a taller arch in a thick wall that almost certainly carried a bell cote, not a tower.

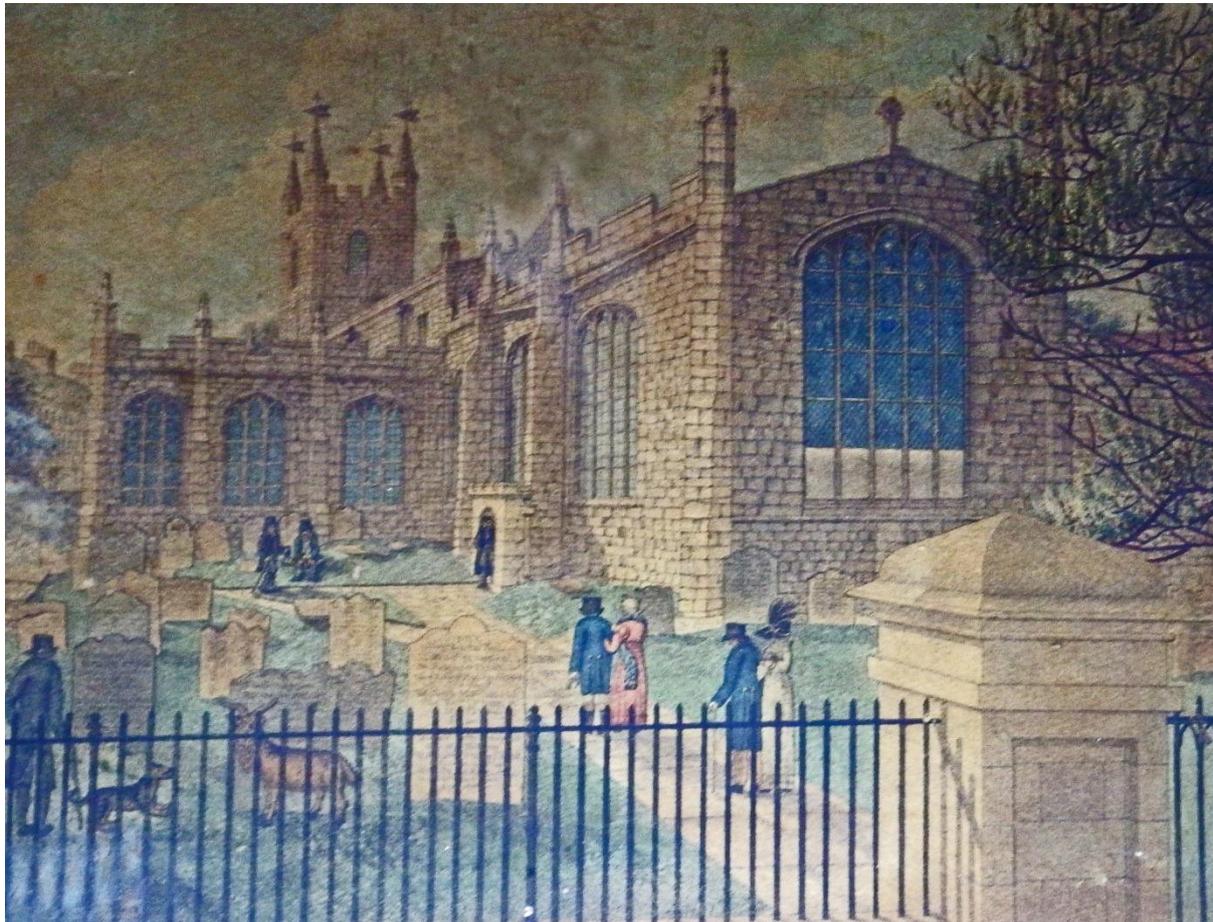
Early 19th century (?) painting of the church, now in the Clergy Vestry, showing the chancel before the rebuilding of its south and east walls in 1848, and the addition of the Organ Chamber in 1884

³ This is backed up by the fact that an early 19th century (?) painting, now in the Vestry, shows a central steeply-pitched gable, with the clerestory walls on either side clearly a later addition. The chancel arch is recorded as having been rebuilt in 1885, so presumably the wall above was renewed as well.

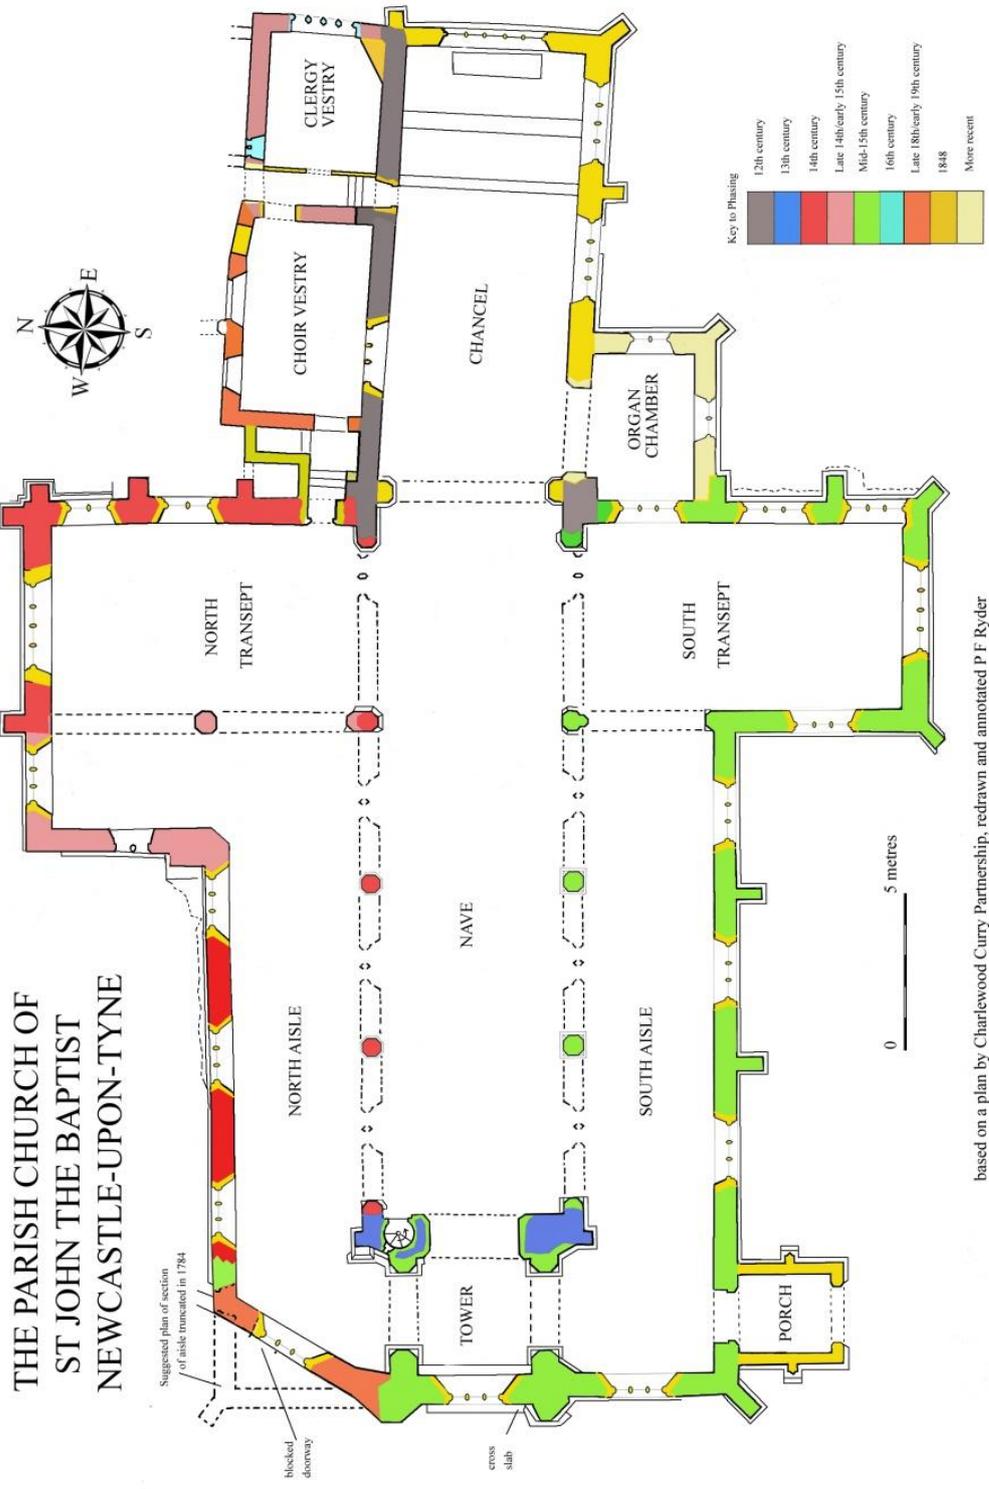
based on a plan by Charlewood Curry Partnership, redrawn and annotated P F Ryder

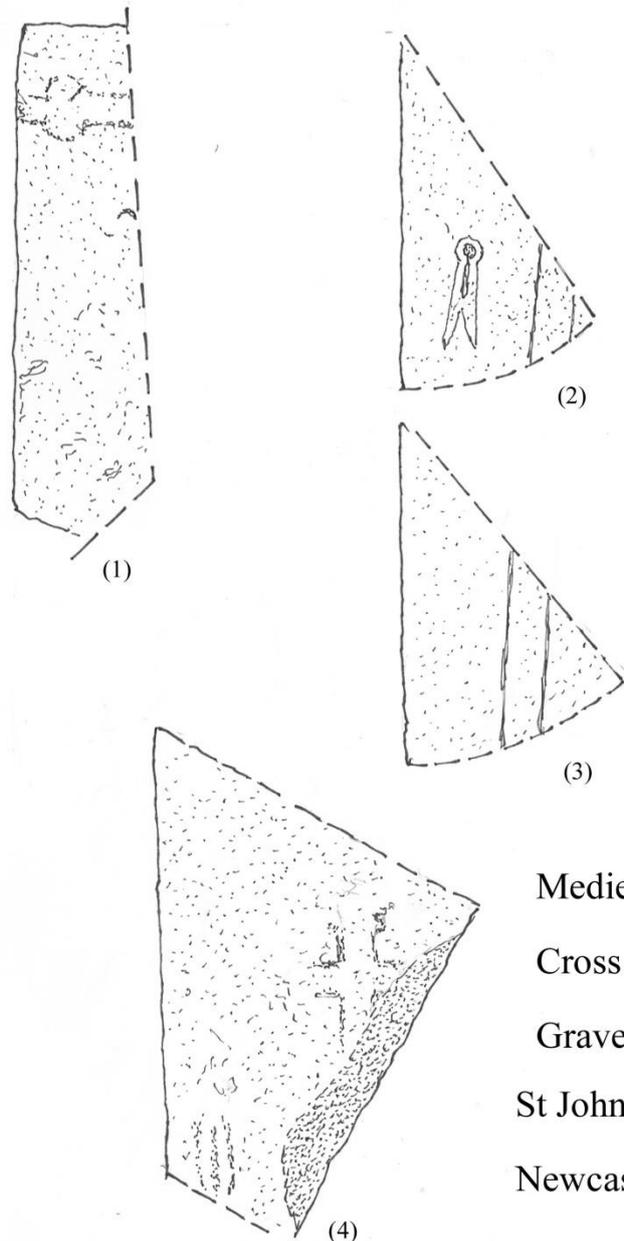
Medieval
 Cross Slab
 Grave Covers
 St John the Baptist
 Newcastle

A number of slabs found in the church during the 19th century restorations were taken to the Society of Antiquaries of Newcastle museum in the Castle Keep, where they remain¹⁵. The slabs shown here do not seem to have been previously recorded.

- (1) Footing of west wall of Tower
 (2) Sixth roof slab from base of Tower Stair
 (3) Tenth roof slab from base of Tower Stair
 (4) Head of door into Ringing Chamber

opens into the north-east corner of the ringing chamber. The lintel of this doorway is another re-used grave slab, with remains of an incised sword and a probable pair of shears (see appendix 1 for cross slabs)
