ST GILES CHURCH, BIRTLEY

AN ARCHAEOLOGICAL ASSESSMENT

FEBRUARY 2019

PETER F RYDER
B.A, M.Phil, F.S.A
HISTORIC BUILDINGS CONSULTANT

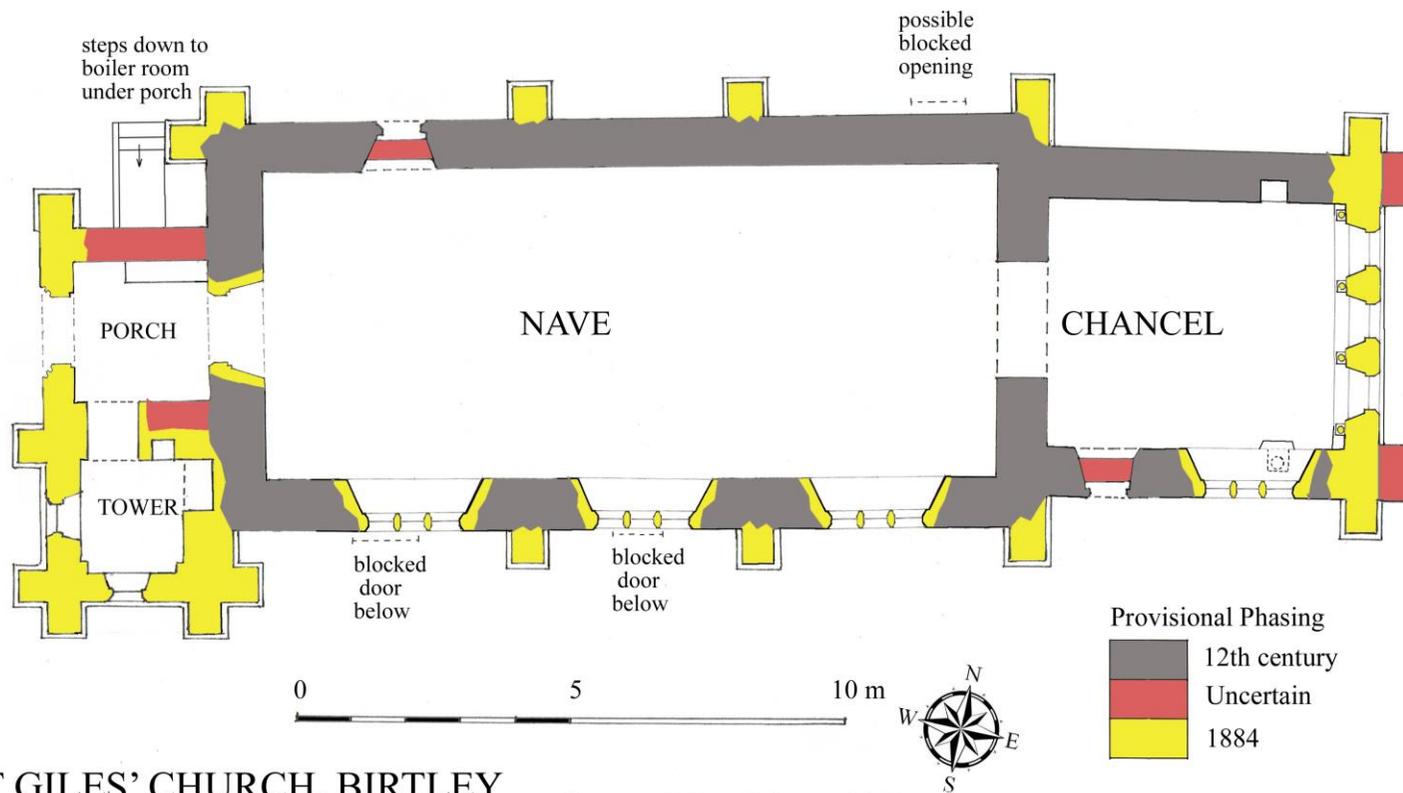
ST GILES' CHURCH, BIRTLEY

Survey P F Ryer February 2019

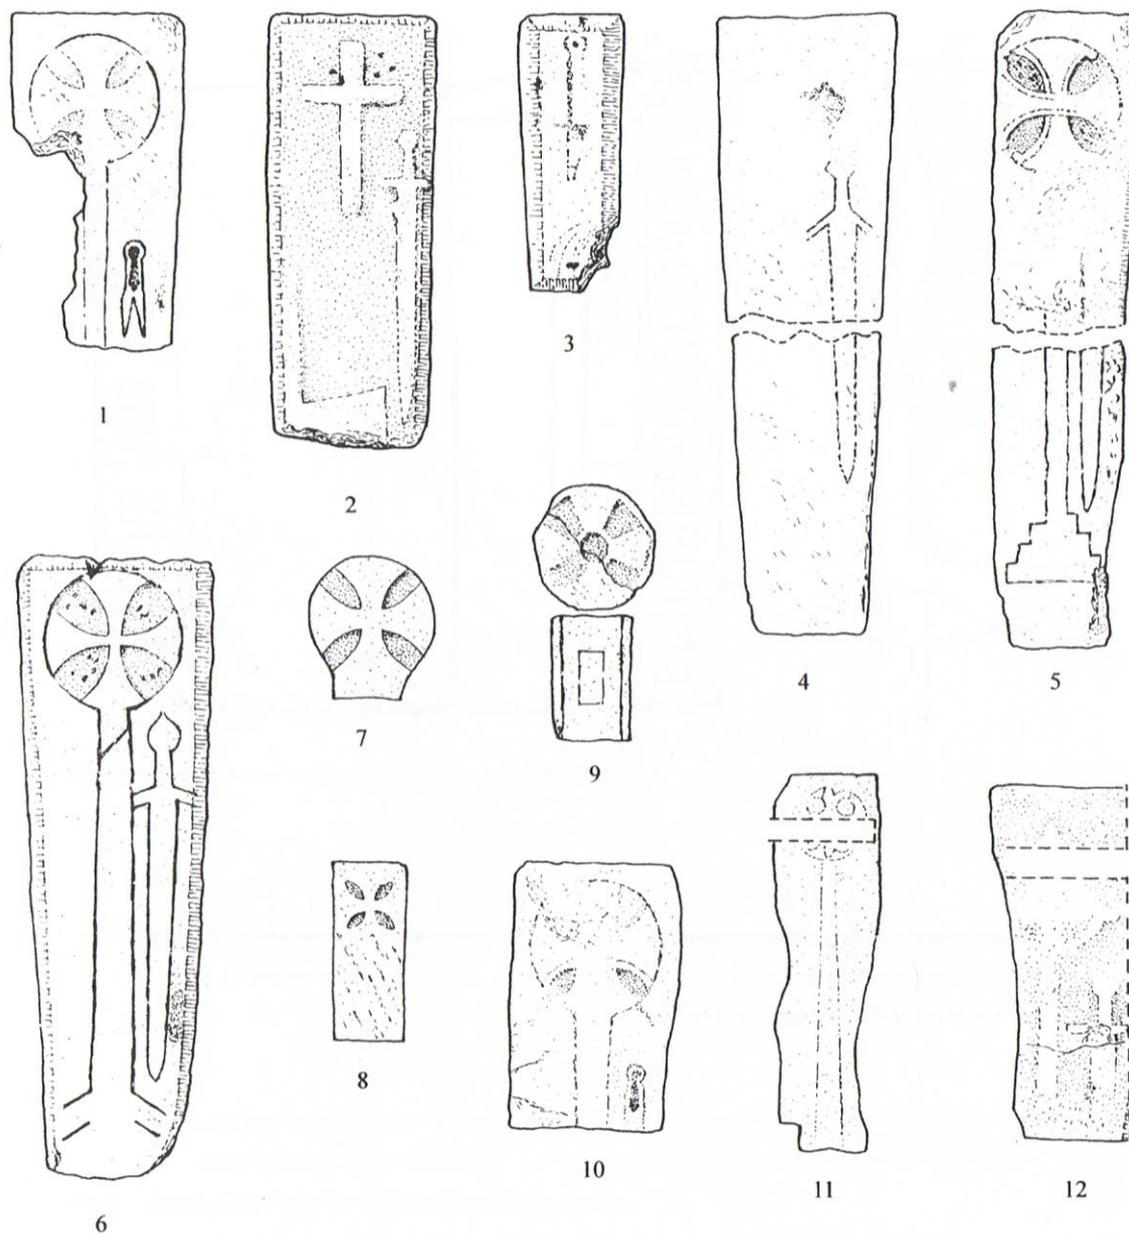
Appendix 1. The Cross Slab Grave Covers

- (1) Upper part of slab of pinkish sandstone, with its design incised except for sunk panels in the cross head. Cross paté with a pair of shears on the r. of the shaft. Probably 12th century.
- (2) Rectangular slab of a more coarse-grained fawn sandstone with relief design; simple straight-armed cross only half the length of the stone, with sword on r. and an inverted axe beneath. This slab is illustrated in the Hodges notebook ; the sketch, dated Dec 5th 1883, is accompanied by the note ‘another small one decayed beyond recognition and fragments built into S buttress east end of church’. No dateable features, but perhaps 12th century..

- (7) Discoidal sandstone headstone with cross paté of usual type, with sunk panels between the arms. The reverse feels similar, but, perched as it is in the eaves, it is difficult to inspect the stone without braining oneself with it. Cramp (1984, I, 237, II, pls. 232-4) sees this as a ‘round-headed grave marker’ of the second half of the 11th century.
- (8) A rectangular block, possibly either a headstone or a small conventional slab, very worn, but showing the sunk lenticular panels of the usual cross paté. 12th century?

- (10) Upper part of a slab of coarse yellowish sandstone., Cross paté, very worn, with shears on r. of shaft. 12th century.
- (11) Narrow slab of orange ferruginous sandstone. Incised bracelet cross within a circle, on tapering shaft. Late 12th or 13th century.
- (12) Part of a slab of light fawn sandstone, very worn. Relief design; the cross appears to have had fleur-de-lys terminals, with a sword on its r., with a discoidal pommel and square-set quillons. Date uncertain.
