St Cuthbert's Church

Bellingham

An Archaeological Assessment

October 2014

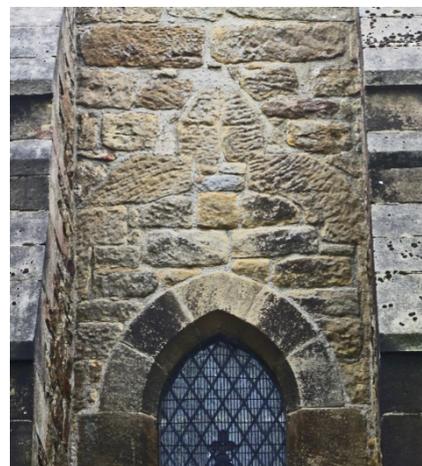
The west end of the nave has a central pair of tall stepped buttresses, with the west window in the narrow gap between. The greater part of the wall is of roughly-coursed and roughly-squared stone, with some quite elongate blocks; there are ragged breaks at either end, showing that the end buttresses of the side walls are secondary. The central buttresses, which rise to the base of the bellcote, have chamfered plinths and steeply-sloped offsets, and typically mid-late 19th-century dressings of tooled-and-margined ashlar, as has the window between them, a tall lancet with a chamfered surround. Above it is what appears to be the head of an earlier window, cut into two inclined blocks, both of which appear to have been roughly tooled back (right). Its original form (a segmental arch?) is not quite clear, as it has been cut both on the intrados and extrados by later sockets. The bell-cote is constructed of parallel-tooled 19th-century ashlar and has a simple round-arched opening, chamfered off-sets to its sides, and a gabled top with an oversailing chamfered coping that has a roll mould at the apex.

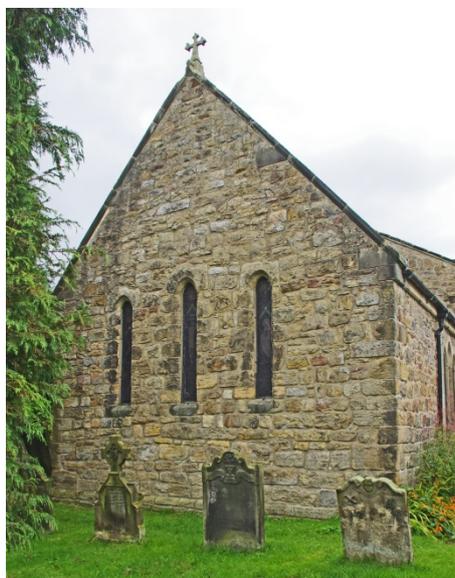
The east end (left) has rather more regular alternating quoins on the north, another indicant that the south wall may have been rebuilt. It has a triplet of narrow lancet windows, with monolithic heads, of quite different character to those elsewhere in the church. and presumably of 13th century date. The central is only slightly taller than the northern, with the southern a little shorter. The upper part of the gable looks as if it may have been rebuilt⁷; the coping, chamfered on its underside and carrying a cross fleury finial, is certainly 19th century.
