BELTINGHAM
THE CHURCH OF ST CUTHBERT
AN ARCHAEOLOGICAL ASSESSMENT

PETER F RYDER
B.A., M.Phil, F.S.A
HISTORIC BUILDINGS CONSULTANT

BELTINGHAM, ST CUTHBERT

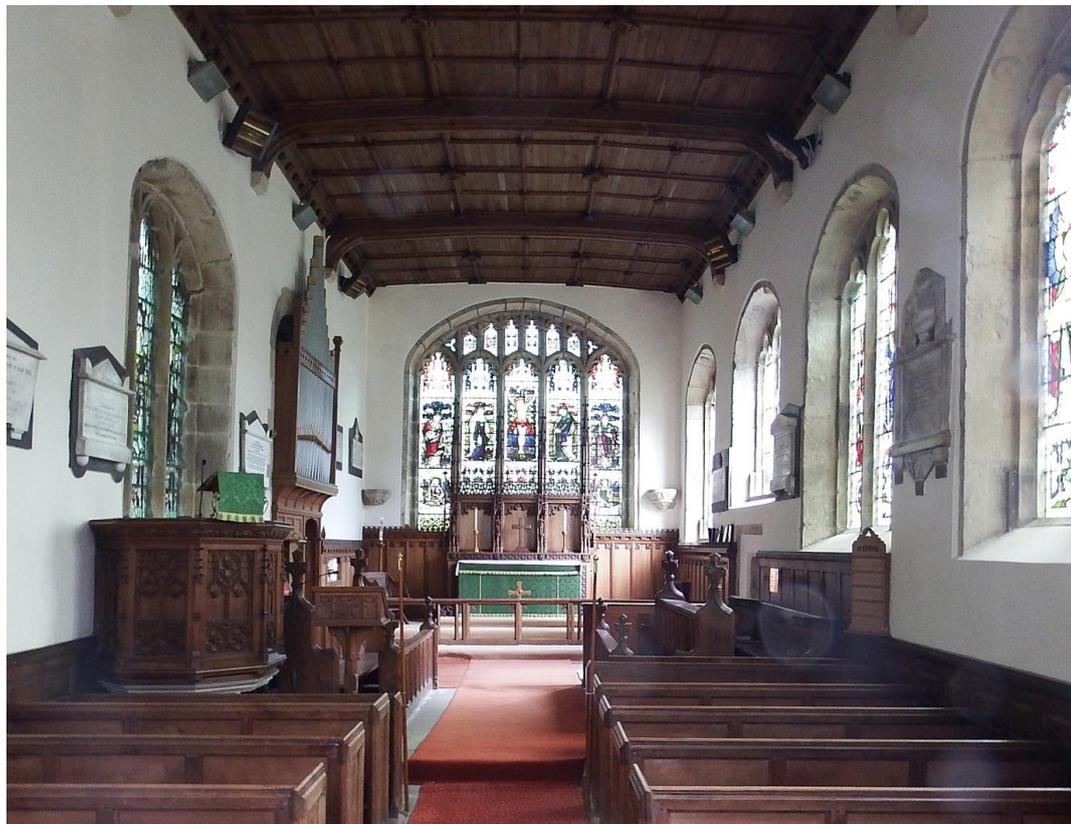
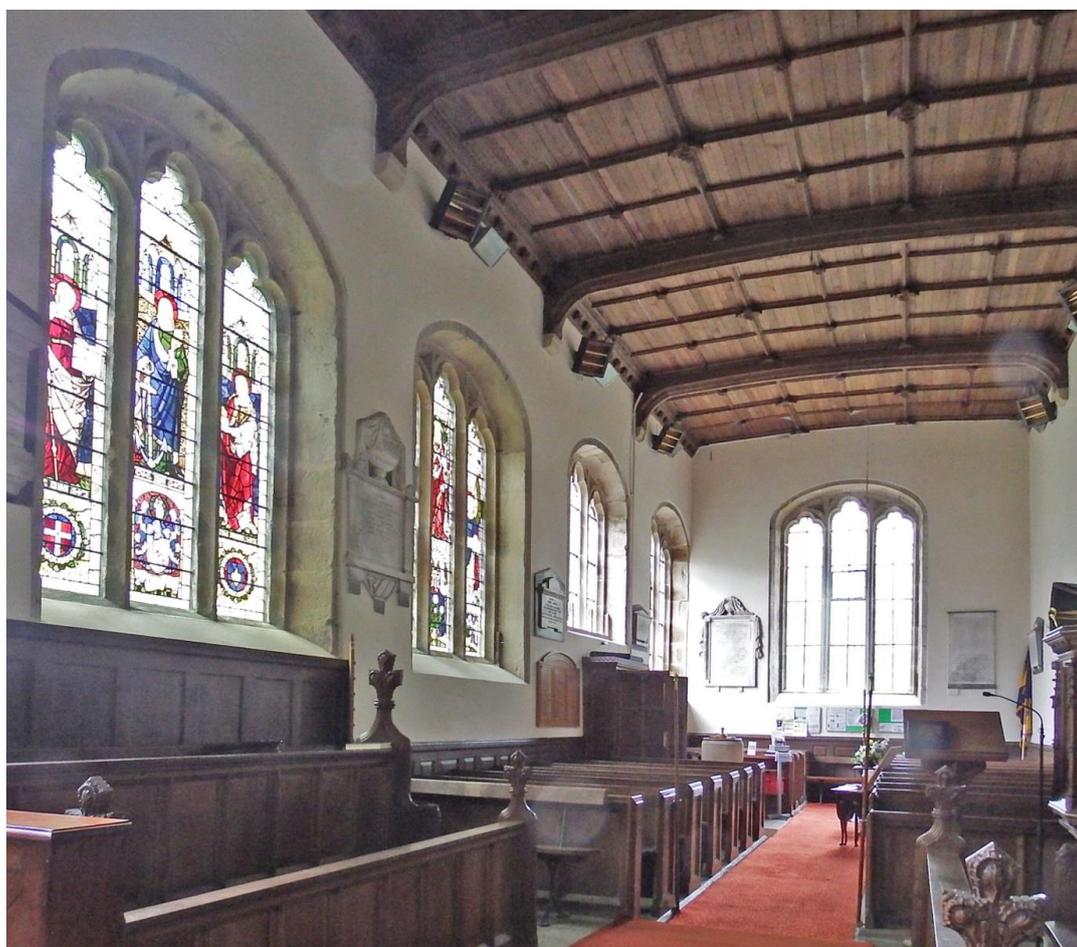
Interior looking east (above) and west (below)

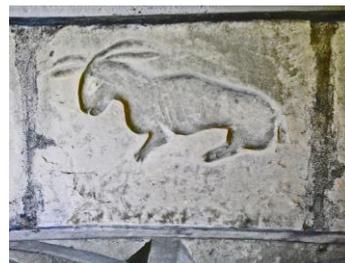
- (1) The easternmost window has a double-ended fleur-de-lys half way up its east jamb, and on the soffit of its arch an eight-spoked wheel and an animal which looks like a rabbit, although it could be a donkey.

The relief-carved motifs on the rear arches of the south windows (and the south-eastern corner buttress) are another enigma; they may be of some significance, other than merely decoration, but any interpretations would be pure speculation.

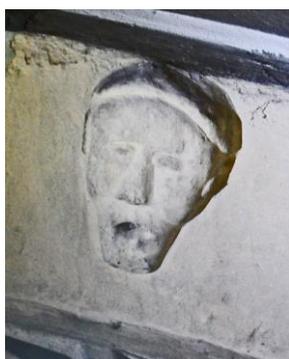
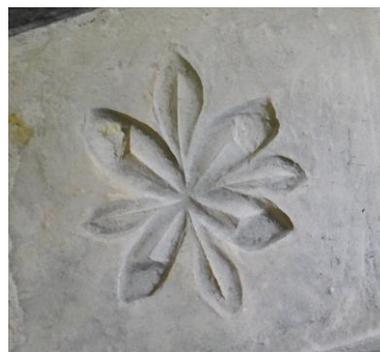
- (2) The next window has, on its soffit, a human head, mouth open, wearing a cap of some kind and a rather anguished expression; to the east of this there is an octofoil leaf.

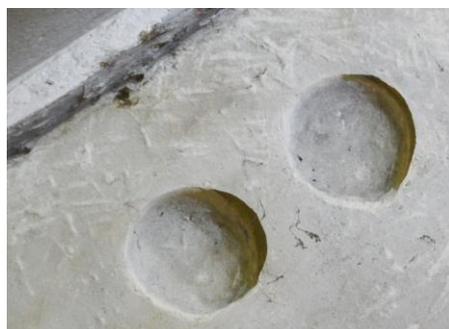
- (3) The third window has two raised half-balls at the apex of its rear arch.

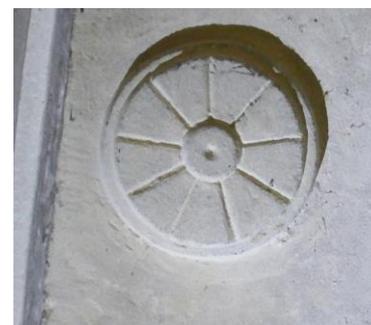
- (4) The fourth window (in the extended section of the church) has a roundel with a central raised disc, nine radiating lines and a moulded edge.

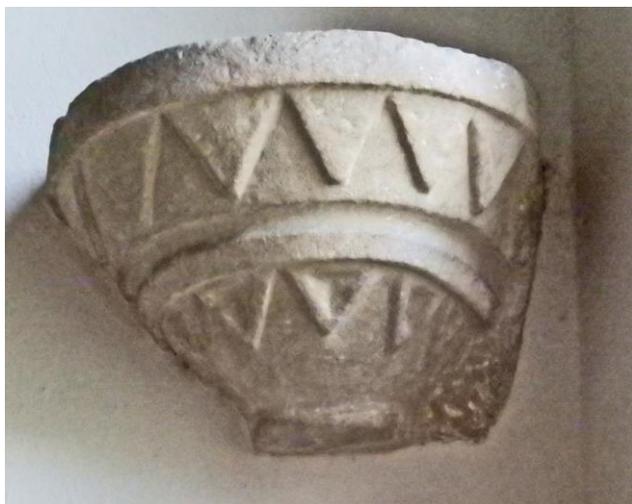
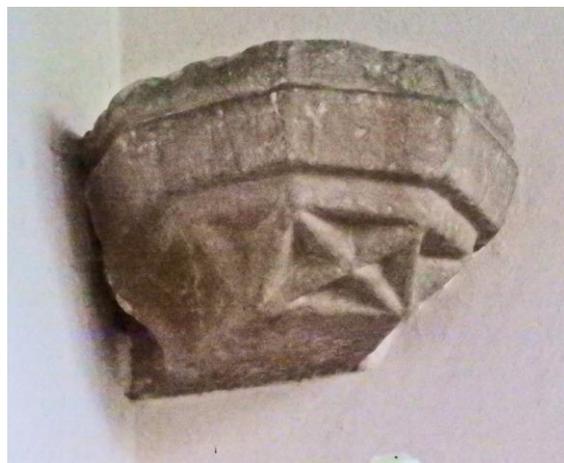
On either side of the east window are corbels, the southern sub-circular with large toothed or indented ornament, and the northern semi-octagonal with sunk panels containing geometrical patterns. It is difficult to date these – they could be 13th century work, or late medieval pieces reviving earlier motifs.
